# **District Disaster**

# **Management Plan (DDMP)**

**FOR CHIKKAMAGALURU DISTRICT  
2019-20**

## GEOTECHNICAL APPRAISAL, OBSERVATIONS AND RECOMMENDATIONS

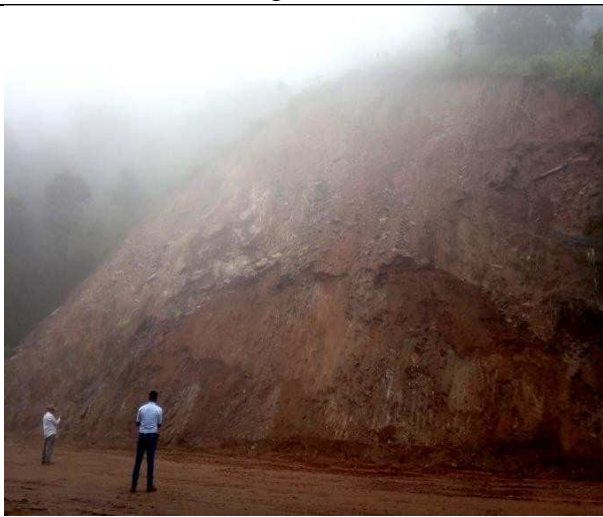
<p style="text-align: center;"><b>View of Landslide along Kotigehera-Charmadi road</b></p>

40	Summary/Abstract	:	The landslide is a debris slide having translational movement along a single rupture plane with approx. 70m run-out distance. The debris material has been moved along with trees and other vegetation. This landslide has occurred on concave slope with 35°-40° gradient. The slope forming material (SFM) laying over the hard rock got saturated by percolation of water during rains which increased its mass. Initially, high angel slope cut for road construction made the slope unstable. Consequently the saturated debris material moved down the slope along a weak plane under the influence of gravity. The slide has been occurred adjacent to the first order streams running southerly. Almost all loose material has been moved exposing the underlying rocks below the crown. Rocks are highly sheared. Crown of the slide is fractured that may lead to another failure during increased stress.

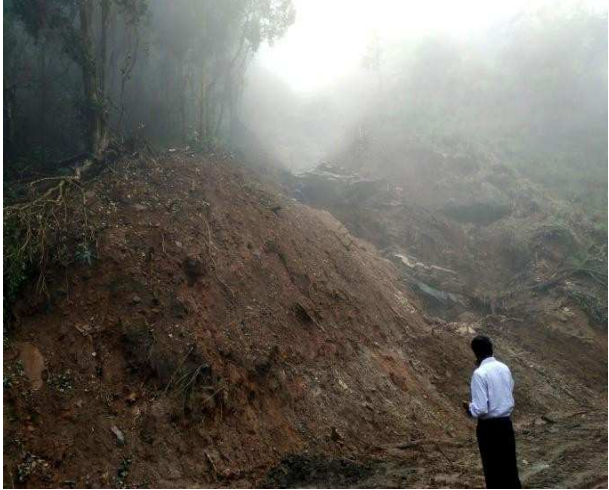
<p data-bbox="810 680 1326 712"><b>View of Debris flow occurred along a stream</b></p>

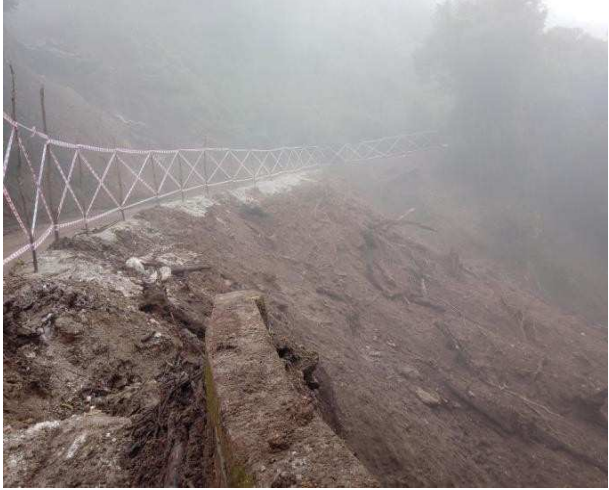
<p data-bbox="783 1200 1353 1256"><b>Debris flow damages the road and parapet along Kotigehera- Charmadi road</b></p>
40	Summary/Abstract	:	<p data-bbox="703 1256 1414 1848">The debris flow is confined to a long narrow valley. The slide is initiated as a planar failure. The debris is highly saturated with water &amp; the resulted runoff in steep slope damaged the road and parapet wall. The slope forming material (SFM) laying over the hard rock all along the valley path got saturated by percolation of water during rains which increased its mass. Initially, high angel slope has been cut for road construction making the slope unstable. Consequently the saturated debris material moved down the slope along a weak plane under the influence of gravity. The debris flow has been occurred adjacent to the southerly flowing first order streams. Almost all debris has been removed exposing the underlying rocks below the crown. Rocks are highly sheared &amp; folded.</p>

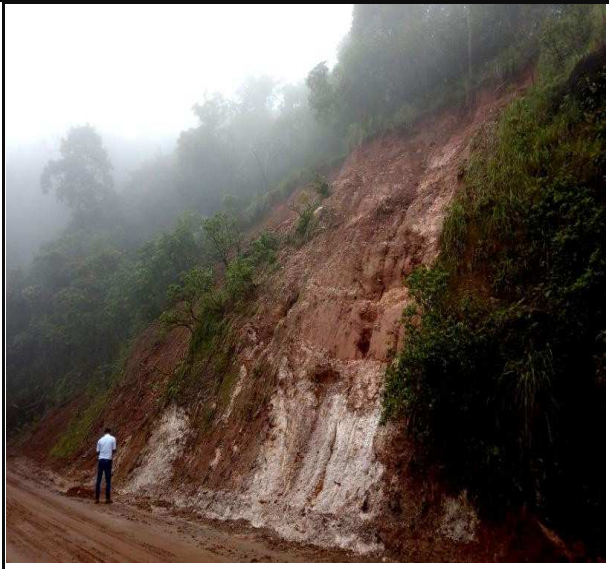
<p style="text-align: center;"><b>Multiple Debris slides along Kotigehera-Charjadi road</b></p>
40	Summary/Abstract	:	Multiple debris slides are observed downslope of road. The slide is initiated as a planar failure. The debris is highly saturated with water & the resulted runoff in steep slope damaged the road and parapet wall. The slope forming material (SFM) laying over the hard rock got saturated by percolation of water during rains which

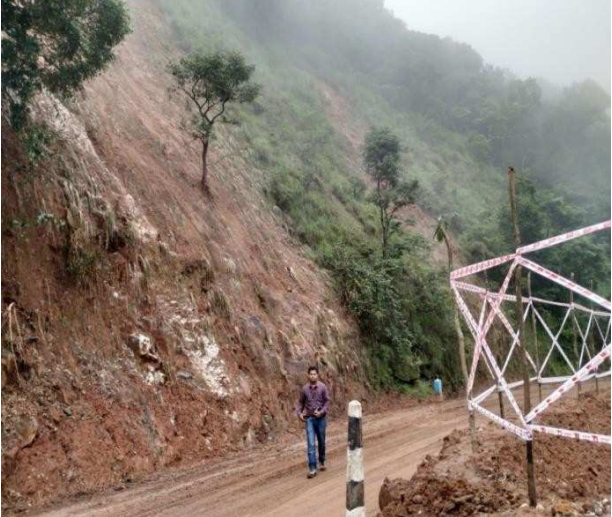
<p><b>Multiple Debris slides along Kotigehera-Charmadi road</b></p>

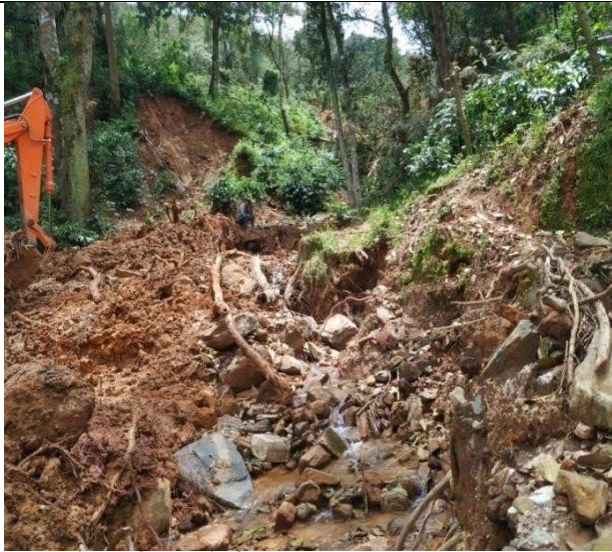
<p style="text-align: center;"><b>View of Debris flow occurred along a stream</b></p>

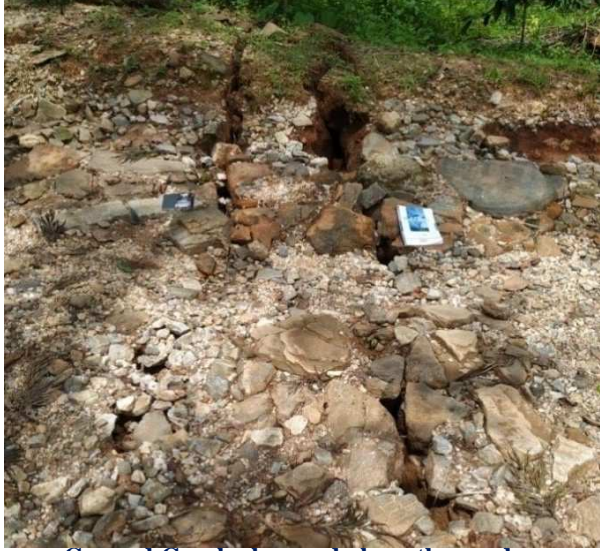
<b>Ground Crack observed along the road</b>
40	Summary/Abstract	:	Earth flows caused by intense surface-water flow, due to heavy precipitation that erodes and mobilizes loose soil on steep slopes. The slide initiated as translational failure & is further graded as earth flow collecting fines from upper catchment area. The flow is usually confined to the steep gully that facilitates their downward movement. Highly weathered & fractured rock is observed on the slope corresponding to soil thickness of 3m to 5m. Consequently the saturated earth material moved down the valley slope along a weak plane under the influence of gravity. Ground cracks observed on the road that can be widen up with more percolation of water. This will result in subsidence of the road.
41	Date of Reporting	:	21/08/2019
42	Landslide Category	:	II

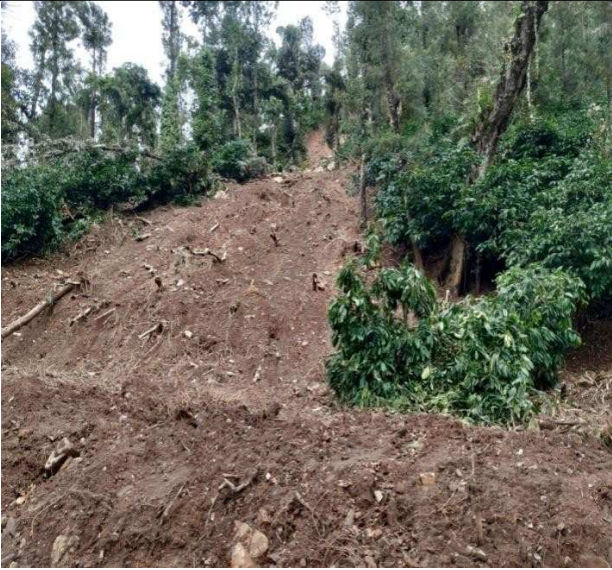
<p data-bbox="762 763 1422 792"><b>View of Debris flow along Channahodulu- Hallikere road</b></p>

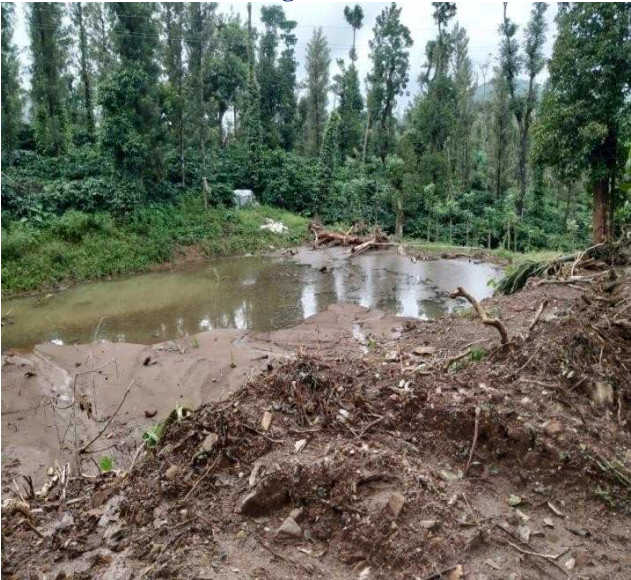
<p data-bbox="868 1370 1307 1400"><b>Runoff of the Debris clogged the pond</b></p>
40	Summary/Abstract	:	<p data-bbox="678 1406 1422 1872">Debris flow caused by intense surface-water flow, due to heavy precipitation that erodes and mobilizes loose soil or rock on steep slopes. The slide initiated as translational failure &amp; is further graded as debris flow collecting debris from upslope having coffee plantation. Top of the hill sparse vegetation is observed reflecting presence of rock and thin soil cover. However, highly weathered &amp; fractured rock is observed on the slope corresponding to soil thickness of 5m to 7m. Consequently the thickly soil saturated with water moved down the slope rapidly under the influence of gravity. A small running stream has been generated within the slide.</p>

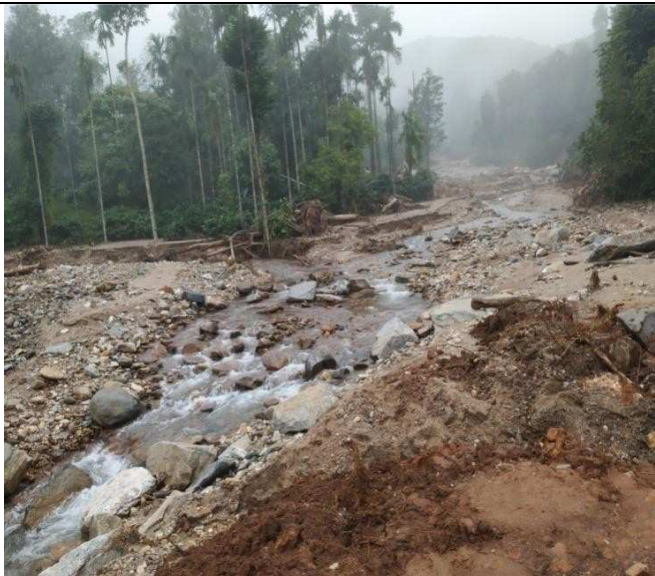
<p style="text-align: center;"><b>View of runoff of the Debris flow along Channahodlu-Ukkada road</b></p>

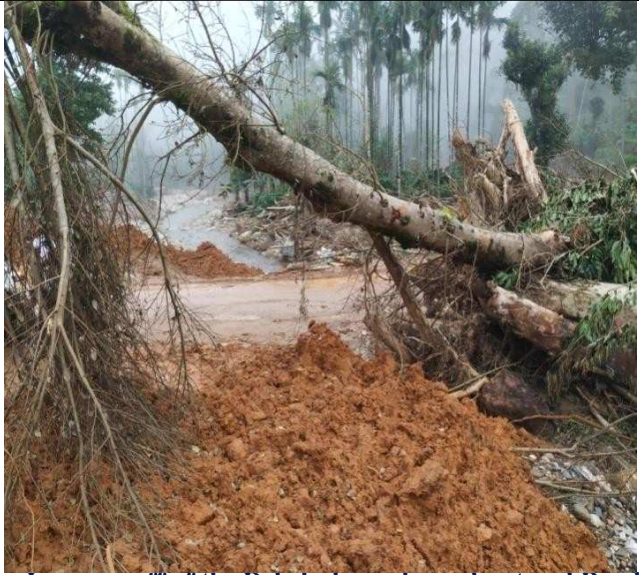
<p style="text-align: center;"><b>Long runoff of the Debris damaging culvert and Road</b></p>
40	Summary/Abstract	:	<p>Debris flow caused by intense surface-water flow, due to heavy precipitation that erodes and mobilizes loose soil or rock on steep valley slopes. The slide initiated as translational failure &amp; is further graded as debris flow collecting debris from upslope. However, highly weathered &amp; fractured rock is observed on the slope corresponding to soil thickness of 5m to 7m. Consequently the thickly soil saturated with water moved down the slope rapidly under the influence of gravity. Debris flows from two different direction merge near the road junction. The rapid flow of the debris breached the road and damage the culvert. Timbers stored in the upper region have been carried downslope under intense debris flow. Huge amount of debris corresponds to the material draw down from two different directions.</p>

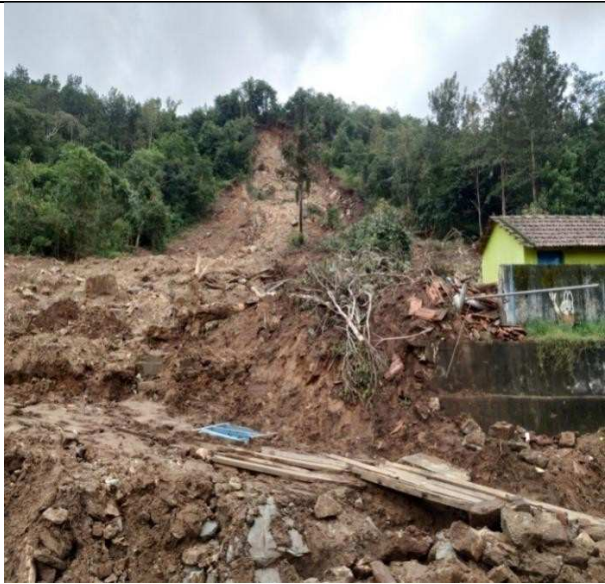
<p style="text-align: center;"><b>View of Debris slide along Mattikadde- Ukkada road</b></p>

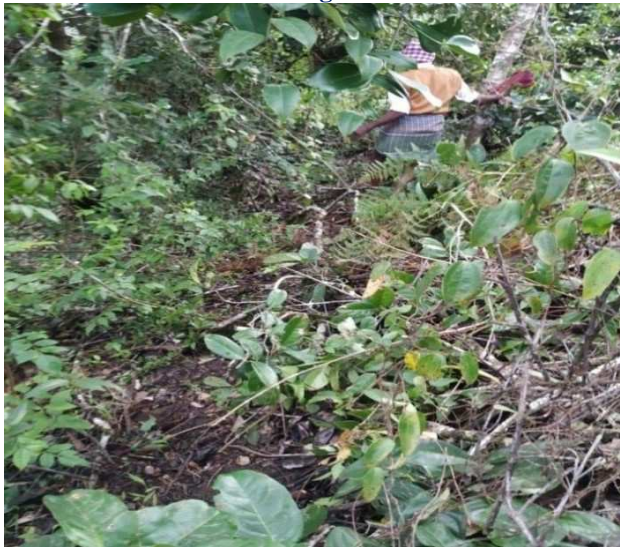
<p style="text-align: center;"><b>Ground cracks observed at the top of crown</b></p>

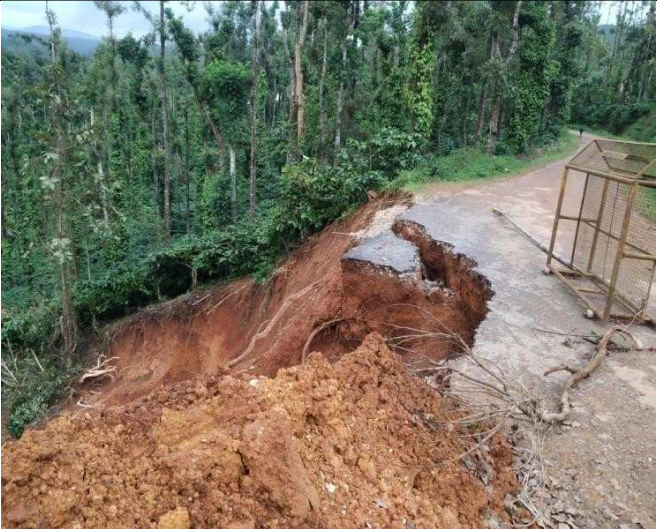
<p style="text-align: center;"><b>Subsidence of the road along Channahodlu-Ukkada road</b></p>

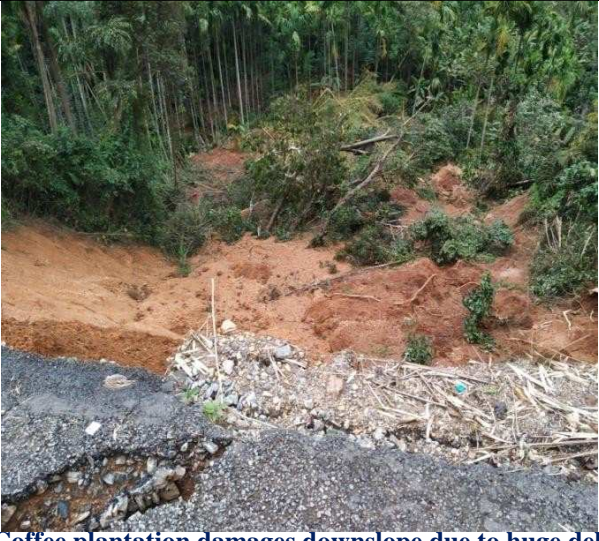
<b>Coffee plantation damages downslope due to huge debris</b>
40	Summary/Abstract	:	The collapse of the road due to a huge mass failure beneath the road has occurred at the road junction. The level of the suffered road is down as compare to the main road connecting it. The drainage system along the road is not supported by concrete works. They are made simply as dug out trenches and the bottom is left uncovered. The water coming from the slope is running on the road & following the lower level of road. This increases surface & sub-surface water pressure on downside of the road. There is no lateral support along the road. There is subsurface seepage of water beneath the road that removing the soil from beneath & making other side of the slope unstable.
41	Date of Reporting	:	21/08/2019
42	Landslide Category	:	II

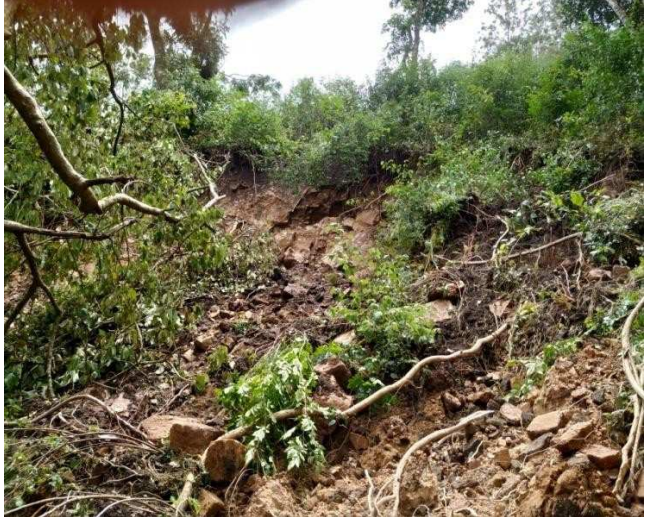
<p style="text-align: center;"><b>Debris slide along Mudigere-Kadur road</b></p>

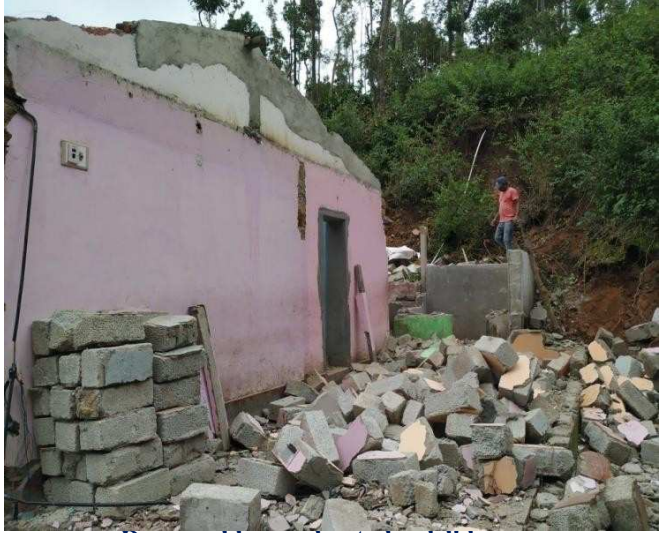
<p style="text-align: center;"><b>Damaged house due to landslide</b></p>
40	Summary/Abstract	:	The slide initiated as a planar failure. Debris slide, including big size boulders, was formed at the base of the slide. The debris is highly saturated with water. This occasional type of debris cum earth flow had blocked the road & uprooting the trees & poles. The slide is still active as the crown of the slide is jointed. Bashir's house on the upslope is damage due to another small slide. House of Sundar & Mutti (02houses) near the flanks of slide to be relocated to some safer place during the monsoon.
41	Date of Reporting	:	22/08/2019
42	Landslide Category	:	II

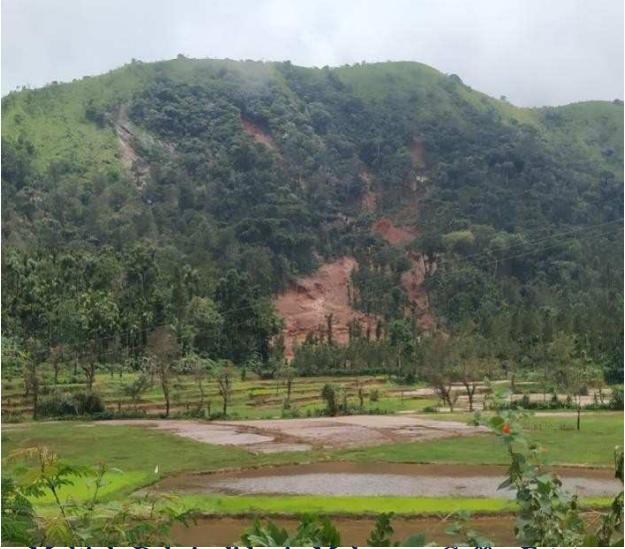
<p style="text-align: center;"><b>Multiple Debris slides in Malemane Coffee Estate</b></p>

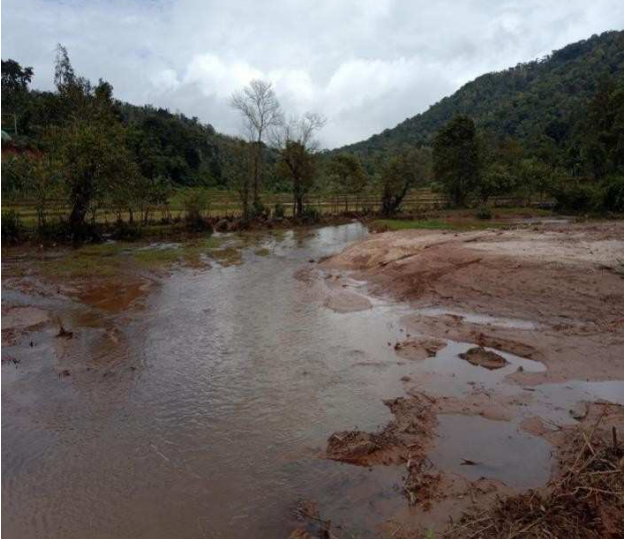
<p style="text-align: center;"><b>Cultivation land converted into stream</b></p>
40	Summary/Abstract	:	<p>Multiple debris flows occurred along first order stream sections. The slide initiated on the upper slope of the ridge as translational failure &amp; is further graded as debris flow collecting fines from upper catchment area. The flow is usually confined to the steep gullies that facilitate their downward movement. The ridge part of the hill is barren with thin slope wash, whereas in the mid-slope&amp; downslope the thickness of the regolith increases and attains a thickness &gt;5m. Cultivation in the steep slopes has been practiced after removing the vegetation cover on the upper parts of the slopes. The coffee plantation covered the valley part that is now consumed under debris flow. A higher order nala running at the foot of hill was converted into cultivation land. After the landslide incident the nala has been rejuvenated into a flowing stream damaging the cultivation.</p>

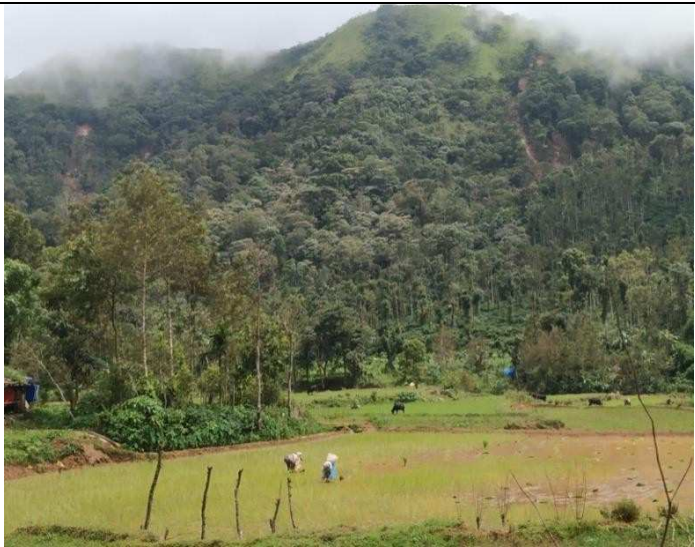
<p style="text-align: center;"><b>Distant view of Multiple Debris slides in Megur Coffee Estate</b></p>
40	Summary/Abstract	:	Debris flows occurred along first order stream sections. The slide initiated on the upper slope of the ridge as translational failure & is further graded as debris flow collecting fines from upper catchment area. The flow is usually confined to the steep gullies that facilitate their downward movement. The ridge part of the hill is barren with thin slope wash, whereas in the mid slope & downslope the thickness of the regolith increases and attains a thickness >5m. Cultivation in the steep slopes has been practiced after removing the vegetation cover on the upper parts of the slopes. Coffee plantation covering valley part is now consumed under debris flow. A higher order nala running east-west at the foot of hill. As per locales, 03 houses are present in the vicinity of the slide.

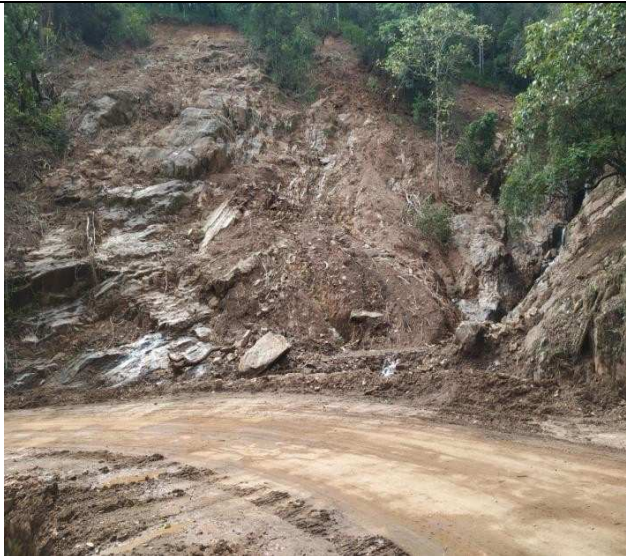
<p style="text-align: center;"><b>Debris flow occurred adjacent to a stream</b></p>

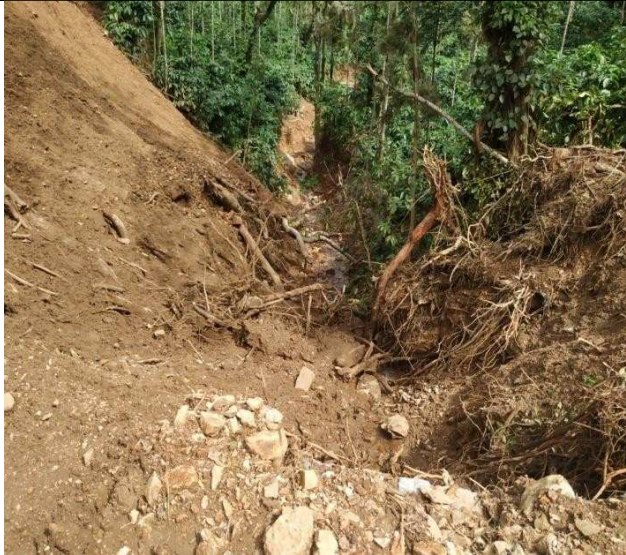
<b>Debris flow downhill side of the road</b>
40	Summary/Abstract	:	Debris flows caused by intense surface & sub-surface water flow, due to heavy precipitation that erodes and mobilizes loose soil or rock on steep slopes. The slide occurred at the bend of the road. The slide initiated as translational failure & is further graded as debris flow. High amount of water discharge into the stream, resulted in broadening its valley. The underlying rocks are exposed after the debris flow. Rocks are highly sheared & jointed. Lithological contact between Granite gneiss and Banded magnetite quartzite is well distinct. It is observed through Google imagery that the landslide area covered with sparse vegetation. Though it is seen in the field that with high saturation the sliding took place at the interface of rock and soil contact. Consequently the saturated debris material immediately slide down to join with the running stream causing long run off of the debris material.

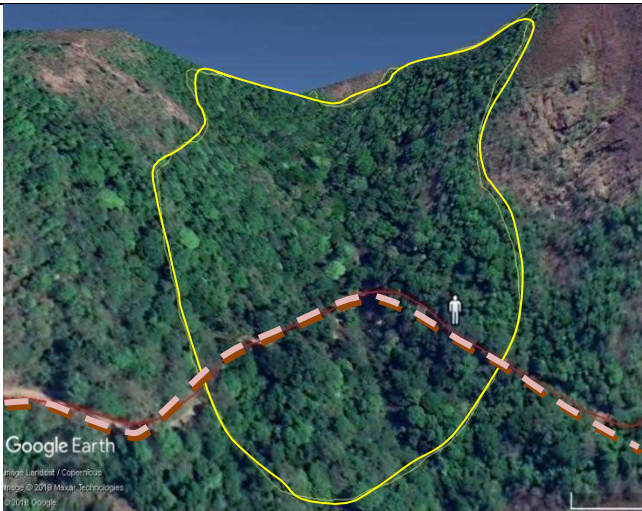
<p><b>Coffee plantation in the valley part (Google imagery of the year 2018)</b>  <b>Dash line showing the road section (toe cut) making the slope unstable</b></p>

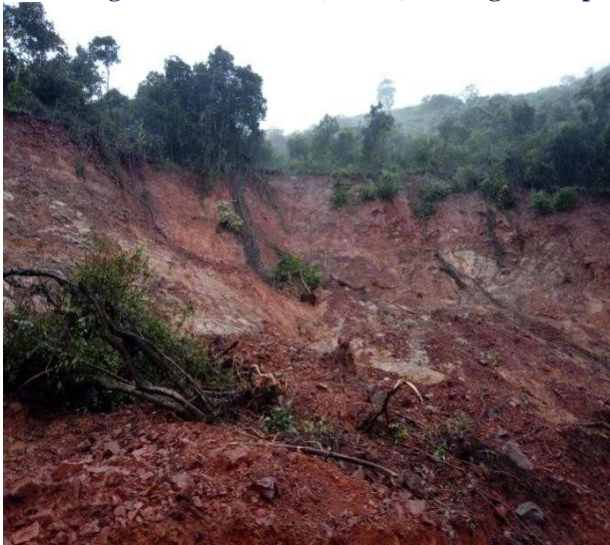
<p><b>Slope failure along the valley</b></p>

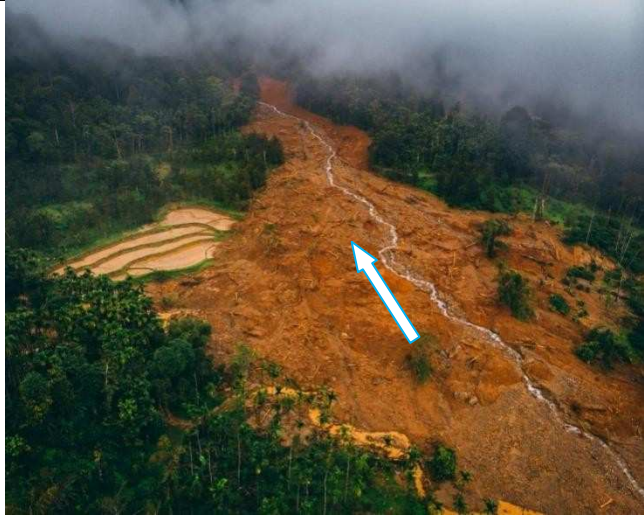
**Rapid flow of debris at downhill slide, destroyed the plantation**

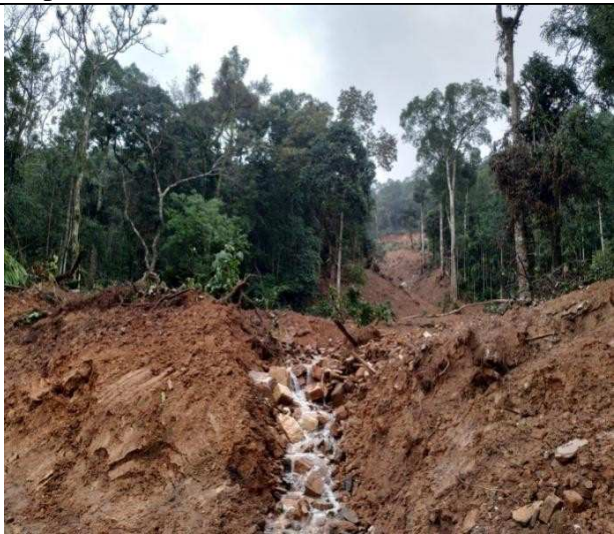
<p style="text-align: center;"><b>Debris flow along valley in Balige area</b></p>

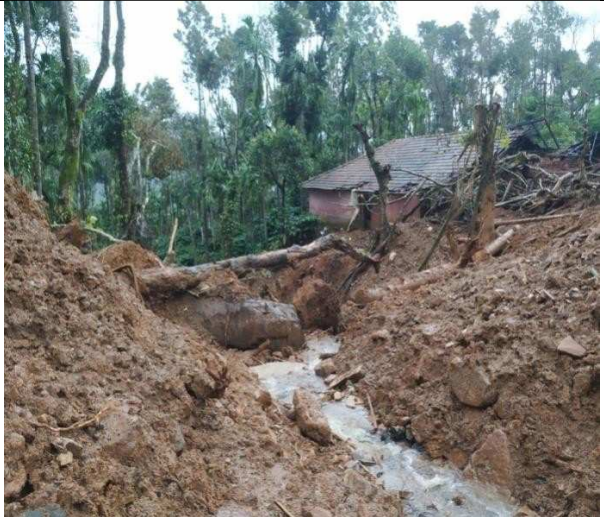
<p><b>Highly charged debris flows along downslope damages the house</b></p>
40	Summary/Abstract	:	<p>Massive debris flows occurred along a seasonal nala. The slide initiated on the upper slope of the ridge as translational failure &amp; is further graded as debris flow collecting fines from upper catchment area. Steep slope accompanied with heavy discharge of water is deduced to have aggravated the pace of erosion along the nala. Rapidly running water and gravity driven movement induced by lubricating action of ground water thus derived the debris down slope at fast pace. The northeast flowing seasonal stream is observed to have overrun the coffee plantation and completely damaged the house of D.V Ganisha in Hebbaragundi stage.01 person injured in this incident. The runoff is 200-300 metres long that damages Road &amp; culvert. Cultivation in the steep slopes; especially in basin area has been practiced after removing the vegetation cover on the upper parts of the slopes. Geologically the area comprises weathered Metabasalt rock.</p>

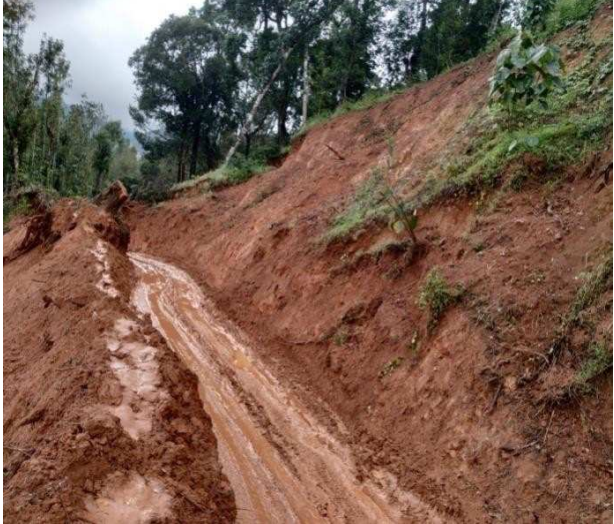
<p style="text-align: center;"><b>Debris Slide along Sunkasale- BallalarayanaDurga road</b></p>

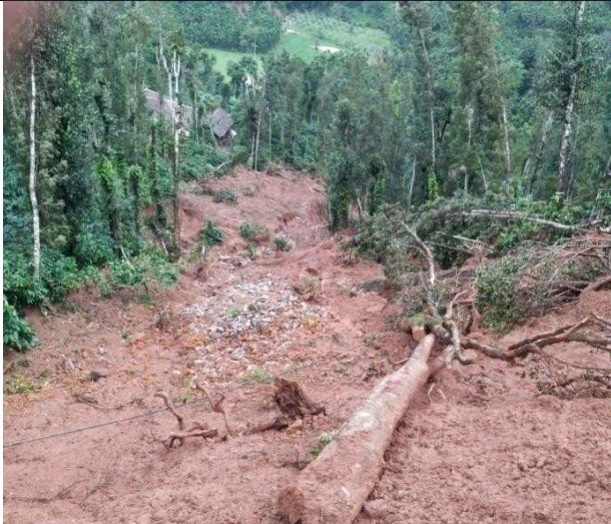
<b>Run-off along downhill side of the road</b>
40	Summary/Abstract	:	The debris slide is observed to have occurred on the south-easterly slope. The inclination of failure slope is observed to be around 40°. The width of the failure slope is about 32 meters along the road section. The slide initiated as translational failure & the debris are further descending down through the coffee plantation land. The landslide debris is observed to have accumulated at the road. Top of the hill sparse vegetation is observed reflecting presence of rock and thin soil cover. However, oversaturated weathered rock & soil is observed on the slope corresponding to soil thickness > 5m. This thickly overburden material is observed to comprise of hill wash and debris consisting of brown to reddish brown, coarse-grained sandy matrix. The debris terminates at the base of the slope consuming part of coffee plantation land, down the road.

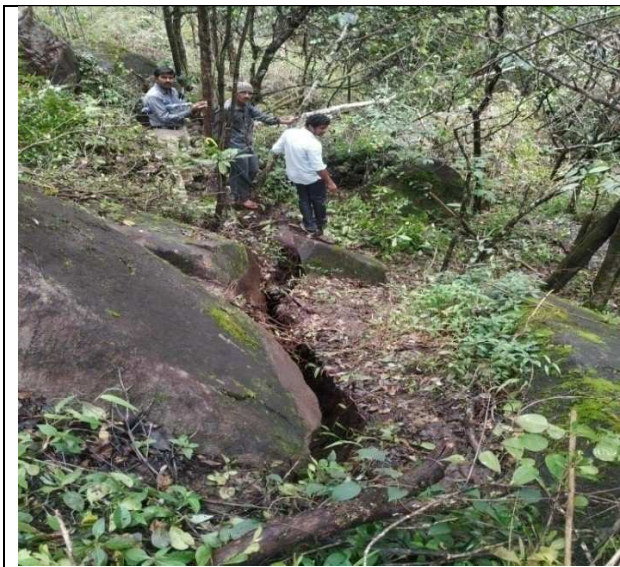
Large size arc shape crack observed on top of the hill

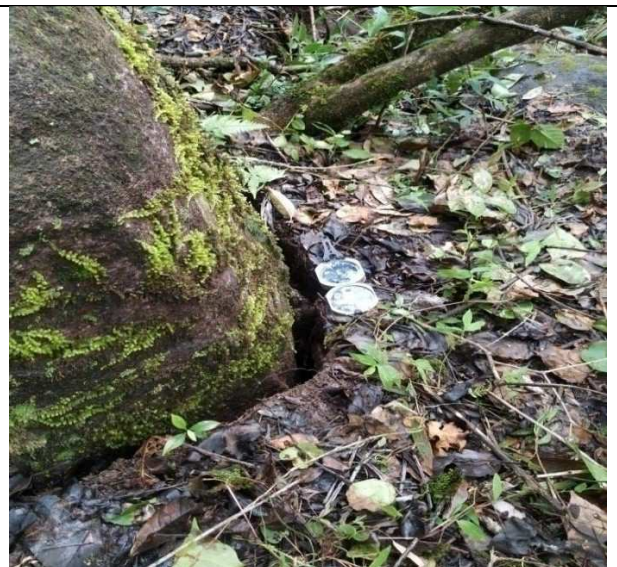
Crack is formed at the contact of rock and soil

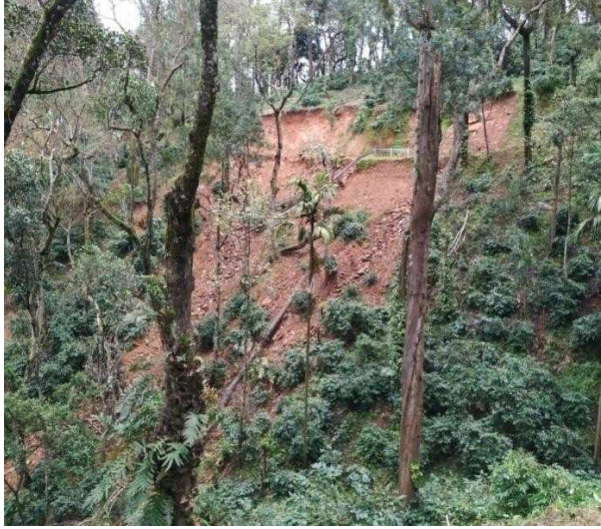
<p data-bbox="783 725 1453 786"><b>Debris slide occurred along Hirebail-Hemmakki road and damaging Parapet</b></p>

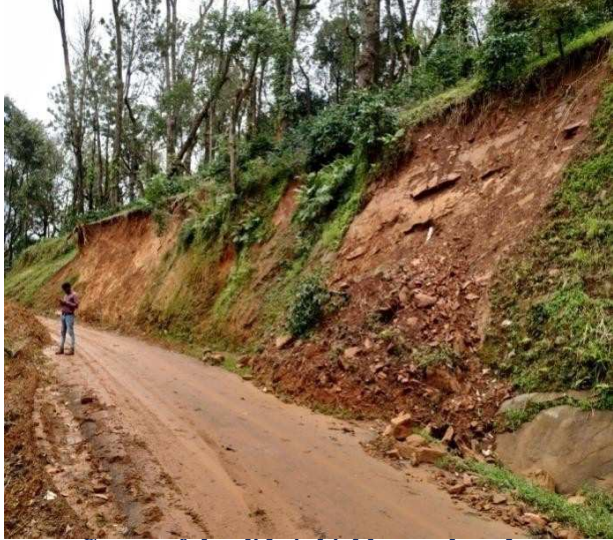
<p data-bbox="871 1323 1310 1346"><b>Crown of the slide is highly weathered</b></p>
40	Summary/Abstract	:	<p data-bbox="715 1357 1473 1715">This landslide is a debris slide having translational movement along a single rupture plane with approx. 70m run-out distance. The debris material has been moved along with trees and other vegetation on other side of the road. This landslide has occurred on concave slope with 35°-40° gradient. The slide has been occurred along the first order streams. Almost all debris has been removed exposing the underlying rocks below the crown. Highly weathered amphibolites rocks are observed. The landslide has damaged the road&amp; parapet.</p>
41	Date of Reporting	:	24/08/2019
42	Landslide Category	:	II

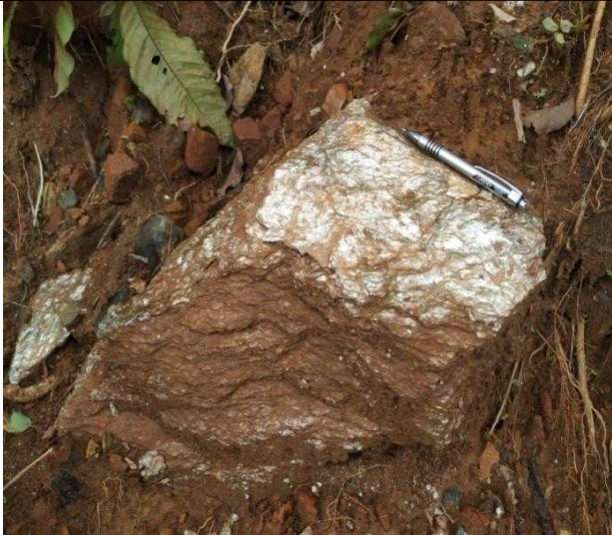
<p style="text-align: center;"><b>Presence of mica sheet along the bedding plane</b></p>
40	Summary/Abstract	:	<p>Multiple debris slides occurred in Malleshvara Gudda. Massive debris slides occurred in westerly directed steep slope. Huge debris has been accumulated all along the road and is also overrun the road and discharge debris into the westerly and south-westerly running drainages at downslope. The slide initiated on the upper slope of the ridge as translational failure &amp; is further graded as debris flow collecting fines from upper catchment area. The ridge part of the hill is barren with thin slope wash, whereas in the mid slope &amp; downslope the thickness of the regolith increases and attains a thickness &gt;5m. The hill is disturbed with road cuts &amp; settlements at the mid slope. The runoff is km's long as it is flowing in the course of running stream at downslope. Cultivation in the steep slopes has been practiced after removing the vegetation cover on the upper parts of the slopes. A part of coffee plantation land is now consumed under huge debris flow. Geologically, the area comprises amphibolites rocks forming the ridge part while granite gneiss forms the slope of the area. Relatively fresh rock was exposed at the top and saprolite was exposed relatively at the lower sections. Along the road quartzofeldspathic layers interbedded between well jointed &amp; fractured Banded magnetite quartzite rocks (BMQ). Mica (Muscovite) sheet observed along the bedding plane. The hill (MalleshvaraGudda) is highly dissected with numerous first order streams.</p>

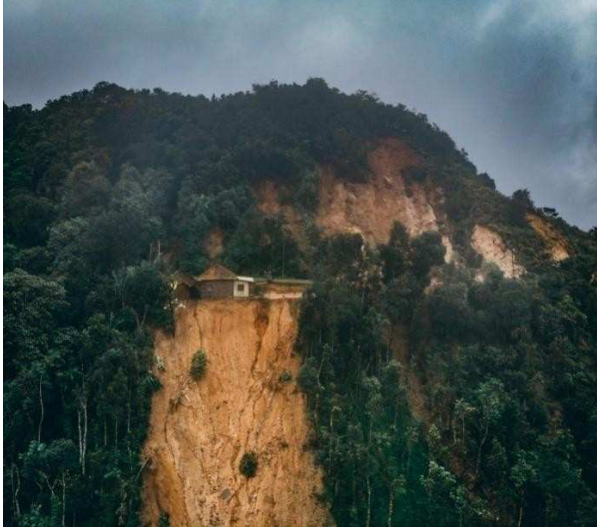
<p><b>Bird view of Debris slide at downhill side of the house along Hirebail-Hemmakki road at Malleshwara Gudda.</b></p>

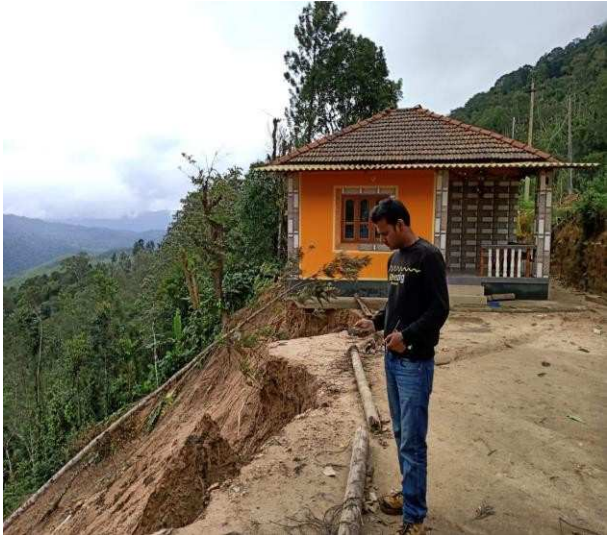
<p><b>Damaged house at the crown of the slide</b></p>
40	Summary/Abstract	:	Multiple debris slides occurred in Malleshwara Gudda. Massive debris slides occurred in westerly directed steep slope. Huge debris has been accumulated all along the road and is also overrun the road and discharge debris into the westerly and south-westerly running drainages at downslope. The slide initiated on the upper slope of the ridge as translational failure & is further graded as debris flow collecting fines from upper area. The ridge part of

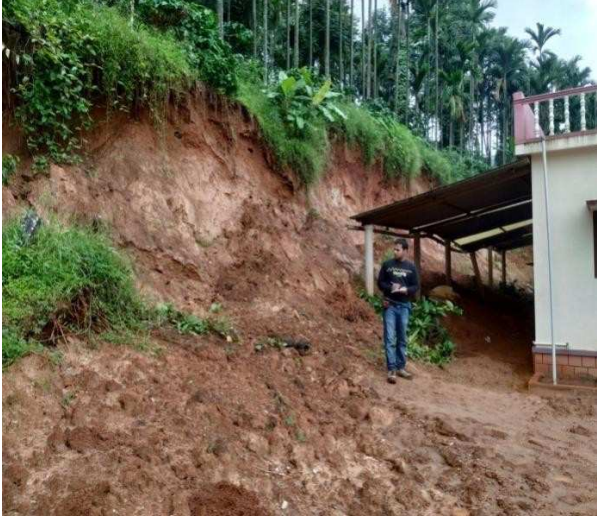
<p style="text-align: center;"><b>Debris slide behind the house</b></p>

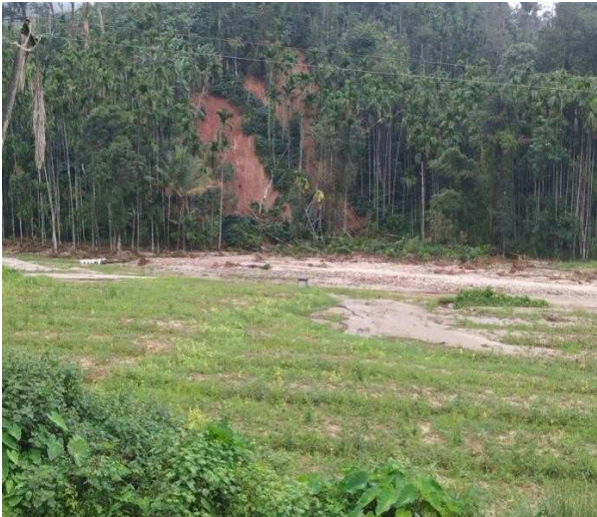
<p style="text-align: center;"><b>Cultivation land converted into stream causing another landslide on other part of the slope due to down cutting</b></p>
40	Summary/Abstract :	<p>The debris slide is observed to have occurred on the north-easterly slope. The inclination of failure slope is observed to be around 30°. There are number of settlements present along the foot of the hill &amp; are constructed without giving any lateral support to the slope. Backward of the house of Narayan Gowda is partly damage due to debris slide. A higher order nala is running around 125m from the house. At top of the hill a large construction observed through Google imagery &amp; is close to the higher order nala. The slide initiated as translational failure &amp; the debris are further descending down through the coffee plantation land. However, oversaturated weathered rock (Granite gneiss) &amp; soil is observed on the slope corresponding to soil thickness 2- 5m. Soil pipe is observed at the crown pipe that is responsible for removing soil and water from sub-surface. This will make the slope more vulnerable. Cultivation in the steep slopes has been practiced after removing the vegetation cover on the upper parts of the slopes. North of this slide on the other side of cultivation</p>

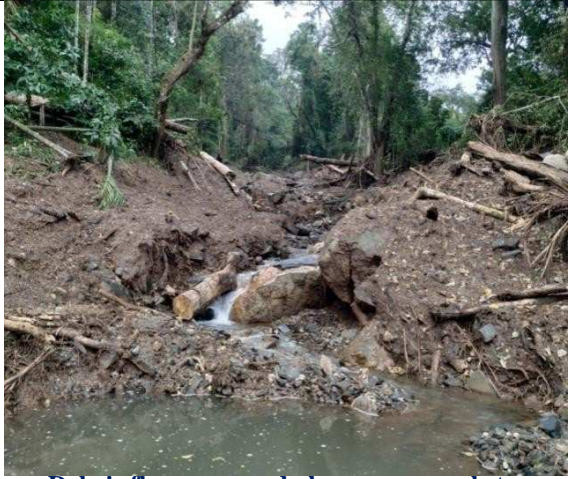
<p style="text-align: center;"><b>Debris flow occurred along a seasonal stream</b></p>

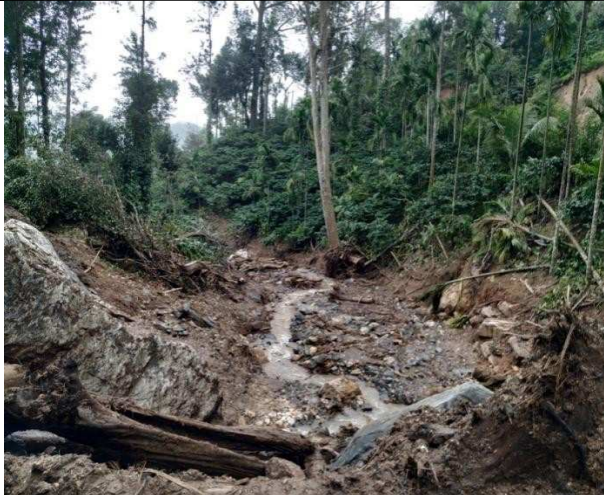
<p style="text-align: center;"><b>High sediment laden discharge by the stream</b></p>
40	Summary/Abstract	:	<p>Massive debris flows occurred along a seasonal nala of first order. The slide initiated on the upper slope of the ridge as translational failure &amp; is further graded as debris flow collecting fines from upper catchment area. Steep valley slope accompanied with heavy discharge of water is deduced to have aggravated the pace of erosion along the nala. Rapidly running water and gravity driven movement induced by lubricating action of ground water thus derived the debris down slope at fast pace. The debris is observed to comprise of river borne material consisting of dark brown to reddish, fine grained silty-sandy matrix with rounded boulders and pebbles. The southeast flowing seasonal stream is observed to have over run the coffee plantation and damaging the road. Cultivation in the steep slopes; especially in basin area has been practiced after removing the vegetation cover on the upper parts of the slopes. Geologically the area of investigation comprises litho contact between granite gneiss and amphibolites. Through Google imageries it is evident that the earlier stream has widened its valley. The Valley widening may be corresponding to the structural discontinuity (litho-contact) or through some weaker planes. The hill (Malleshvara Gudda) is highly dissected with numerous first order streams.</p>

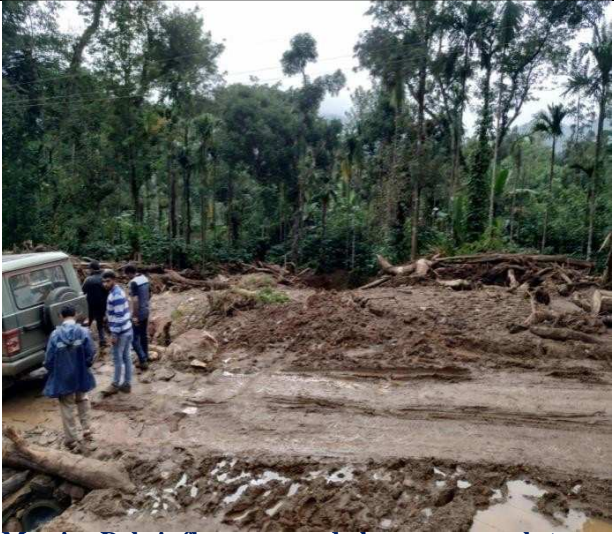
<p><b>Massive Debris flow occurred along a seasonal stream</b></p>

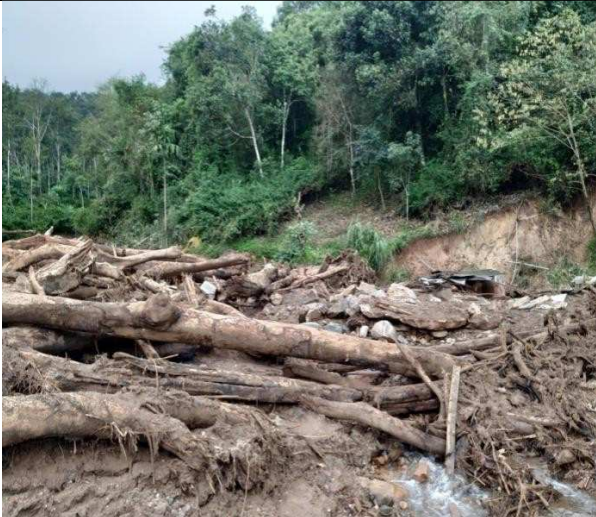
<p style="text-align: center;"><b>High sediment laden discharge by the stream transported the log to the downstream</b></p>
40	Summary/Abstract	:	<p>Massive debris flows occurred along a seasonal nala of first order. The slide initiated on the upper slope of the ridge as translational failure &amp; is further graded as debris flow collecting fines from upper catchment area. Steep valley slope accompanied with heavy discharge of water is deduced to have aggravated the pace of erosion along the nala. Rapidly running water and gravity driven movement induced by lubricating action of ground water thus derived the debris down slope at fast pace. The debris is observed to comprise of river borne material consisting of dark brown to reddish, fine grained silty-sandy matrix with rounded boulders and pebbles. The southeast flowing seasonal stream is observed to have over run the coffee plantation and completely damaged the house of Chinmay Gowda &amp; the culvert. Cultivation in the steep slopes; especially in basin area has been practiced after removing the vegetation cover on the upper parts of the slopes. Geologically the area of investigation comprises litho contact between granite gneiss and amphibolites. Through Google imageries it is evident that the earlier stream has widened its valley. The Valley widening maybe correspond to the structural discontinuity (litho-contact) or through some weaker planes. The hill (Malleshvara Gudda) is highly dissected with numerous first order streams.</p>

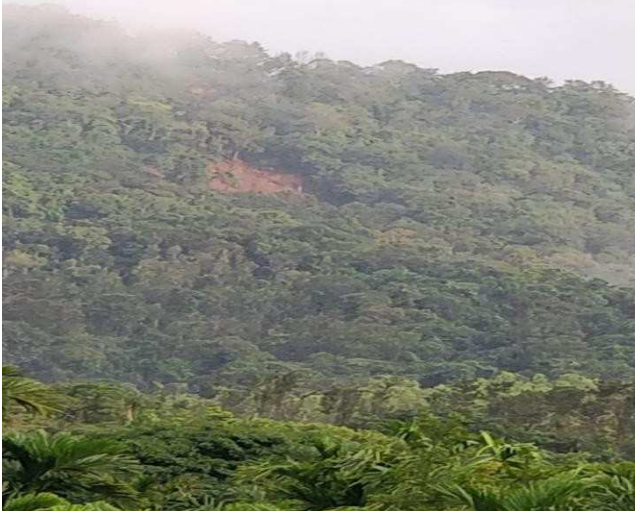
<p><b>Remotely sensed Debris slide occurred along a Malleshvara Gudda hill in Hemmakki area</b></p>

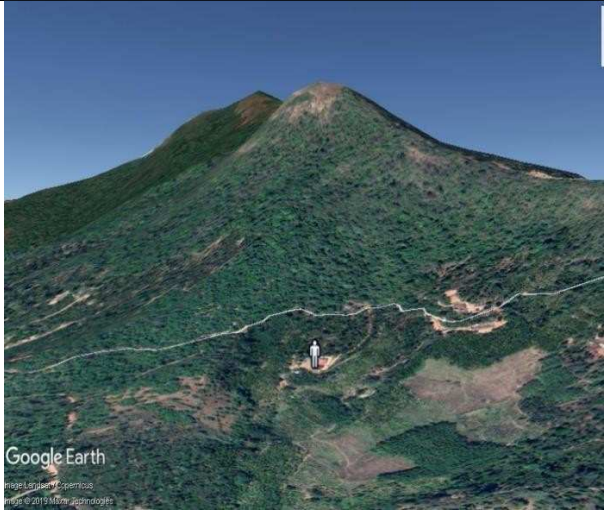
<p><b>Google Imagery of the Malleshvara Gudda hill showing barren ridge with forest cover at mid-slope and down slope</b></p>
40	Summary/Abstract	:	<p>Massive debris flows occurred along a large basin in the forest region at upslope. The failure is translational &amp; is further graded as debris flow collecting fines from upper catchment area. The flow is usually confined to the steep gullies that facilitate their downward movement. The ridge part of the hill is barren with thin slope wash, whereas in the mid slope &amp; downslope the thickness of the regolith increases and attains a thickness &gt;5m (as observed in tone and texture of vegetation) .The failure has been occurred at the interface of rock (at the ridge) and soil (at the basin).Cultivation in the steep slopes; especially in basin area has been practiced after removing the vegetation cover on the upper parts of the slopes. Geological map of G.S.I shows that the ridge part of the Malleshvara Gudda hill is composed of Amphibolites rock while at mid slope &amp; downslope granite gneiss rocks are dominating. The area of investigation is traversed with east-southeast flowing first order drainages. These dissections in such discontinuities (litho-contact between amphibolites and Granite gneiss) making the easterly facing slope more vulnerable. The runoff is km's long as it is flowing in the course of running stream at downslope. The house situated at downslope at coordinate N13<sup>0</sup>08'49.0" and E75<sup>0</sup>27'13.5 are around 700 m away from the landslide &amp; the direction of flow is towards this house. The house can be triggered with debris flow during heavy rainfall.</p>

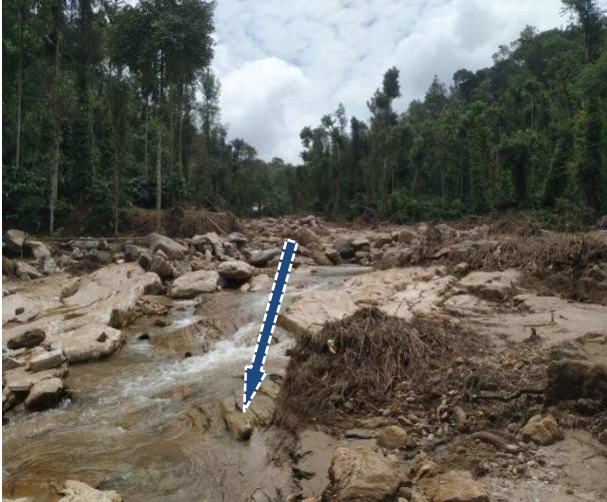
<p style="text-align: center;"><b>High sediment laden discharge by the stream</b></p>

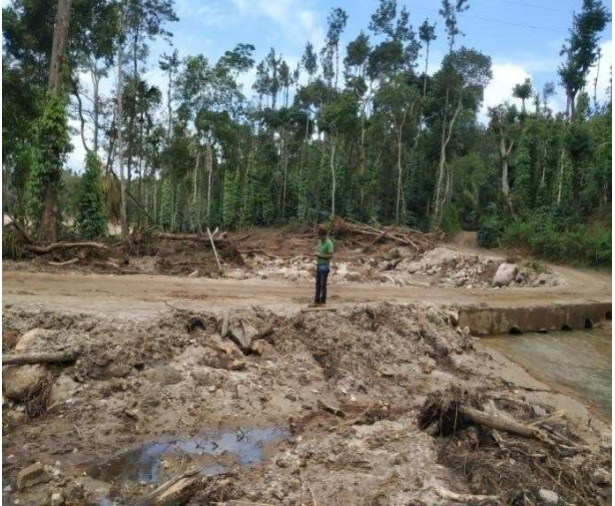
<p style="text-align: center;"><b>Debris flow downside damage the culvert &amp; paddy field</b></p>
40	Summary/Abstract	:	<p>During spells of prolonged heavy rainfall slope mass got completely saturated with water and pore water pressure exceeded due to coarse grained soil. This facilitated debris flow along the westerly flowing seasonal stream. Rapidly running water and gravity driven movement induced by lubricating action of ground water thus derived the debris down slope at fast pace. The debris is observed to comprise of river borne material consisting of dark brown to reddish, fine grained silty-sandy matrix with rounded boulders and pebbles. The seasonal stream charged with debris cum rock is observed to have over run the coffee plantation and destroy the culvert. The runoff is km's long as the debris comes from first order streams contributed its load with the higher running stream, destroying paddy field. Cultivation in the slopes; especially in basin area has been practiced after removing the vegetation cover on the upper parts of the slopes. The earlier stream has widened its valley with the influx of water. Through Google imageries it is observed that there are several stone quarries on the slope &amp; are filled with water. As per revenue officer a large pond was present at the upslope of the hill at Nandi Coffee Estate, which was using for irrigation.</p>

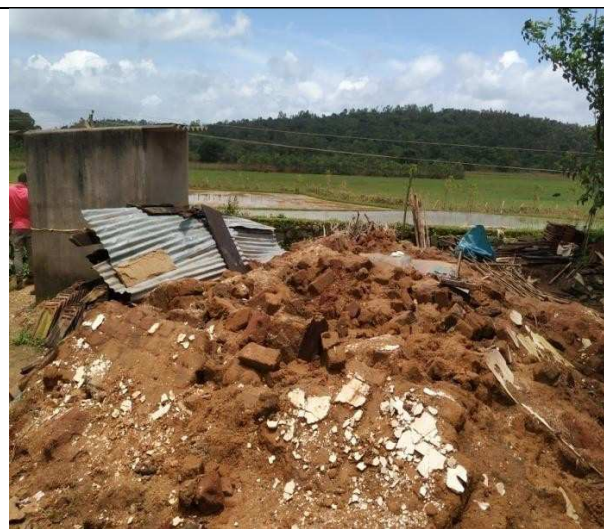
**Cause:** Heavy rainfall is deduced to be the main triggering factor responsible for flash flooding.

**Completely collapsed house due o flash flood**
