# **District Disaster**

# **Management Plan (DDMP)**

**FOR CHIKKAMAGALURU DISTRICT  
2019-20**

## GEOTECHNICAL APPRAISAL, OBSERVATIONS AND RECOMMENDATIONS

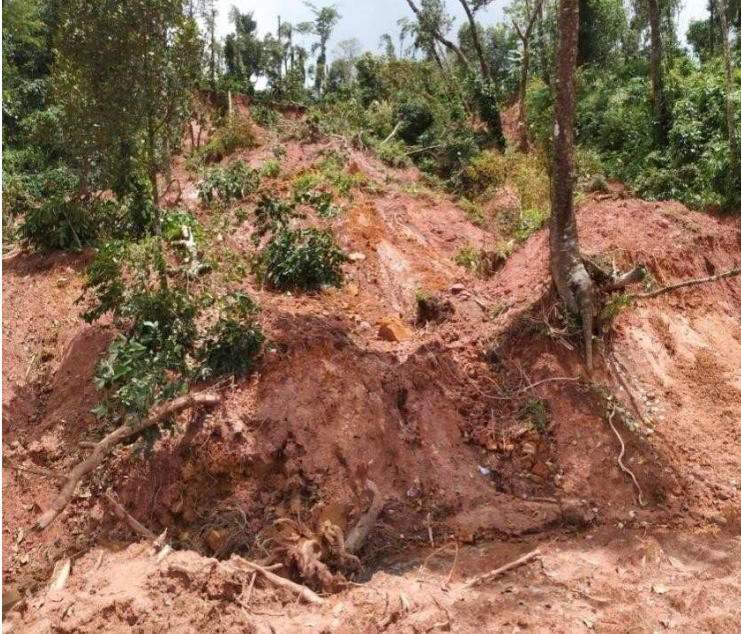
<p style="text-align: center;"><b>Slope failure at steep slope near Devarunda village</b></p>

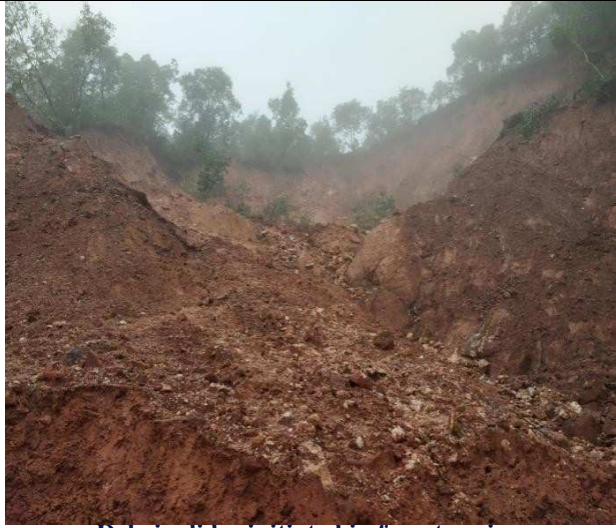
<p style="text-align: center;"><b>Debris slides initiated in forest region</b></p>

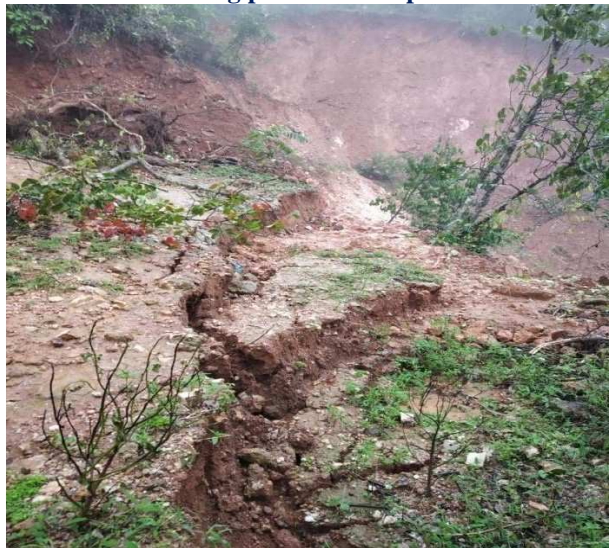
**Large crack & subsidence observed near crown**

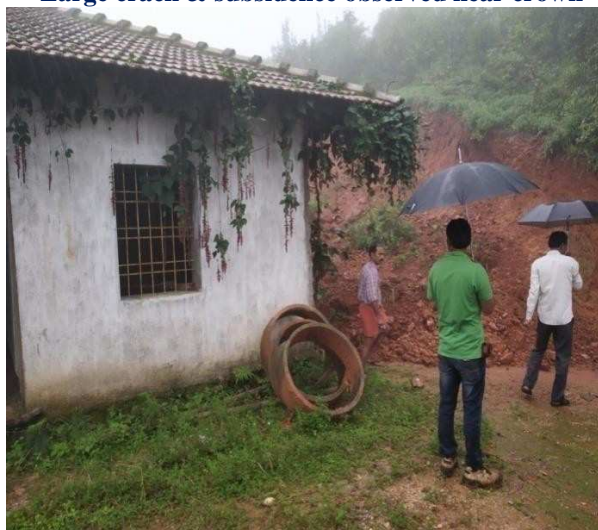
**Partly damage house near the crown part of slide**

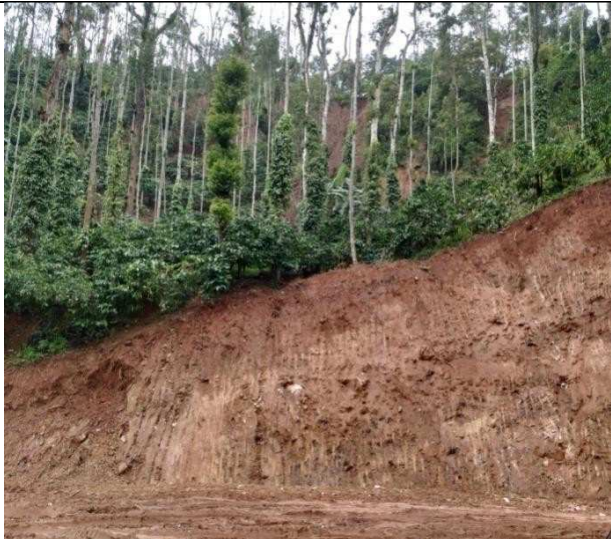
<p style="text-align: center;"><b>Earth slide at Sunkasale-Hirebail road section</b></p>

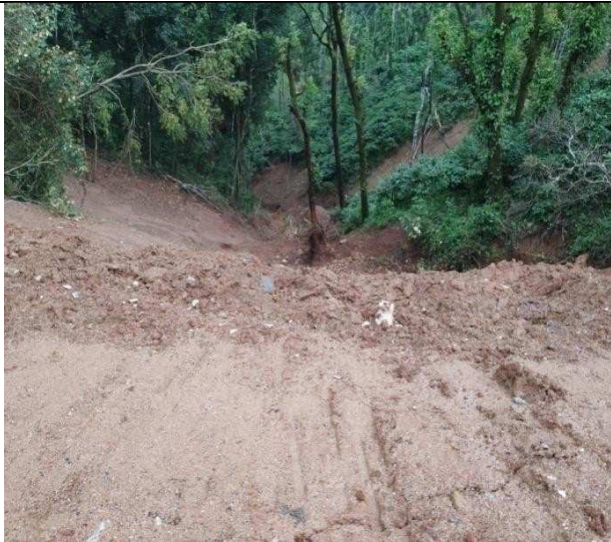
<b>Earth material moved down the hill along high angel slope</b>
40	Summary/Abstract	:	Earth flow occurred along first order stream section. The slide initiated on the upper slope of the ridge as translational failure & is further graded as earth flow collecting fines from upper catchment area. The flow is usually confined to the steep gullies that facilitate their downward movement. The ridge part of the hill covered with sparse vegetation having thin slope wash, whereas in the mid slope & downslope the thickness of the soil increases and attains a thickness >5m. The run-off moves down rapidly along the basin after broadening the valley. Cultivation in the steep slopes has been practiced after removing the vegetation cover on the upper parts of the slopes. The coffee plantation covered the valley part is consumed under earth flow. The loose soil on the foot of the slope has been removed by JCB.

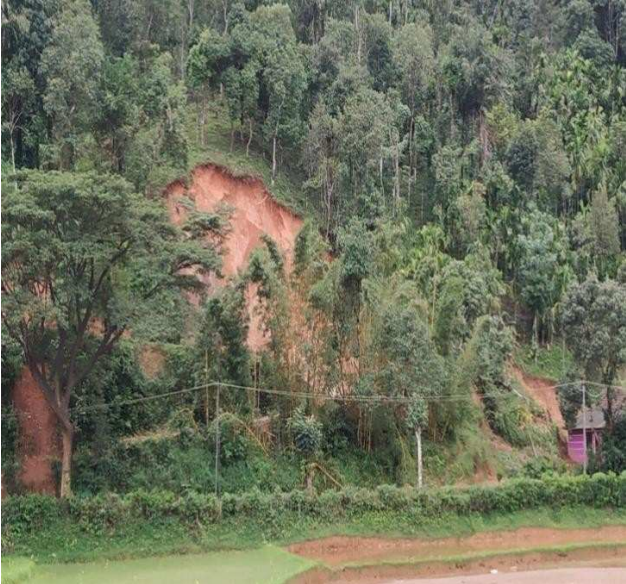
<p style="text-align: center;"><b>Debris slides near Karagadde village</b></p>

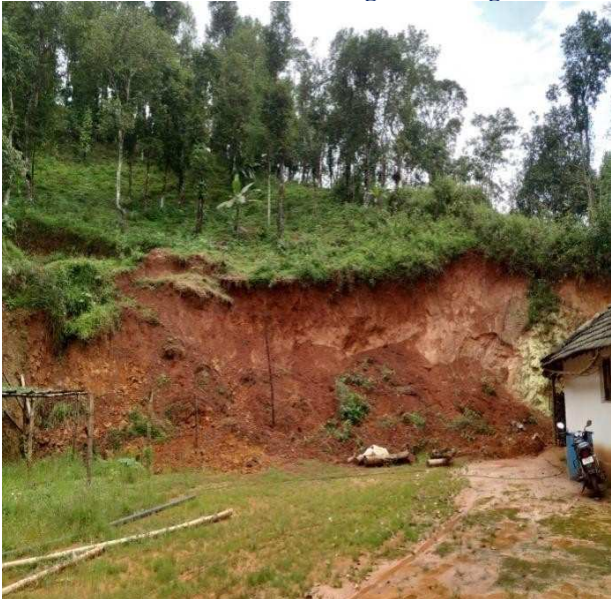
<p style="text-align: center;"><b>Slope failure at the back of house near the crown of slide.</b></p>
40	Summary/Abstract	:	The earth slide is observed to have occurred on the northerly slope. The inclination of failure slope is observed to be around 35°. The slide initiated as translational failure. The width of the failure slope is about 22 meters along the bend of the road and height of the crown from the road is about 12 meters. The thickness of the debris accumulated in the area is observed to be around 5 meters. This overburden material is observed to comprise of dark brown to reddish, fine grained silty-sandy matrix with rounded pebbles. Mid-slope and up-slope of the hill

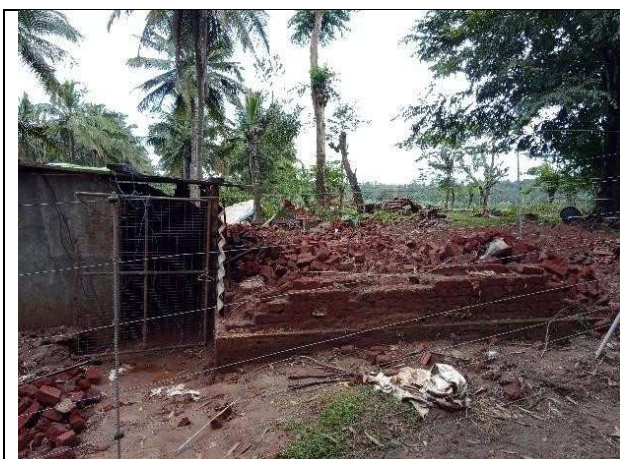
**Damaged house due to flooding**

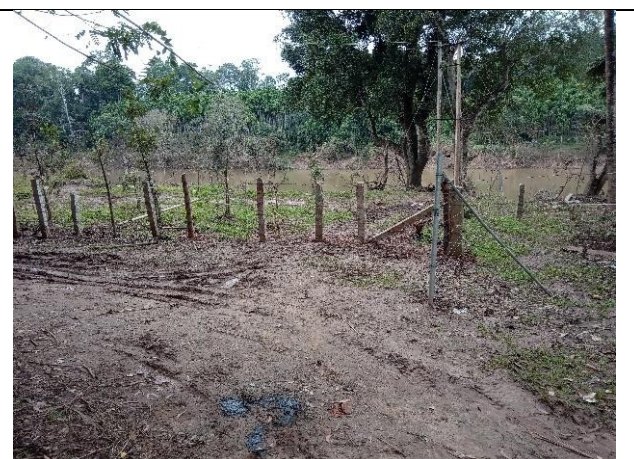
**Cultivation land affected after flash flood**

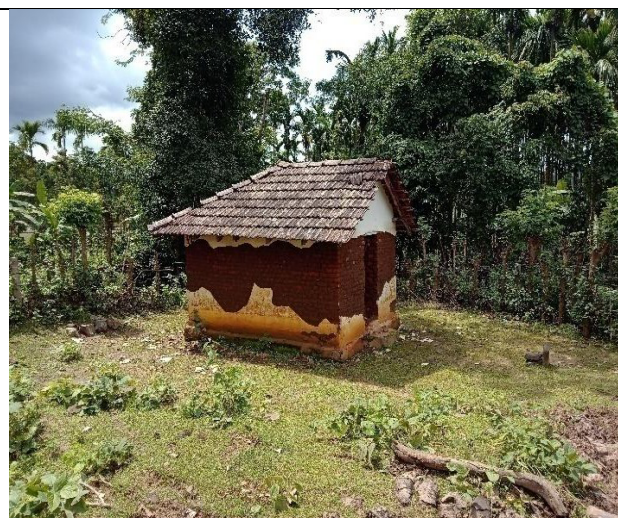
**Damaged house due to flooding**

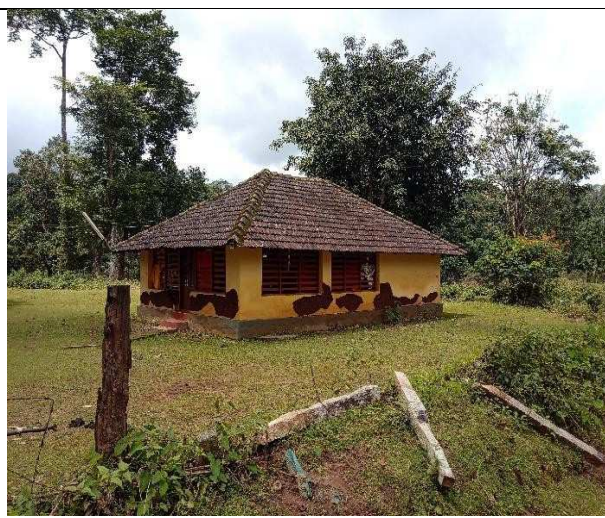
**Damaged house due to flooding**

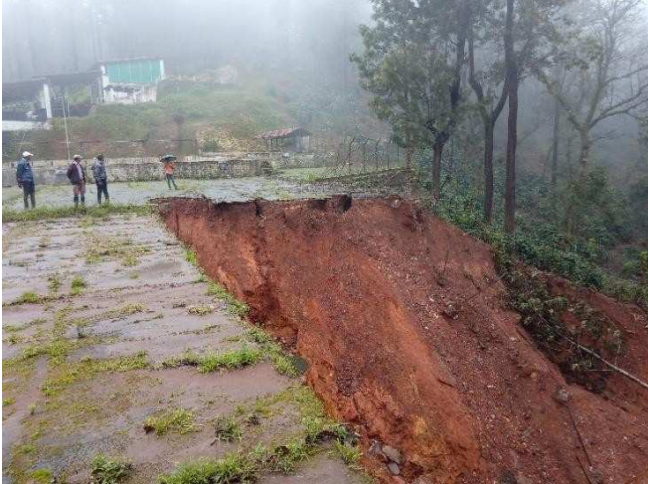
<p style="text-align: center;"><b>Debris slide at Badnekhan Coffee Estate</b></p>

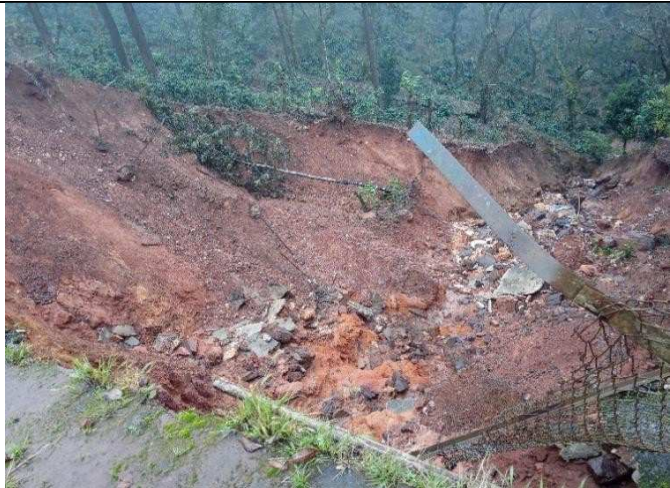
<p style="text-align: center;"><b>Part of coffee land consumed due to debris flow</b></p>
40	Summary/Abstract	:	<p>The debris slide initiated on the upper slope of the coffee drying area. Steep slope accompanied with heavy discharge of water is deduced to have aggravated the pace of erosion along the nala. A subsurface ground water steam was flowing beneath the coffee drying area. Rapidly running water and gravity driven movement induced by lubricating action of ground water thus derived the debris down slope at fast pace. The northeast flowing seasonal stream is observed to have over run the coffee plantation and partly damage one staff's house. The area of investigation comprises fully weathered rock and converted to a thick pile of overburden soil. In the coffee drying area cracks are present near the landslide crown that can reactivate &amp; cause mass failure again. With more percolation of water &amp; widening of the cracks, landslide can again trigger.</p>

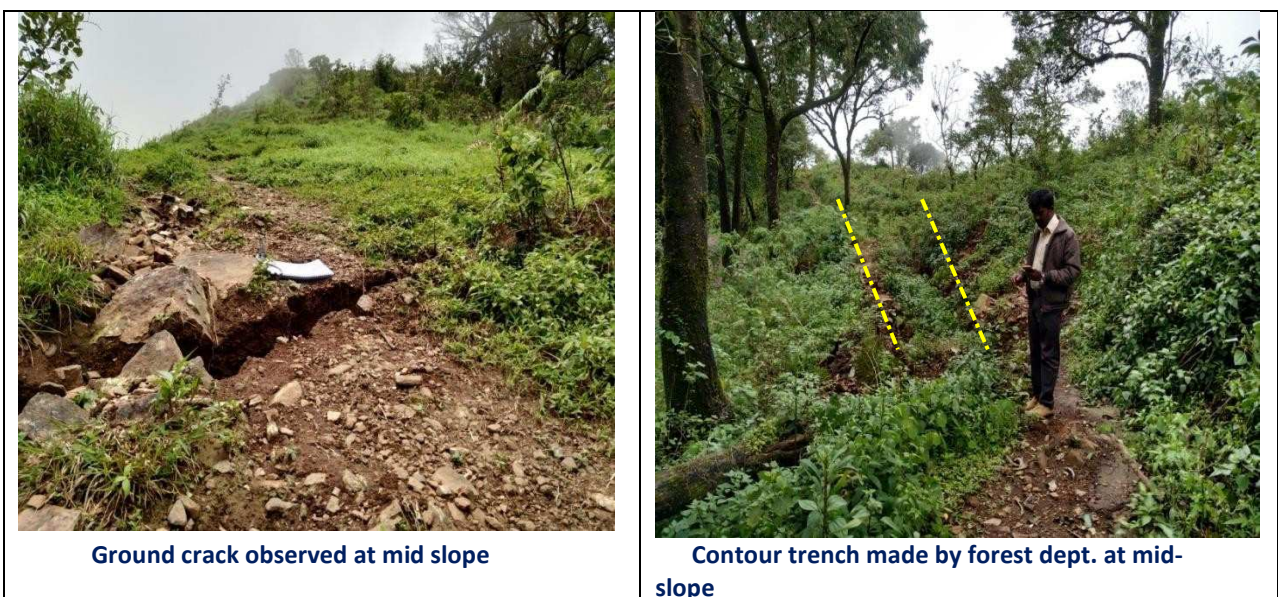
Ground crack observed at mid slope

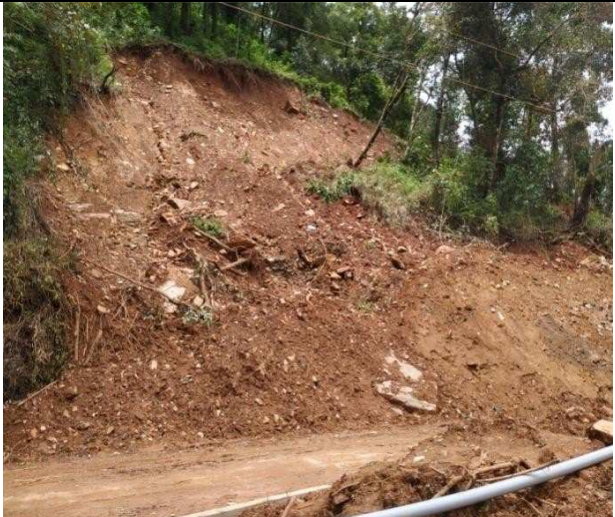
<p>Debris slide along Sunkasale- Ballalarayanadurga road.</p>

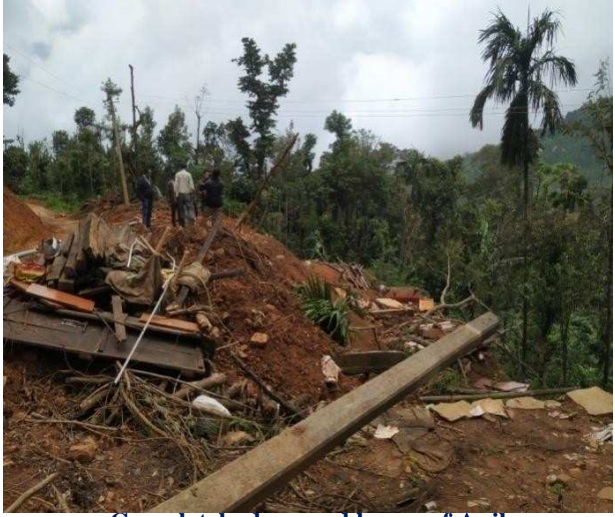
<p style="text-align: center;"><b>Completely damaged house of Anil</b></p>
40	Summary/Abstract	:	<p>Multiple debris slides are observed to have occurred on the east-north easterly slope. The inclination of failure slope is observed to be around 40°. The width of the failure slope is about 35 meters along the road bend. The slide initiated as translational failure. The debris is further descending down through the coffee plantation land, overrun the road and completely damage the house of Anil. The landslide debris is observed to have accumulated at the road. Oversaturated weathered rock &amp; soil is observed on the slope corresponding to soil thickness &gt; 5m. This thickly overburden material is observed to comprise of hill wash and debris consisting of brown to reddish brown, coarse-grained sandy matrix. The debris terminates at the base of the slope consuming part of coffee plantation land down the road.</p>

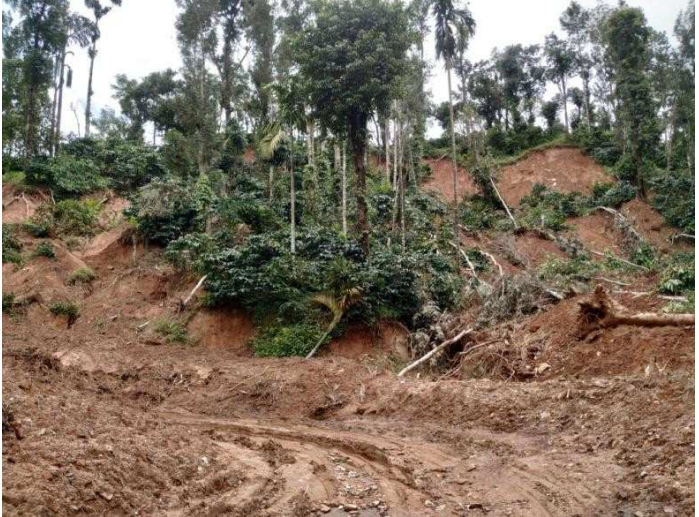
<p style="text-align: center;"><b>Debris slide along Sunkasale- Ballalarayana Durga road.</b></p>
40	Summary/Abstract	:	Large debris slide occurred on the east-north easterly slope. The inclination of failure slope is observed to be around 40°. The width of the failure slope is about 32 meters along the road section. Cultivation of coffee plantation in the steep valley slope; especially in basin area has been practiced after removing the vegetation cover on the upper parts of the slopes. Geologically the area of investigation comprises Metabasalt. The debris descending down through the coffee plantation land, overrun the road and damages the culvert. The landslide debris is observed to have accumulated at the road. Oversaturated weathered rock & soil is observed on the slope corresponding to soil thickness > 5m. This thickly overburden material is observed to comprise of hill wash and debris consisting of brown to reddish brown, coarse-grained sandy matrix. The debris terminates at the base of the slope consuming part of coffee plantation land down the road.

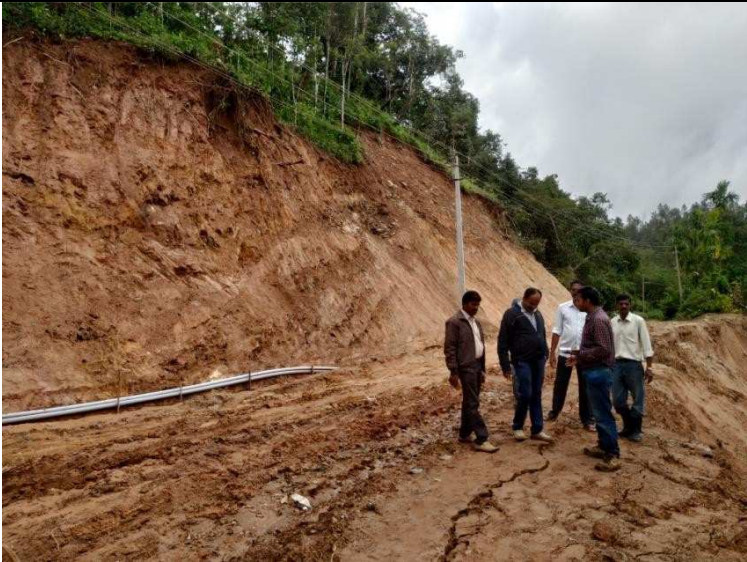
<p style="text-align: center;"><b>Debris slide along Sunkasale- BallalarayanaDurga road.</b></p>
40	Summary/Abstract	:	The debris slide is observed to have occurred on the southerly slope. The inclination of failure slope is observed to be around 40°. The width of the failure slope is about 30 meters along the road section. The slide initiated as translational failure & the debris are further descending down through the coffee plantation land. The landslide debris is observed to have accumulated at the road. Top of the hill sparse vegetation is observed reflecting presence of
