# Compendium of Traditional Earthquake Resilient Construction

# Compendium of Traditional Earthquake Resilient Construction for Knowledge Sharing and Disaster Risk Reduction

**Project Report**

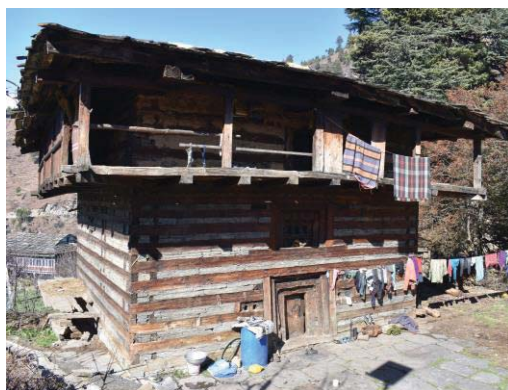
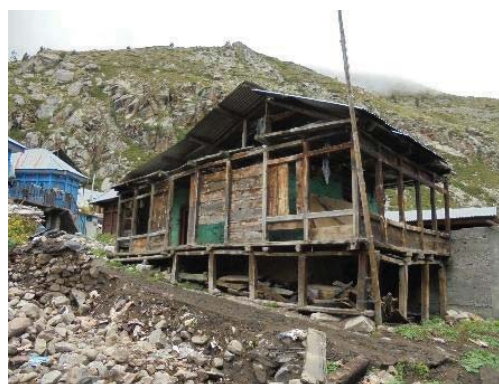
Figure 2.2: Different siting observed in Kath-kunni buildings

(a) On flat ground

(c) On a raised dry-stone platform

(d) On a raised wooden platform

The siting of a building plays a crucial role in achieving adequate seismic performance. Generally, sites with flat terrain for building construction are usually preferred due to frequent unstable slope failure in the study region. However, selecting sites with flat terrain is not always possible due to the region's topography. As a result, three different siting possibilities have been observed in the construction of Kath-kunni buildings: (i) the building is located on flat ground (Fig. 2.2(a)), (ii) the building is located on sloped ground, with a raised dry-stone platform (Fig. 2.2(b)-(c)), and (iii) the building is located on the sloped ground with a raised wooden platform (Fig. 2.2(d)). The height of the dry stone/wooden raised platform can be up to 2.0 m. In the case of Kath-kunni buildings constructed on slopes, the observed slope gradient does not exceed 2:1 (H: V). Photographs showing siting features of the Kath-kunni buildings collected during field surveys are presented in Fig. 2.2.

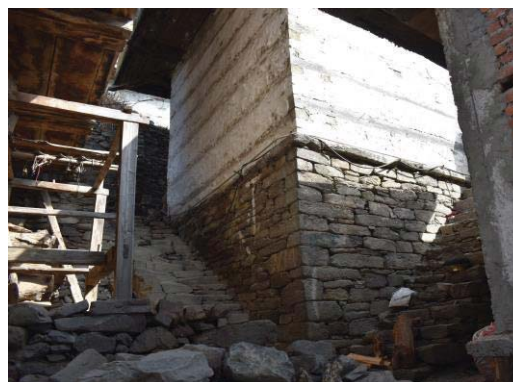
(b) On a raised dry-stone platform

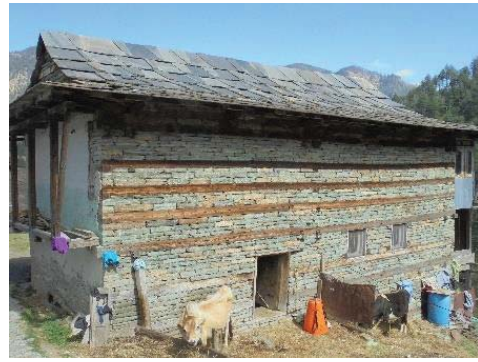
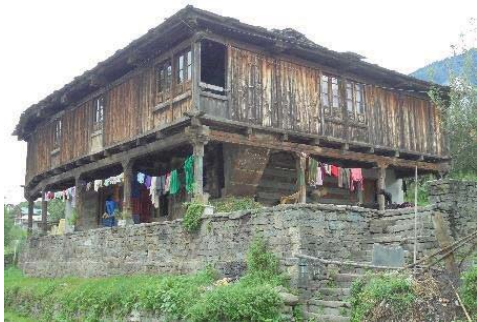
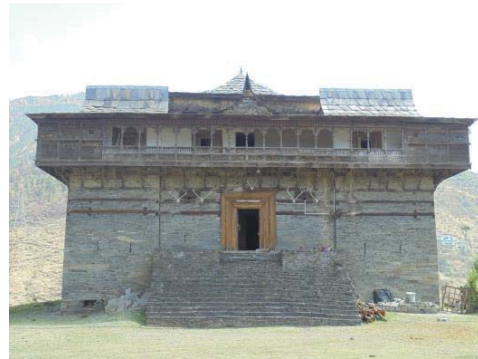
Figure 2.7: Plan shapes observed in Kath-kunni buildings

(b) Rectangular plan shape

(c) Rectangular plan

(d) Rectangular plan

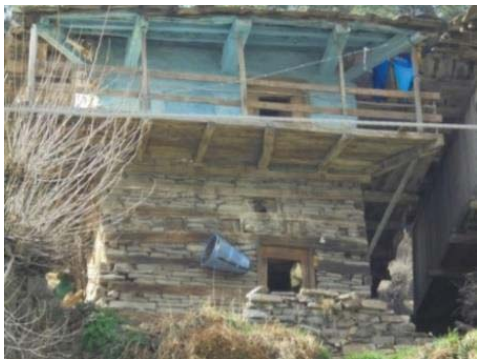
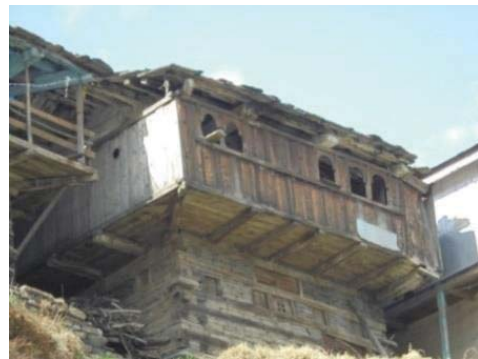
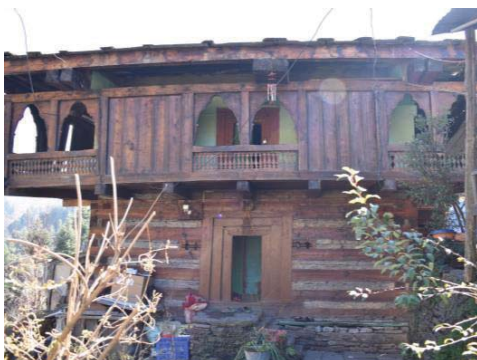
Figure 2.8: Openings in Kath-kunni buildings

(a) Small openings

(b) Small openings

(c) Small openings

The field investigations conducted in the states of Himachal Pradesh and Uttarakhand revealed that both the variants of the Kath-kunni style of traditional building construction consider the fundamental premise of earthquake safety of the building in their architecture by selecting a robust structural configuration, maintaining the symmetry in their plan and regularity in their elevations. It has been observed that most of the Kath-kunni buildings are rectangular plan shaped with their plan aspect ratios in the range of 1.1-1.4 (Fig. 2.7). The typical lengths and widths of Kath-kunni buildings are in the range of 3.5-8 m. The Kath-kunni buildings have small entrances in the ground story without any windows. Staircases are provided internally to access the upper floors. The Kath-kunni style of traditional construction includes doors and windows of minimal sizing (typically, total openings do not exceed 15% of the length of the wall) (Fig. 2.8), which are mostly placed centrally.

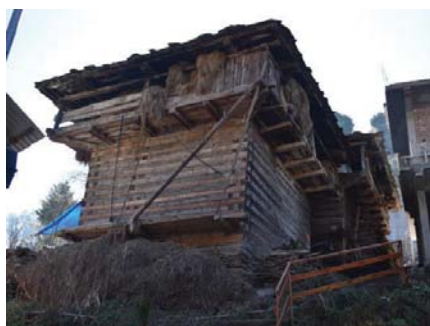
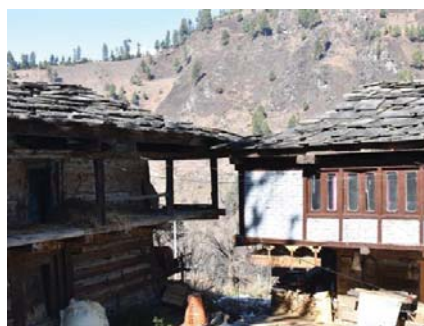
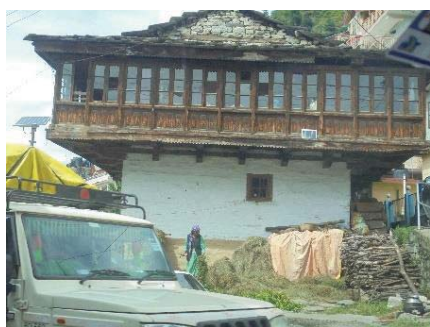
Figure 2.9: Horizontal projections in Kath-kunni buildings

(a) Small projections

(b) Small projections

(c) Small projections

In Kath-kunni buildings, no vertical projections were observed. On the other hand, horizontal projections exist almost in all Kath-kunni buildings. Usually, on the uppermost floor, a balcony is provided to take sunbaths and to protect the building occupants from rain and snow in both variants of the Kath-kunni construction. The length of horizontal projections is usually between 1.2-1.5 m (Fig. 2.9). Mostly, the Kath-kunni buildings are constructed in isolation. Therefore, a sufficient gap exists between the two buildings. However, in a few cases, closely spaced Kath-kunni buildings were also seen (Fig. 2.10), with the distance between them varying from 0.3-1.2 m.

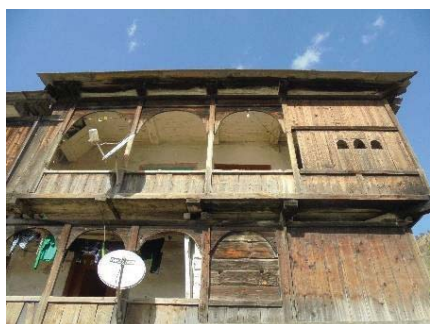
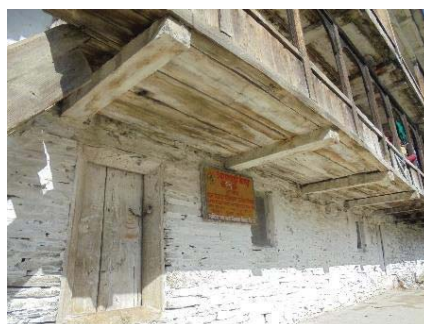
Figure 2.10: Distance between adjacent Kath-kunni buildings

(a) The gap between adjacent buildings

(b) The gap between adjacent buildings

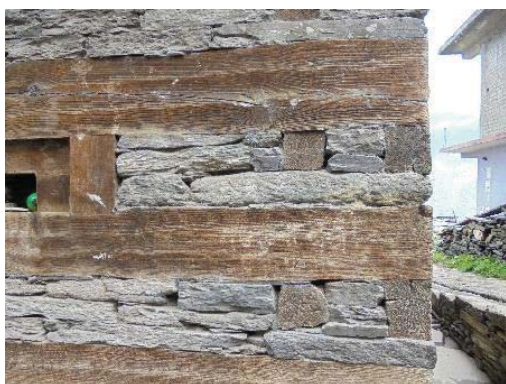
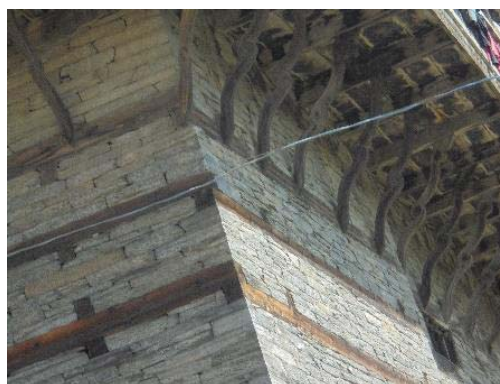
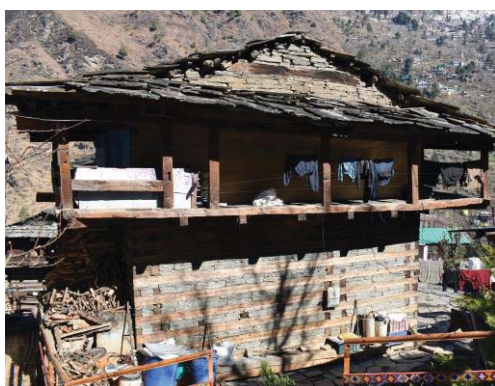
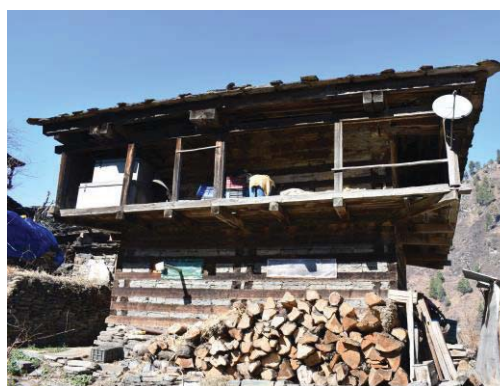
Figure 2.11: Wall thickness and wall lengths in Kath-kunni buildings

(a) Wall thickness @ 0.30 m

(b) Wall thickness @ 0.90 m

(a) Small wall length

(b) Small wall length

The load-bearing system of Kath-kunni buildings can be categorized as timber-laced stone masonry construction without any mortar. Kath-kunni buildings have been observed in various wall thicknesses ranging from 0.30-0.90 m, with 0.45 m thick walls being the most common. Small story height, along

with the reported high wall thickness, ensures that the height-to-thickness ratios in walls of Kath-kunni buildings are not exceeding 6 (Fig. 2.11). An equal distribution of walls exists in two horizontal directions, with wall lengths usually not exceeding 5 m (Fig. 2.11). The structural wall plan density for Kath-kunni buildings can range from 25-35%. The higher wall plan density in Kath-kunni construction is associated with a greater number of stories. The load-bearing walls in Kath-kunni buildings are laid in courses of semi-dressed/dressed stones (without any mortar) and closely spaced timber bands, oriented in two horizontal building directions at multiple levels along the height of the wall (Figs. 2.11-2.13). The horizontal timber members (runners) in the walls are placed on all four sides at the inner and outer edges of the walls. These horizontal runners are further interconnected through timber links (locally called 'Maanvi' or 'Makdi' Fig. 2.14) using double dovetail connections (Fig. 2.14), at an approximate spacing of 0.50 m. The vertical spacing (internal-to-internal) between timber bands is almost equal to 0.15 m in the old temple/residential buildings (Figs. 2.11 and 2.12). On the other hand, in the relatively newer Kath-kunni buildings, the vertical spacing between timber bands seems to have increased up to 0.45 m, and sometimes bands are seen at the plinth and roof levels. These horizontal timber bands are arranged one above another in two perpendicular walls and inter-connected through timbers nails (locally called 'Kadil,' Fig. 2.14) of size 0.04 m × 0.04 m at all four corners of the walls. Sometimes, mud/cow dung is used as the plastering material on both the internal and external faces of the walls (Fig. 2.13). Intermediate lap-jointed connections are used in longer walls when wooden elements are less than the wall lengths. The wooden logs at the bottom of the walls are embedded into the base platform.

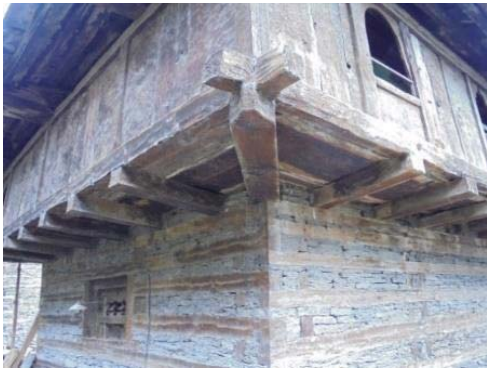
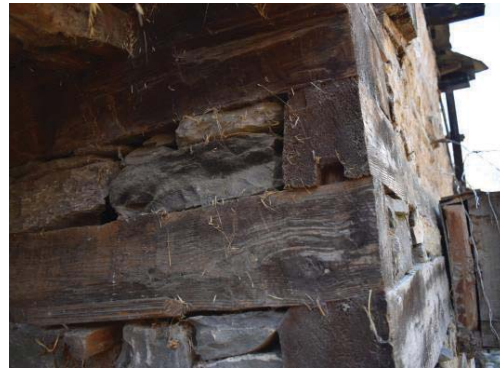
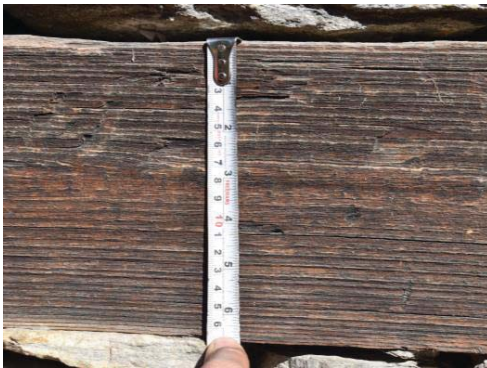
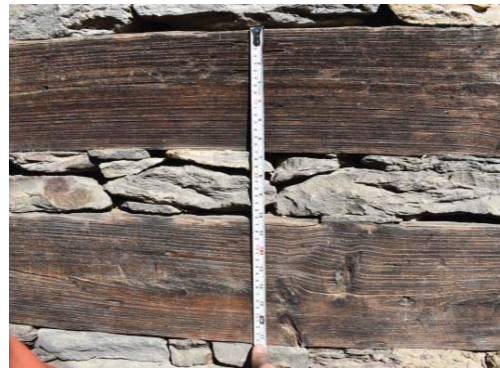
Figure 2.12: Timber bands in Kath-kunni buildings

(a) Wall-to-wall connections

(b) Wall-to-wall connections

(c) Depth of the band

(d) Spacing between bands

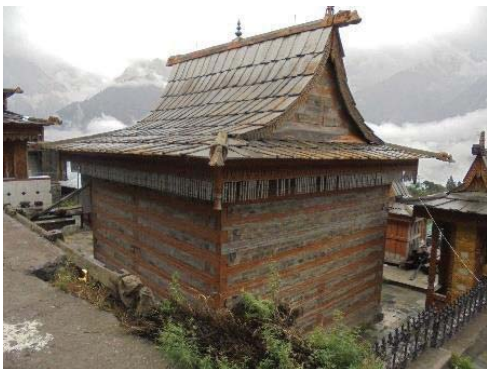
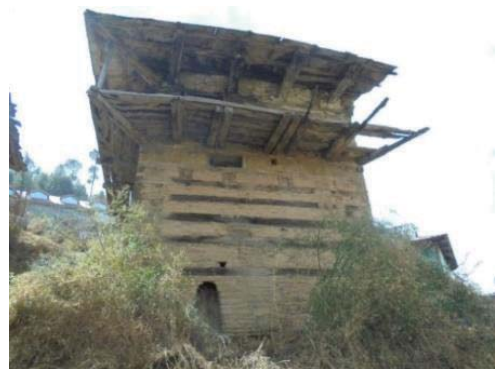
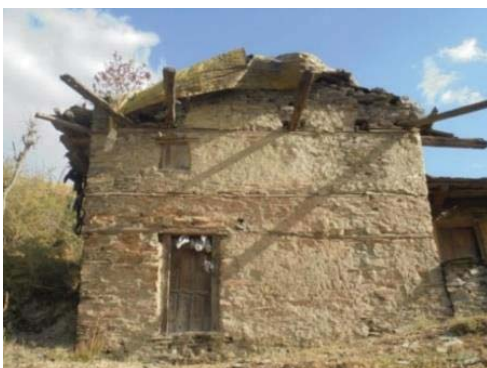
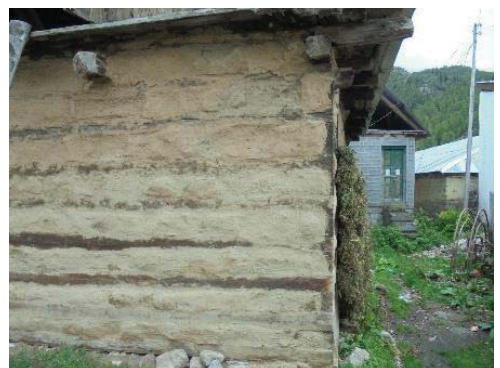
Figure 2.13: Plasters on the external faces of walls in Kath-kunni buildings

(a) No plaster

(b) Mud plaster

(c) Mud plaster

(d) Mud plaster

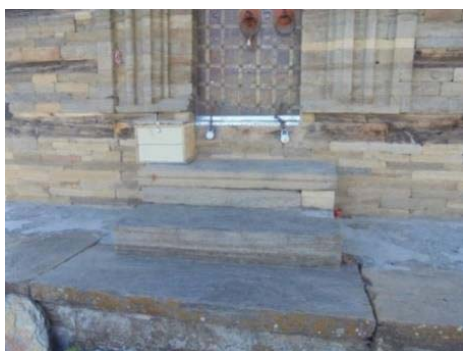
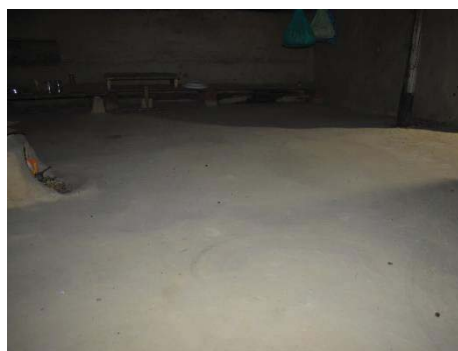
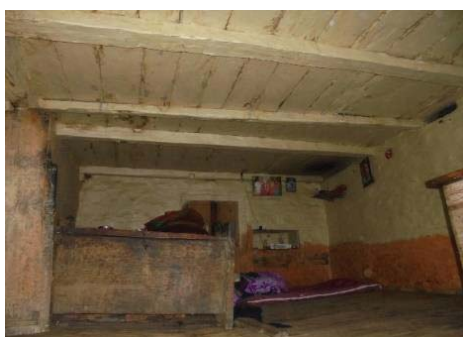
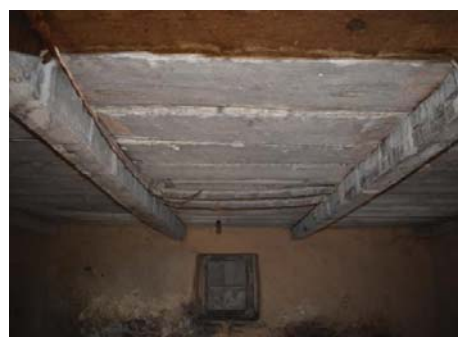
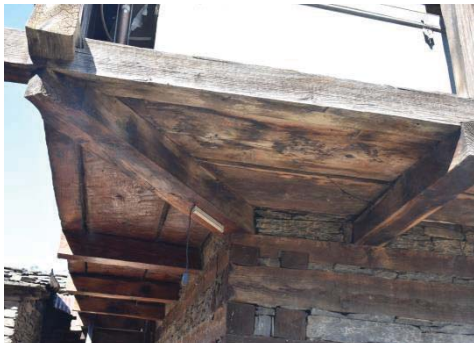
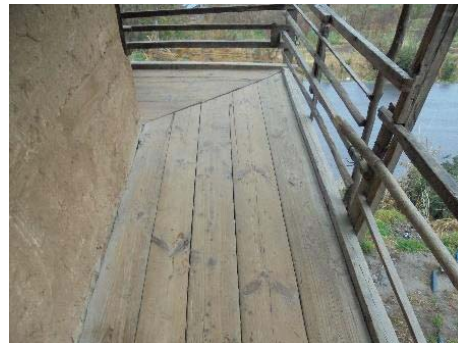
Figure 2.15: Floor system in Kath-kunni buildings

(a) Stone flooring

(b) Mud flooring over timber planks

(c) Timber planks on timber floor joists

(d) Timber planks on timber floor joists

(e) Timber planks on timber floor joists

(f) Timber planks on the floor

Different floor systems are employed in Kath-kunni buildings on the ground floor and upper floors. The ground floor in the Kath-kunni building usually consists of stone filling overlaid by mud flooring in residential buildings. In the case of temples, stone flooring is adapted on the ground floor (Fig. 2.15(a)). Timber planks supported on timber floor joists are used as the floor system on the upper floors (Figs. 2.15 and 2.16). The thickness of timber planks used in the floor system varies between 0.02–0.025 m. The floor joists (0.10 m × 0.15 m) usually span in a shorter direction, with a single member covering the entire building width. These floor joists are nailed to the timber band below them to provide floor-to-wall connections. The Kath-kunni buildings have cantilever projections of timber elements (0.10 m × 0.15 m) on all four sides inserted into the walls nailed to the timber band just below them. They are tied together at the opposite end using the supporting beam on all four sides of the building. The timber planks are further nailed to the floor joists (Figs. 2.11 and 2.15–2.16). Cross-planks or any other arrangements are not seen in the floor system of Kath-kunni buildings, and thus, the floor system in Kath-kunni buildings is expected to behave as a flexible diaphragm.

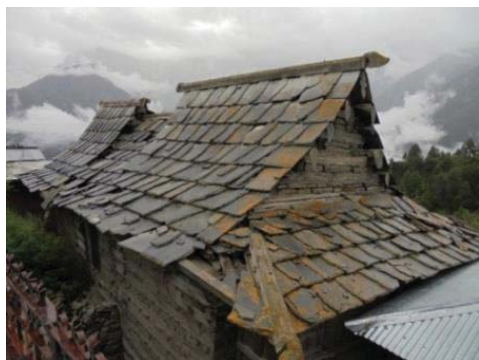
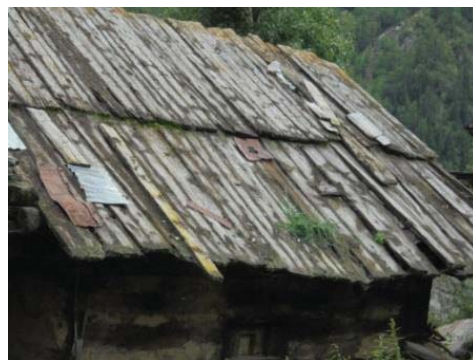
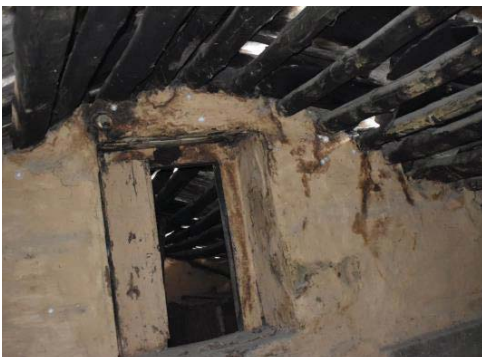
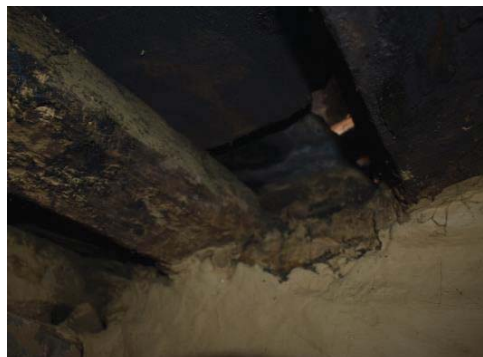
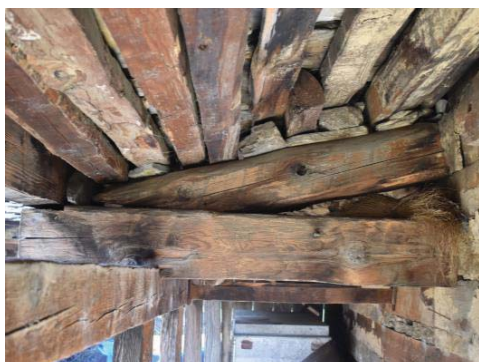
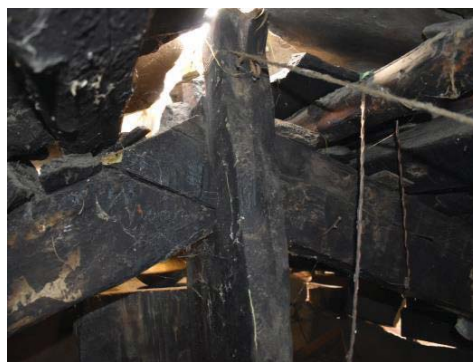
Figure 2.17: Roofing material and systems in Kath-kunni buildings

(a) Dutch-gable roof with stone slates

(b) Gable roof with timber planks

(c) Roof system

(d) Roof system

(e) Roof system in the balcony

(f) Vertical posts in the roof system supporting rafters

Roof systems in the traditional Kath-kunni style of construction in Shimla, Mandi, and Kullu have Dutch-gable roofs (Fig. 2.17) with stone slate (Fig. 2.17 (a)) to cover the roofs that are supported on timber elements. Contrary to this, timber planks are used to cover roofs in the traditional Kath-kunni style of construction, primarily found in Kinnaur (Fig. 2.17(b)), with few exceptions, where timber planks are replaced by CGI sheets or stone slates due to significant degradations in the timber over time. The stone slates in the roof cover are nailed to the roof system. The primary reason for using a Dutch-gable roof in the traditional Kath-kunni buildings is to allow the snow to slide over the roof surface in the winter season, as the area suffers snow cover for at least two to three months a year. In Kath-kunni buildings, walls on the uppermost floor are extended to create a triangular (gable) shape of the roof system (Figs. 2.17 and 2.18). The timber elements of cross-sections 0.10 m × 0.15 m are cantilevered from the walls, and inclined members are connected at one end using nails (Fig. 2.18). The cantilevered roof elements are connected and tied to timber supports on all four sides (Figs. 2.18). In the roof support system, timber members are oriented in two orthogonal directions connected at ends through grooves and also in the diagonal direction (Fig. 2.18), which are further

inserted into the walls. These wooden members are usually kept at a spacing of 1.0-1.5 m. The cross-section size of the timber elements is typically 0.15 m × 0.10 m. The vertical rise of the roof can vary between 1.0-1.5 m. The typical sketch of the roof system is shown in Fig. 2.18.

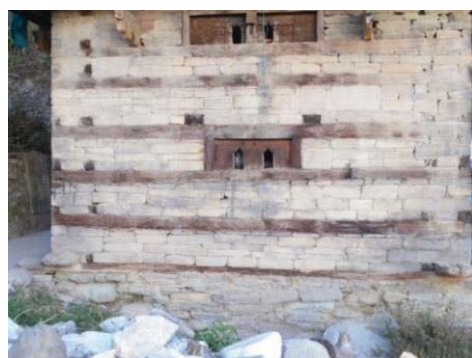
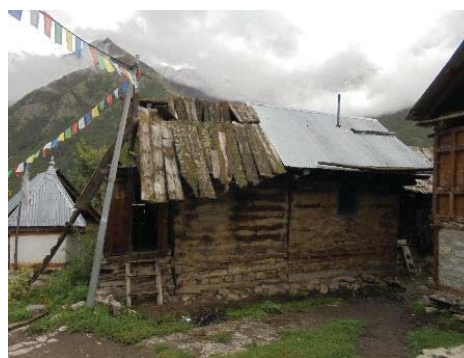
Figure 2.19: Foundations in Kath-kunni buildings

(a) Stone foundation

(b) Stone foundation

Strip foundations of river/field stones are used in Kath-kunni buildings (Figs. 2.19 and 2.20). The foundations' sizes (i.e., width and depth) in traditional buildings are chosen depending on the type of ground strata available at a particular site. The width of the foundation is kept identical to the thickness of the wall when a building is constructed on bedrock. It is increased to 1.5-2.0 times the thickness of walls when the building is built on medium to weak soils. Similarly, the depth of the foundation varies between 0.6-1.0 m when the building is constructed on bedrock, and it is increased up to 1.5 m when medium to weak soils are encountered. Sometimes, in the Kath-kunni buildings, the foundation depth is increased up to 2.0 m due to thicker walls and a greater number of stories. The typical sketches of the foundations are shown in Fig. 2.20. The discussions with locals further revealed a traditional practice used in the foundations of Kath-kunni buildings, in which the foundation is primarily constructed, followed by the construction of the superstructure that begins only after the rainy season ends. This practice ensures the safety of buildings against foundation/ground settlements that are expected to occur in soft soils during and after the rainy season.

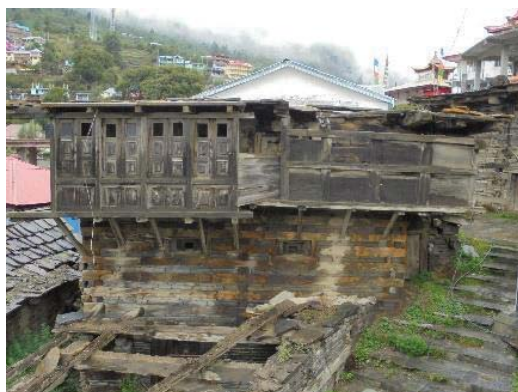
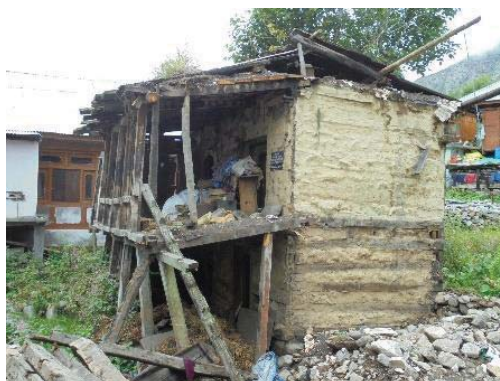
Figure 2.21: Deteriorated Kath-kunni buildings in the study region

(a) Deteriorated building

(b) Deteriorated building

The owners maintain the Kath-kunni buildings. The visual conditions for most of the Kath-kunni buildings have been observed to range from average to good, except for a few buildings, particularly in Chitkul (Kinnaur), which were heavily deteriorated and unoccupied (Fig. 2.21). Non-maintenance of

a few Kath-kunni buildings over a longer period resulted in them being too weak to use for residential purposes. The discussions with locals revealed that the scarcity of timber and lack of skilled artisans are other causes for their non-maintenance. The other primary source of deterioration in Kath-kunni buildings is the degradation of wooden planks in the roof systems due to their direct exposure to rain and snow. The heavily deteriorated buildings in Chitkul were unoccupied.

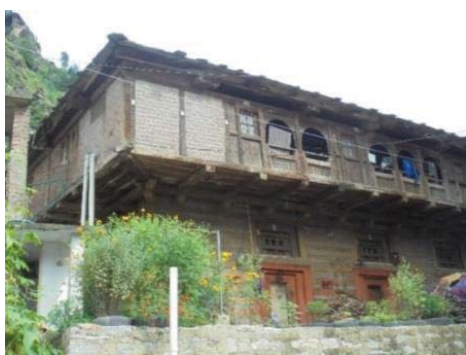
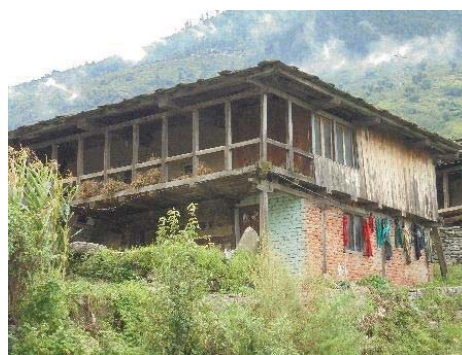
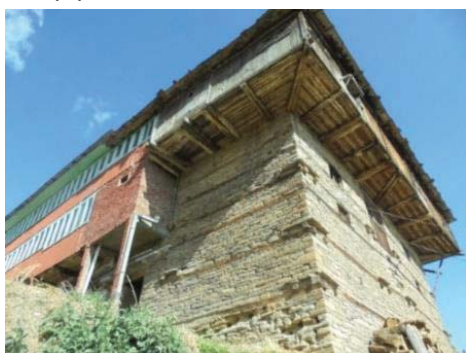
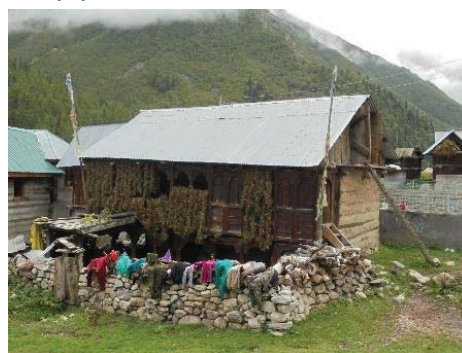
Figure 2.22: Influence of contemporary materials on Kath-kunni buildings

(a) Brick walls in Kath-kunni

(b) Brick walls in Kath-kunni

(c) Brick walls in Kath-kunni

(d) CGI sheets in Kath-kunni

Few buildings are seen that were originally constructed in the Kath-kunni style and later on modified with minor interventions using contemporary construction materials. These modifications include the partitions made using burnt clay bricks, cement plaster, and CGI sheets. The typical photographs depicting the influence of modern materials in Kath-kunni buildings are shown in Fig. 2.22.

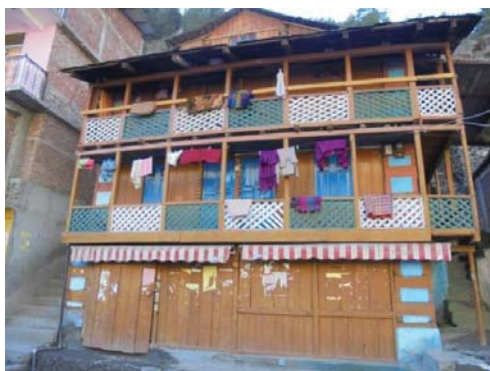
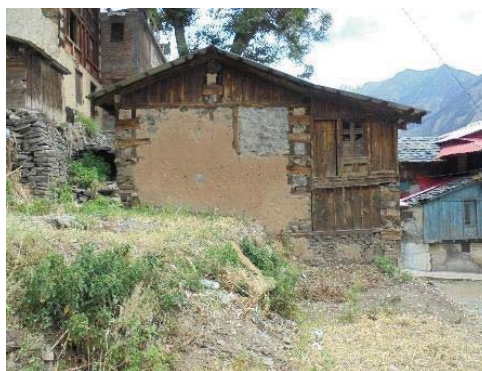
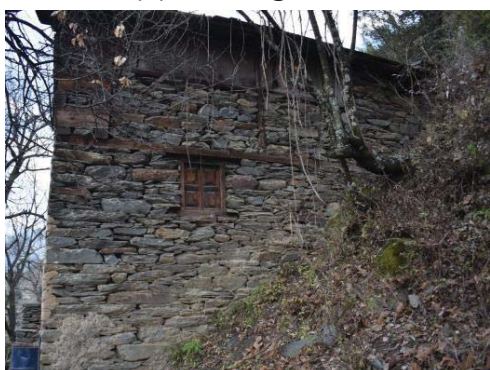
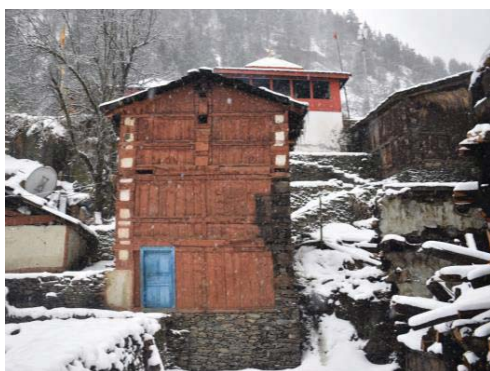
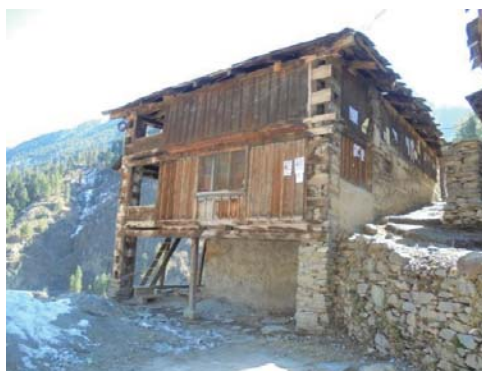
Figure 2.26: Different siting observed in Thathara buildings

(a) On flat ground

(b) Two foundation level

(c) On sloping ground

(e) On raised dry-stone platform

(f) Supported on Thola without walls

The siting of a building plays a crucial role in achieving adequate seismic performance. In general, flat site terrains are preferred for building construction due to frequent slope failure in the study region. However, it is not always possible to select flat landscapes due to the varying terrain present. Depending on the ground conditions, various structural configurations of Thathara buildings are seen during field surveys (Fig. 2.26). These structural configurations include flat ground configuration (Fig. 2.26(a)), a configuration with two largely different founding levels (Fig. 2.26(b)), building on sloped terrain ((Fig. 2.26(c)-(d)), configuration built on a raised dry-stone platform ((Fig. 2.26(e)) and the last configuration which is when the building is supported on Thola without any walls in the ground story in any of the directions (Fig. 2.26(f)). For Thathara buildings constructed on slopes, a slope gradient as high as 1:1 is observed (H: V; Fig. 2.26(c)).

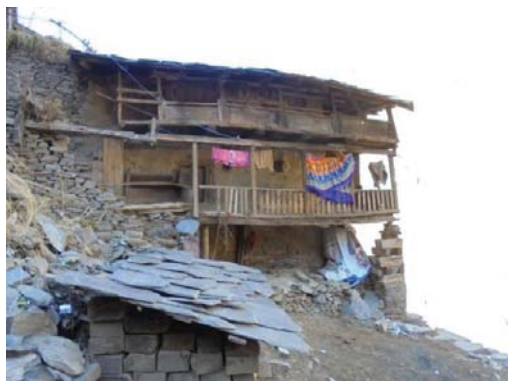
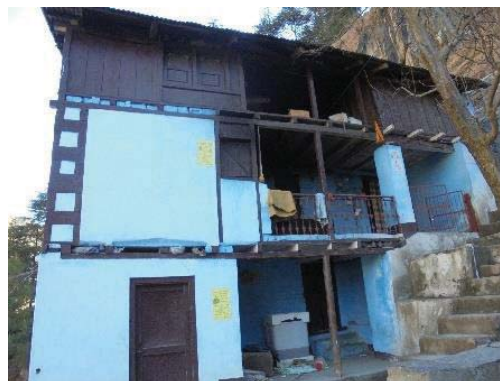
Figure 2.27: Story heights in Thathara buildings

(a) Story height @ 1.60 m

(b) Story height 2.0 m

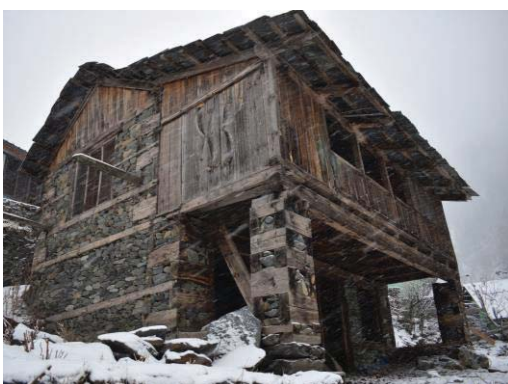
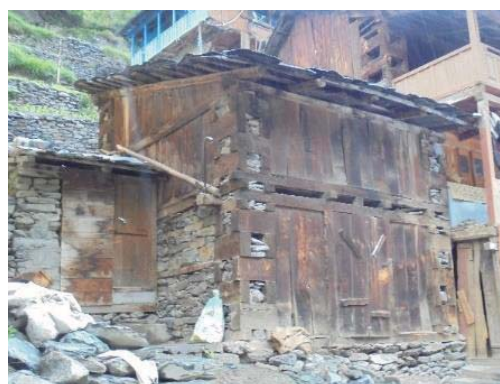
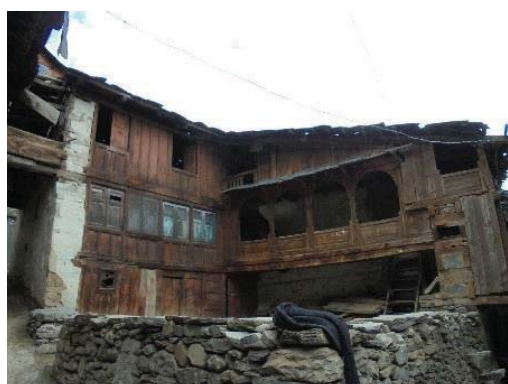
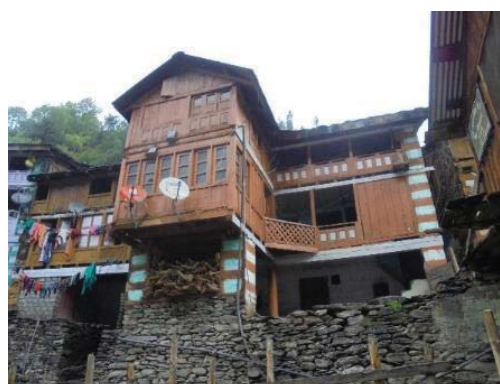
Figure 2.28: Plan shapes of Thathara buildings

(a) Rectangular plan

(b) Rectangular plan

(c) L-shaped plan

(d) T-shaped plan

Thathara buildings are constructed following the basic principles of earthquake safety, maintaining regularity and symmetry in plans and elevations. Owing to this fact, Thathara buildings in the study region were mainly constructed and seen with rectangular plan shapes, keeping their plan aspect ratios between 1-2 (Fig. 2.28(a)-(b)). The oral rules still exist in the region of the prevalence of Thathara buildings for selecting the building plan dimensions. However, a few buildings with a selection of irregular plan shapes, such as L and T, were also seen (Fig. 2.28(c)-(d)), which are several decades old. Dry stone walls without mortar are used on the lowest floor to ensure the stability of the structure (Fig. 2.29(a)), whereas timber partitions are preferred on upper floors to reduce the seismic weight of the structure (Fig. 2.29(a)). These buildings are constructed with a balcony on the front side of the upper floors, whose width typically varies between 1.2-1.6 m, and it is supported by

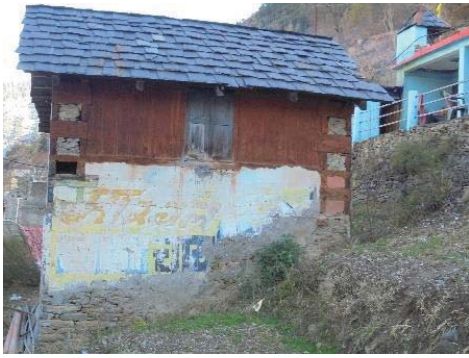
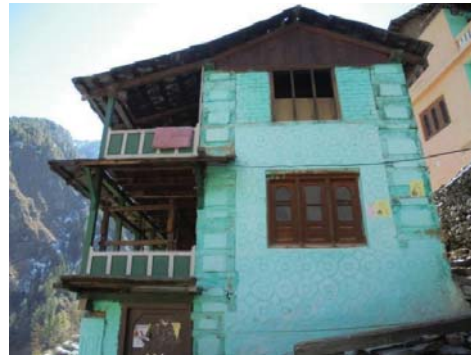
Figure 2.29: Openings in walls of Thathara buildings

(a) Small opening

(b) Moderate opening

wooden posts or brick masonry columns on either side (Figs. 2.29(b)). The walls on the lower floors of Thathara buildings have low opening ratios, whereas the opening ratios significantly increase on the upper floors (Fig. 2.29). It is seen that many Thathara buildings have cupboards in the walls, and thereby, the thickness of walls reduces at those locations. Hence, to further strengthen the walls around those cupboards, the strengthening arrangements are similar to those seen in the Dhajji-Dewari style, i.e., diagonal braces around openings and cupboards could be seen frequently (Fig. 2.30).

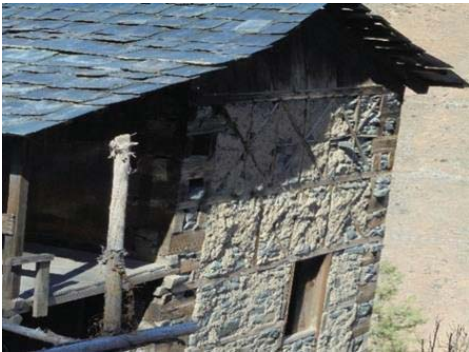
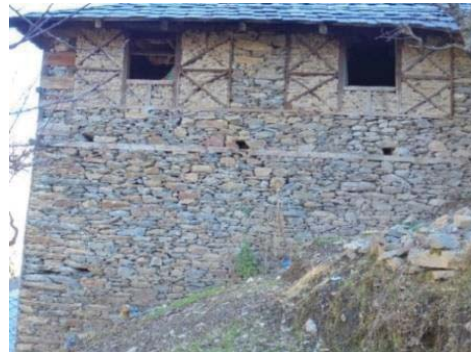
Figure 2.30: Cross-bracings around openings in walls of Thathara buildings

(a) Diagonal bracings

(b) Diagonal bracings

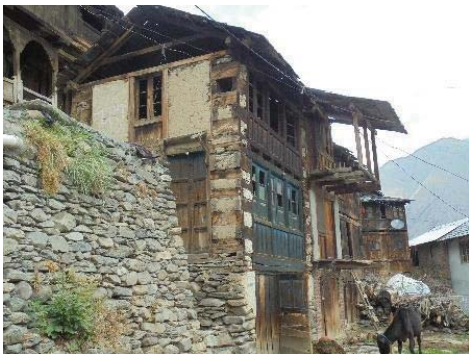
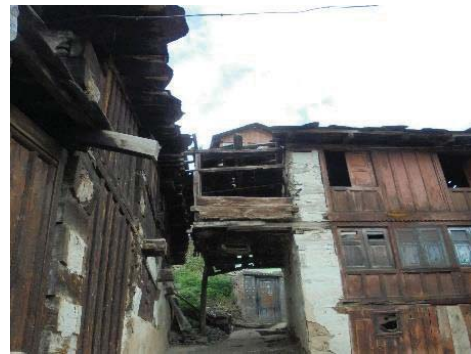
Figure 2.31: Horizontal projections in Thathara buildings

(a) Small projections

(b) Small projections

the other traditional building types prevalent in the region. Vertical projections were not observed (Fig. 2.29-2.31). In addition, Thathara buildings do not share common walls with adjacent buildings, and the distance between adjoining buildings can vary from a few centimeters to several meters (Fig. 2.32).

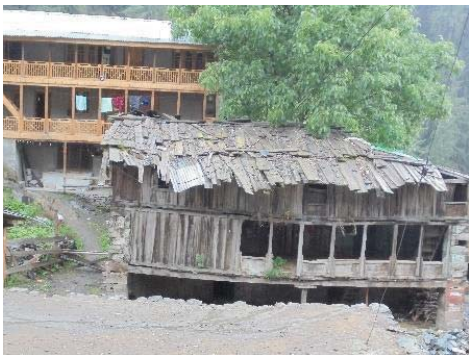
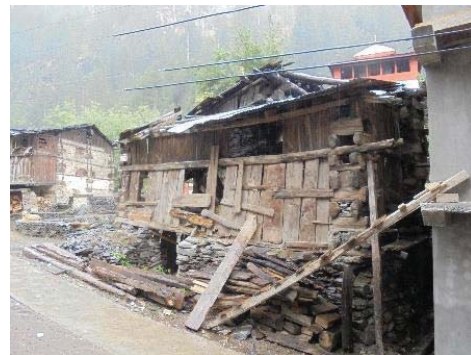
Figure 2.32: Distance between adjacent Thathara buildings

(a) Isolated building

(b) Sufficient gap

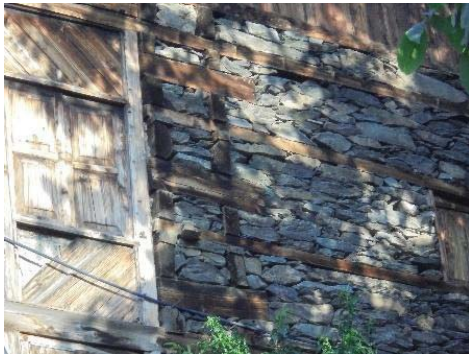
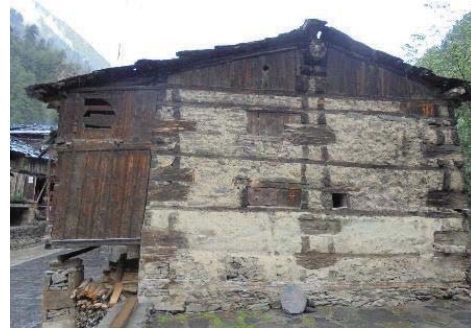
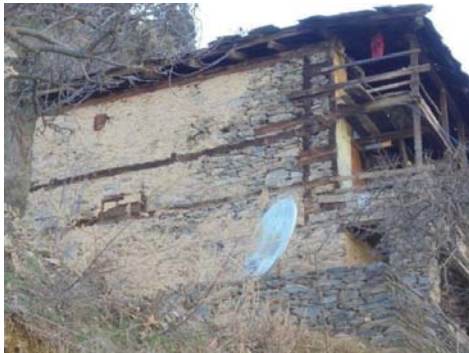
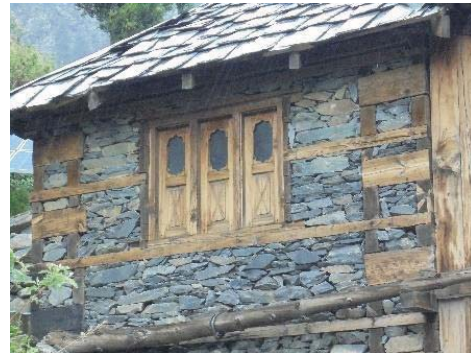
Figure 2.34: Thola-to-wall connections in Thathara buildings

(a) Thola and bands

(b) Floor beam in Thathara buildings

(c) Thola-to-wall connections

(d) Thola and bands

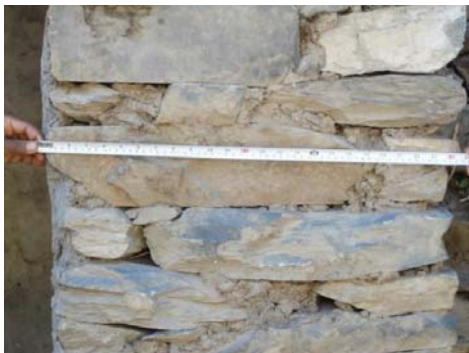
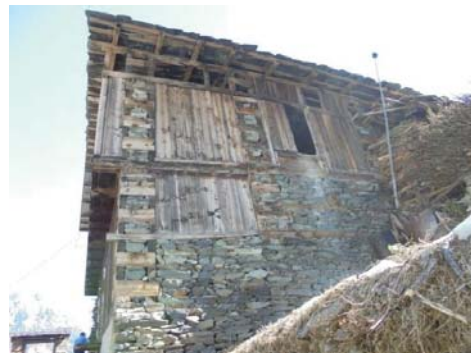
Figure 2.35: Wall thickness in Thathara buildings

(a) Wall thickness @0.45m

(b) Wall thickness @0.45m

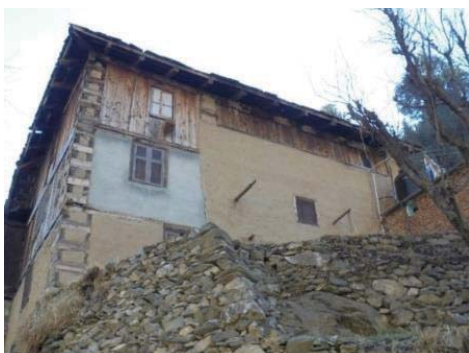
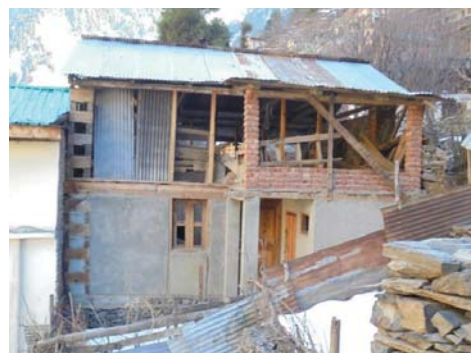
Figure 2.36: Wall plasters in Thathara buildings

(a) Mud plaster

(b) Cement plaster

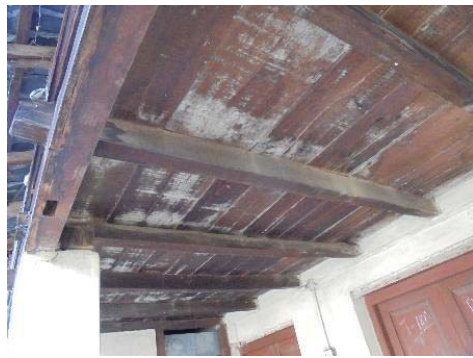
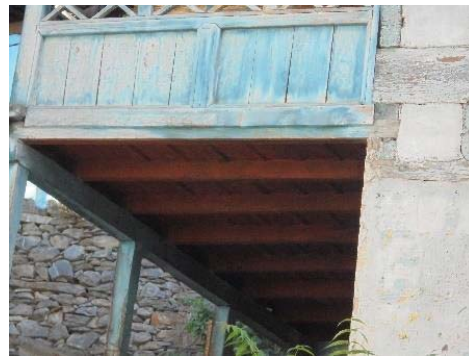
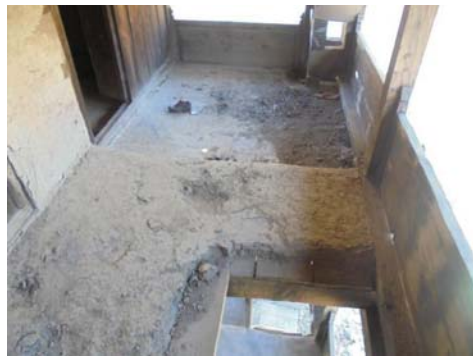
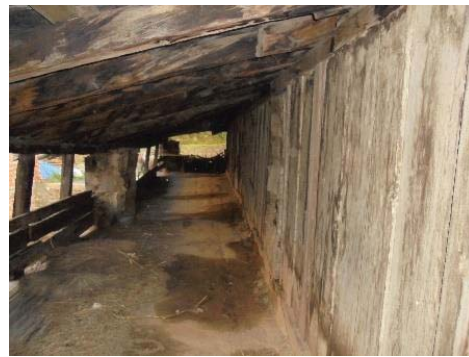
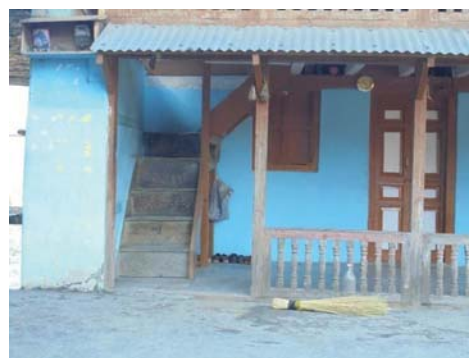
Figure 2.38: Floor systems in Thathara buildings

(a) Primary and secondary floor beams

(b) Primary and secondary floor beams

(c) Earthen cover in wooden floor

(d) Earthen cover in wooden floor

(f) Plain cement concrete floor

The details of the floor system in Thathara buildings are shown in Fig. 2.38. The floor system at the ground floor comprises the stone filling up to the plinth level, over which mud or a mixture of mud and cow dung is used to plaster and level the floor. In contrast, the floor system on the upper floor consists of timber planks on secondary beams resting over primary beams. In Thathara buildings, the secondary timber beams having a cross-section of 0.15 m × 0.15 m are spaced at 0.5 m (Fig. 2.38(a) and 2.39) on the primary timber beams of cross-section 0.20 m × 0.20 m spaced at 3.0 m (2.38(a) and 2.39). The connections between primary and secondary beams are achieved through nails. Timber planks of 0.02 m thickness are then nailed to secondary timber beams, with a thin overlay (approximately 0.025m) of the mud slurry placed to prevent direct timber exposure to fire and water (Figs. 2.38). In a few buildings, the use of plain cement concrete for flooring on the ground floor was also observed in Thathara buildings (Fig. 2.38(f)), though it is only a recent addition. No cross-planks are seen in Thathara buildings. Thus, the floor system of Thathara buildings is expected to behave as a flexible diaphragm.

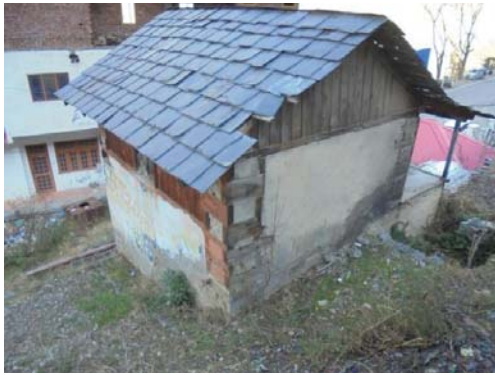
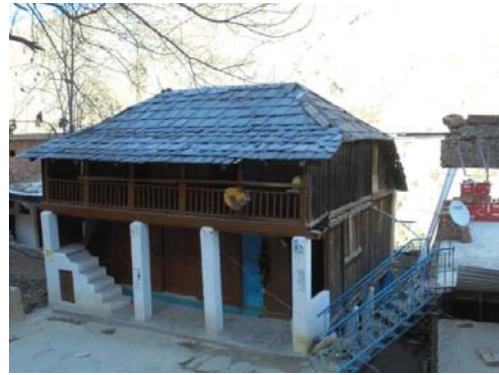
Figure 2.40: Roof geometry in Thathara buildings

(a) Gable roof with stone slate

(b) Hipped roof with stone slate

The sloping roofs (either gable or hipped, sloping in the range of 15-25 degrees, Fig. 2.40(a)-(d)) is traditionally preferred in Thathara practices, primarily due to heavy rainfall and snowfall in the region of their prevalence. Stone slates are usually used to cover the roof system in traditional Thathara buildings. In a few cases, flat rigid RC roofs were also observed. The span of the roof truss varies between 3.60-6.00 m, whereas the rise of the roof truss varies between 0.60-1.20 m. In Thathara buildings, Tholas, located in the middle, are raised to the ridge level (Figs. 2.41 and 2.42) in the two opposite walls. The ridge beam (locally called 'Nhas') is directly placed over Tholas without connection. The rafters connected by the collar and tie beam (sometimes vertical posts are also seen to form a queen post arrangement of timber truss, Fig. 2.41) with c/c spacing of 1.2 m are connected at one end to the ridge beam with timber nails and at the other end to the wall plate (locally called 'Jail-Dal') through grooves. The wall plates are placed directly over the walls without any connection with the walls, although wall plates are connected with Thola at the ends. The rectangular-shaped purlins of cross-section 0.100 m × 0.075 m are spaced at 0.4 m and are nailed to the rafters at a spacing of 1.3 m. The stone slates are secured by connecting them to the purlins with iron nails.

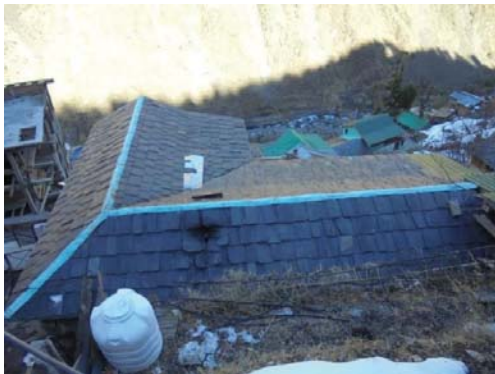
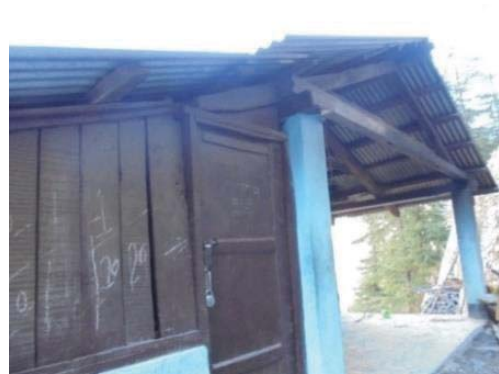
(c) Cross gable roof with stone slate

(d) GI sheet as a roof

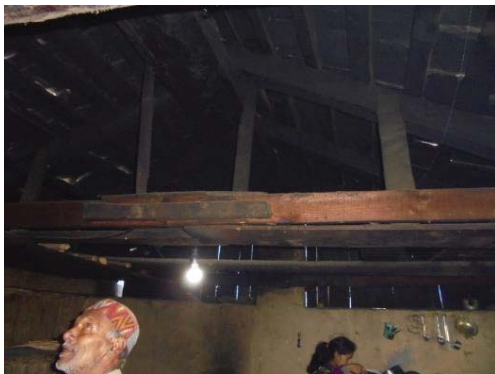
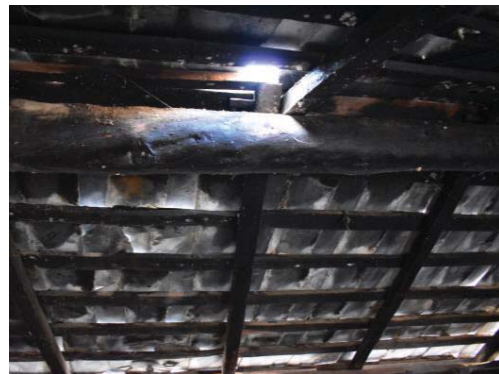
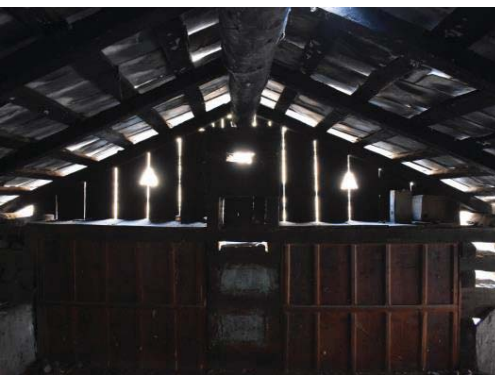
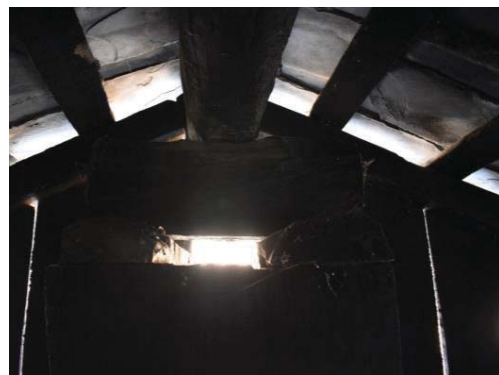
Figure 2.41: Roof system in Thathara buildings

(a) Trussed roof system

(b) Rafter-to-rafter connection

(c) Nhas with rafters spaced @ 1.2 m

(d) Nhas resting on Thola without any

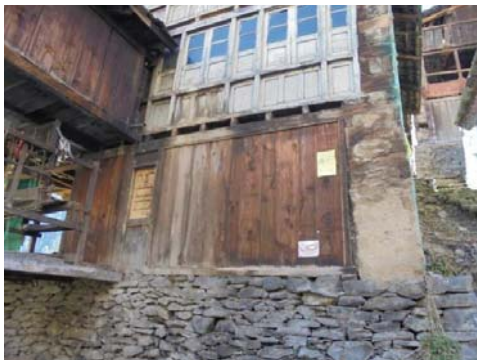
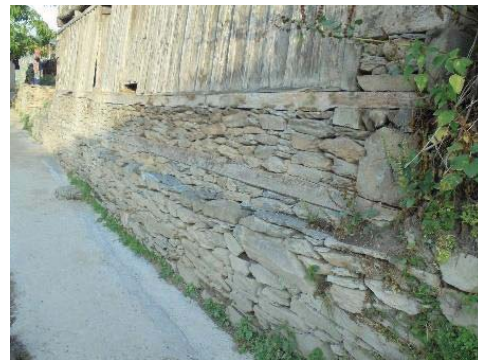
Figure 2.43: Foundations in Thathara buildings

(a) Stone foundation

(b) Stone foundation

The field/river stones are used in the construction of strip foundations in Thathara buildings (Fig. 2.43). The width of the foundation in this construction varies between 0.45–0.9 m. The depth of the foundation varies from building to building depending on the availability of the hard soil/rock strata, usually available in the regions at a shallow depth. Typically, the depth of the foundation varies between 0.6–1.5 m. The Tholas in ‘Thathara’ buildings directly rest on rubblestone strip footing, without any positive connection between Thola and the foundation.

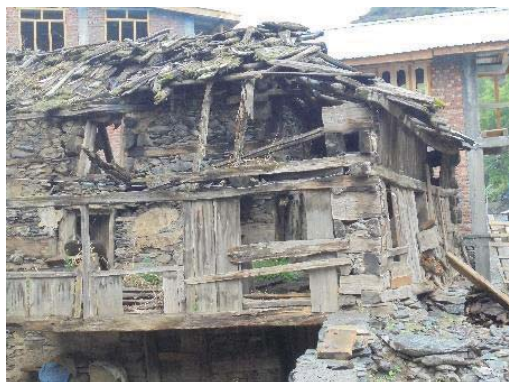
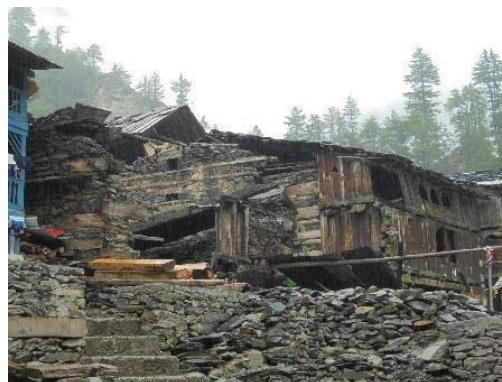
Figure 2.45: Deteriorated Thathara buildings in the study region

(a) Deteriorated building

(b) Deteriorated building

During the field surveys, the visual conditions of many Thathara buildings were observed to be in the range of average to good, whereas some buildings were found to be severely damaged and unoccupied (Fig. 2.45) in Kugti Village, highlighting a paradigm shift in building construction practices from the traditional ones to their contemporary counterparts. The Thathara buildings are maintained by owners. The building occupants revealed that Thathara buildings are expected to perform fairly well for a life span of ~70-80 years, without any excessive maintenance costs, due to the use of highly durable materials (i.e., semi-dressed stones, stone slates, and Deodar wood). The minor interventions that are required frequently in Thathara buildings include the repointing of mud plaster in washed areas due to rain, and significant interventions for maintenance require the replacement of timber elements, particularly in the roofs.
