# Compendium of Traditional Earthquake Resilient Construction

# Compendium of Traditional Earthquake Resilient Construction for Knowledge Sharing and Disaster Risk Reduction

**Project Report**

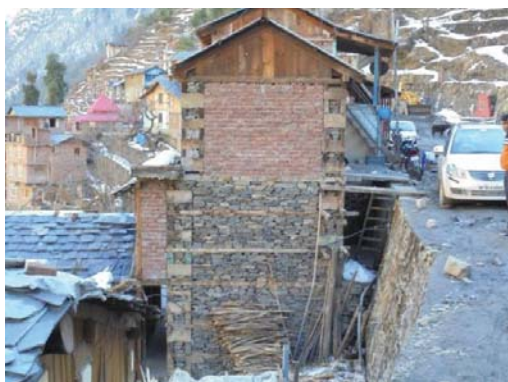
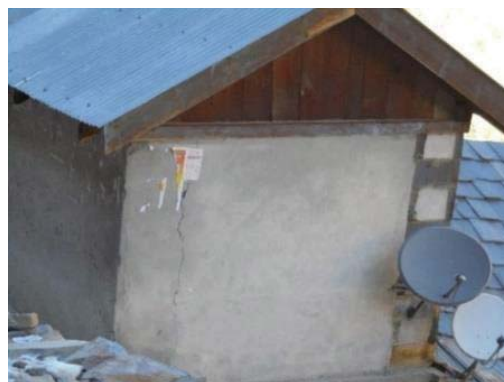
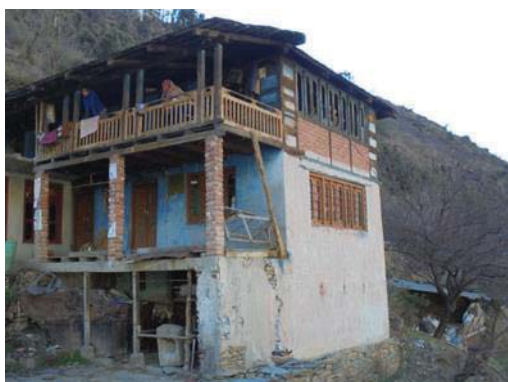
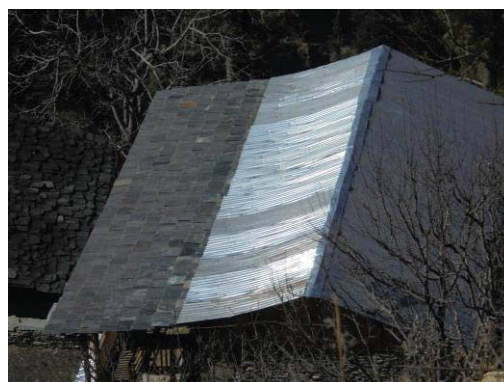
**Figure 2.46:** Influence of contemporary materials on Thathara buildings

(a) Burnt clay brick walls

(b) Structural steel sections

(c) Brick column

(d) CGI sheets on the roof

The occupants of Thathara buildings revealed that the construction scenario in the region had changed significantly in the past few decades. Nowadays, contemporary construction practices such as using flat RC roofs and burnt clay bricks can be seen frequently in and around the region of the prevalence of Thathara construction. Several contemporary construction practices can be seen in the Thathara construction (Fig. 2.46). The practices include using burnt clay bricks to construct walls (Fig. 2.46(a)). The use of steel sections in the roof supporting system (Fig. 2.46(b)), brick columns (Fig. 2.46(c)), and RC rigid roofs can also be seen in Thathara construction. Most of these contemporary modifications are the forced change in this construction style due to the lack of timber required for such construction and the unavailability of skilled artisans knowing Thathara construction.

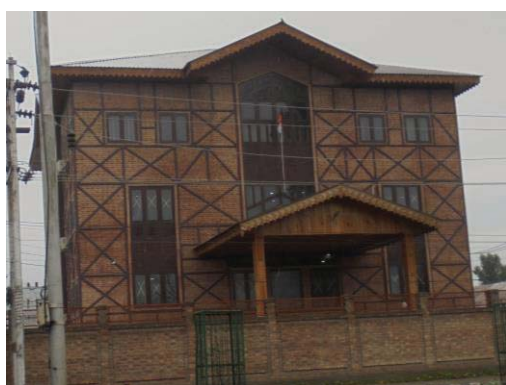
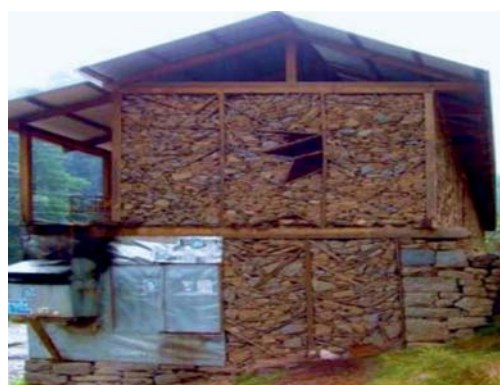
(a) On flat ground

(b) On sloped terrain

Dhajji-Dewari buildings can be found on both (i) flat ground (Fig. 2.50(a)) and (ii) sloping terrain conditions (Fig. 2.50(b)). When located on slopes, an artificial platform is created to attain a flat platform for the building to rest on. The typical photographs showing siting features of Dhajji-Dewari buildings that were captured during field surveys are shown in Fig. 2.50. When sloping terrains are encountered, constructing back walls to retain soil is also seen in some Dhajji-Dewari buildings.

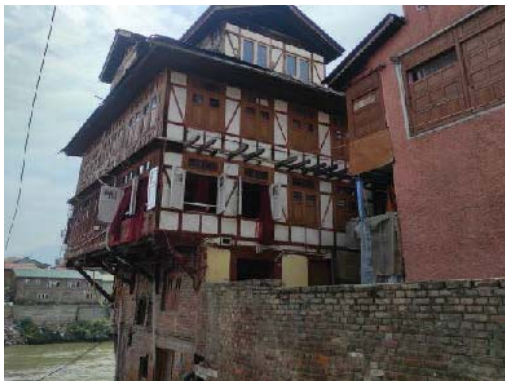
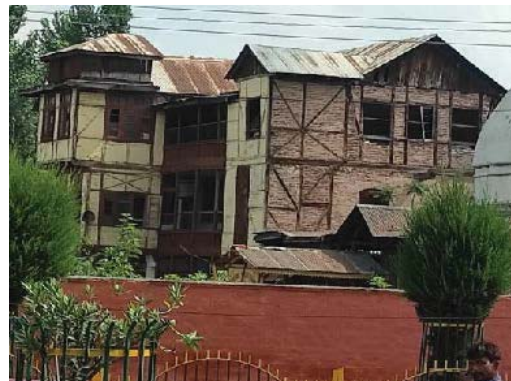
Figure 2.52: Plan shapes in Dhajji–Dewari buildings

(a) Rectangular plan shape

(b) Complex plan shape

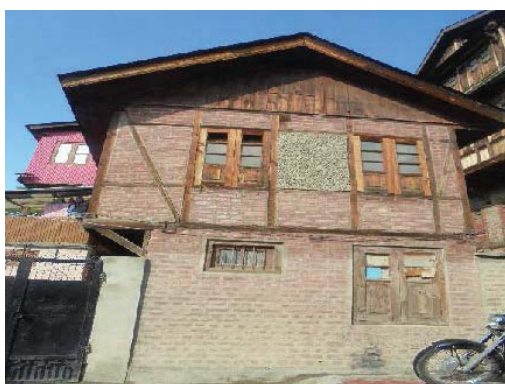
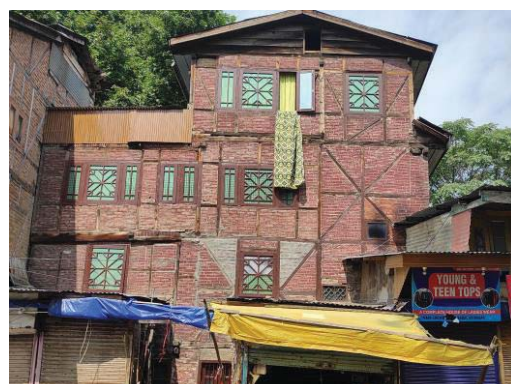
Figure 2.53: Story heights in Dhajji-Dewari buildings

(a) Story height @ 3.0 m

(b) Story height @ 3.0 m

are mainly concentrated on the downhill side of the building which covers approximately 50% of the length of the walls (Fig. 2.53). The alignment of openings is usually uniform in Dhajji-buildings resting on flat ground. In most of the Dhajji buildings, large rooms exist to conduct social gatherings. Large rooms are mostly constructed in the upper story of buildings, essentially called halls with a typical span of 8-10 m. The horizontal projections in Dhajji buildings vary between 1.5-1.8 m (Fig. 2.55). Dhajji buildings are usually constructed in isolation in rural areas. However, in the case of extended buildings, the walls can be shared and many Dhajji-Dewari buildings in the Srinagar downtown area are constructed in rows, sometimes without any gaps between them (Fig. 2.56).

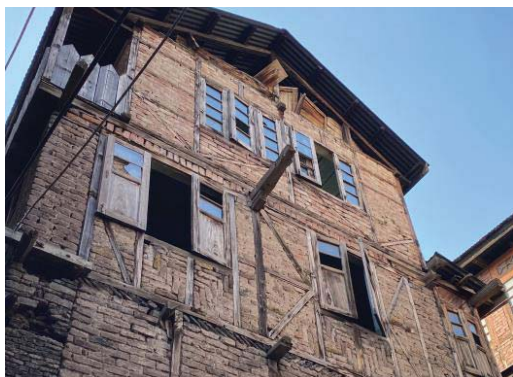
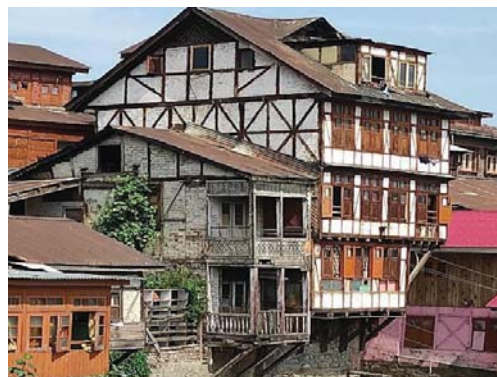
Figure 2.54: Openings in Dhajji-Dewari buildings

(a) Moderate openings

(b) Large openings

The main purpose of the Dhajji-Dewari style of traditional building construction practice is to provide shelter to human beings. Thus, it is mostly used for residential occupancy (Fig. 2.51). However, this traditional style of construction can also be seen in hospitals as well as buildings with residential and commercial occupancies (Fig. 2.51). In general, Dhajji-Dewari buildings are constructed following the principles of earthquake safety by maintaining symmetry and regularity in their plan and elevation. Dhajji buildings are mostly rectangular in plan (Fig.2.52), with a few exceptions, where complex plan shapes are also seen. The typical plan aspect ratio of the Dhajji building varies from 1-3. The typical plan dimensions of Dhajji buildings have lengths in the range of 10-15 m, and widths in the range of 5-15 m. Dhajji-Dewari buildings are seen up to 4 stories with the typical story heights varying between 2.5-3.2 m (Fig. 2.52). The single-storied buildings are found in rural areas, whereas multi-storied buildings are prevalent in urban areas, e.g., Srinagar city. In rural areas, the lowest floor levels are used to shelter livestock, while in urban areas; it is used as a normal townhouse/shop. Dhajji-Dewari buildings have well-distributed openings in two directions, which typically range between 20%-30% of the length of the walls. The photographed images of the Dhajji building with varying openings are shown in Fig. 2.54. In addition, if these buildings are constructed on sloping terrain, the openings

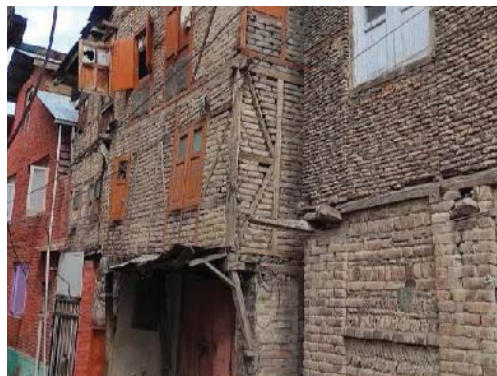
Figure 2.56: Distance between adjacent Dhajji-Dewari buildings

(b) Buildings with a gap of 0.1 m

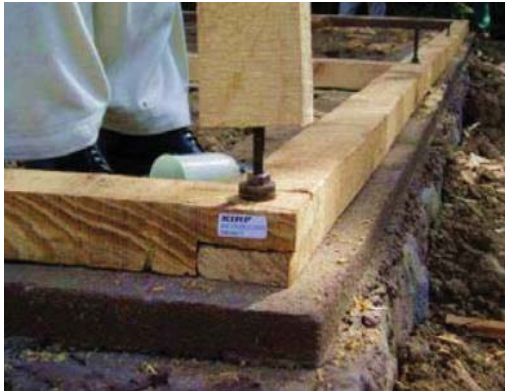
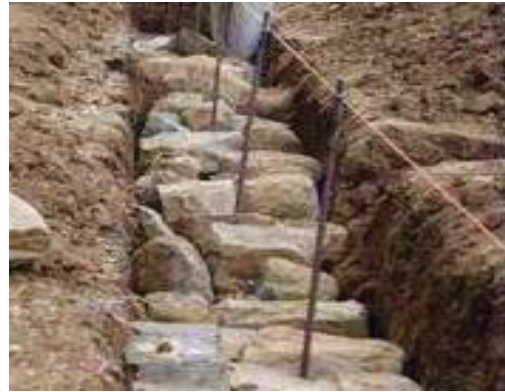
Figure 2.63: Foundations of Dhajji-Dewari buildings

(a) Bolting of plinth beam to foundation

(b) Provision of anchor bolts in the foundation

Typically, Dhajji-Dewari buildings have shallow foundations made up of rubble/field stone strip footing, with the provision of drainage around the timber frame. The depth and width of the foundation vary based on both building and location specifications but Typically, the depth of the foundation in Dhajji buildings is 0.4-0.6 m and the width of the foundation varies between 0.6-1.8 m, depending on the soil strata and the number of stories. Dhajji-Dewari buildings mostly rest on soft soil that is prevalent in and around Srinagar. Nominally reinforced-concrete foundations are also used in recent constructions since the 2005 Kashmir earthquake. At times, the superstructure of Dhajji-Dewari buildings is constructed before site planning. Dhajji-Dewari buildings are generally raised on the stone platform from ground level to prevent the deterioration of timber due to water. The height of the raised stone platform usually depends on the site location and can typically range from 0.5-2.0 m, above the ground level. Although there exists no evidence, the survey shows that previous bolting of foundation existed at some point in time. Traditionally, no anchorage was provided between the foundation and structure. However, post the 2005 Kashmir earthquake, bolts are used to anchor the structure to the foundation (Fig. 2.63). The base plate also called as plinth beam of Dhajji buildings is connected by lap/scarf joints.

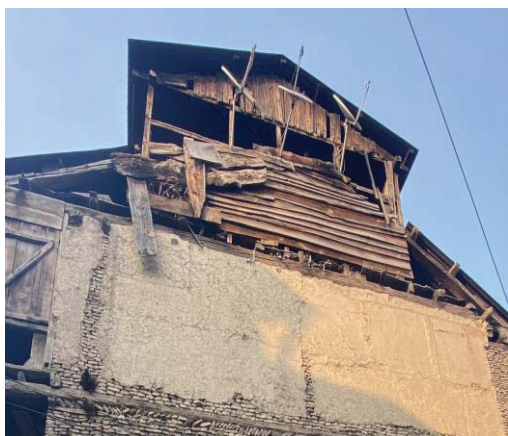
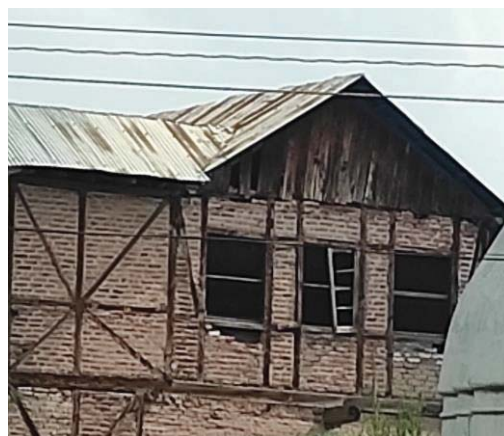
Figure 2.65: Deteriorated Dhajji buildings in the study region

(a) Deteriorated timber

(b) Damaged infill walls

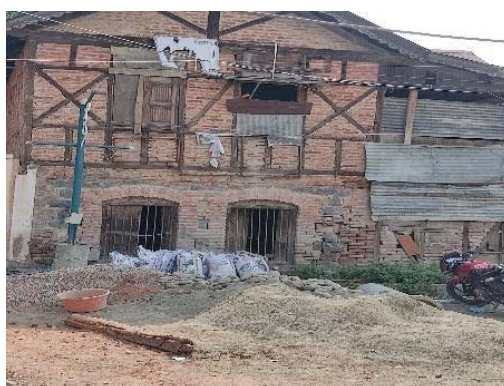
Figure 2.66: Influence of contemporary materials in Dhajji-Dewari buildings

(a) Burnt clay bricks

Nowadays, a few practices from contemporary constructions can also be seen in the Dhajji-Dewari construction or vice-versa (Fig. 2.66). RC columns and the usage of burnt brick clays as infill materials are seen as part of the contemporary modifications in several areas.

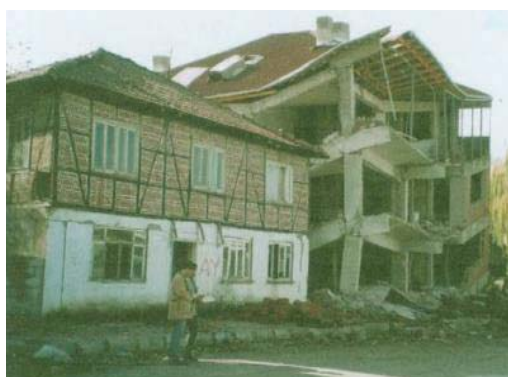
(a) Duzce earthquake, 1999 (Langenbach 2020)

to Dhajji-Dewari buildings during the 2005 Kashmir earthquake. No collapse has been observed for such masonry even in the areas of higher shaking. There are specific reports from India as well as other countries which showed that under strong past earthquakes, the timber frame buildings survived whereas the other structural systems collapsed (Fig. 2.67).

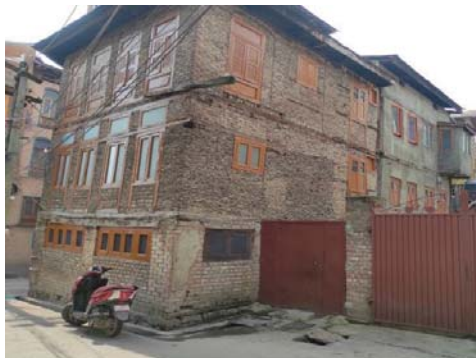
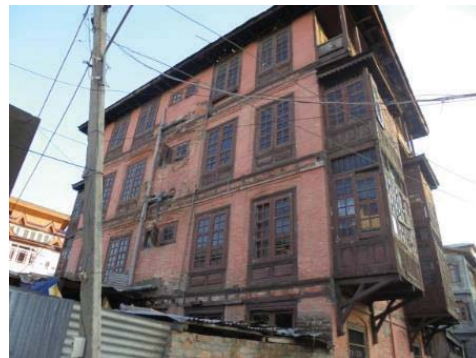
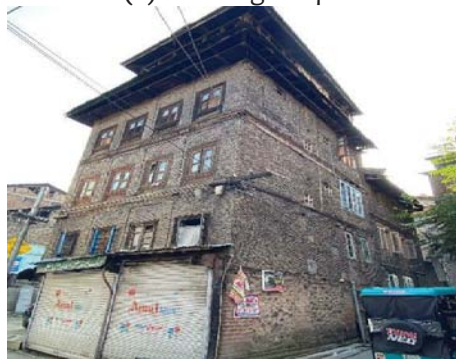
Figure 2.76: Plan shapes in Taq buildings

(a) Rectangular plan

(b) Rectangular plan

(c) Rectangular plan

Taq buildings are not only limited to residential buildings but are also used in the construction of schools, temples, or mosques in the study region. The residential buildings of Taq are generally occupied by joint families and in some parts of the city, shops or even small manufacturing units are functional along with residences that are built in Taq style (Fig. 2.75). The Taq buildings are constructed considering the fundamental principles of earthquake safety. Accordingly, Taq buildings are seen with a square to rectangular plan shape with a few exceptions where complex plan shapes are also seen (Fig. 2.76). The plan aspect ratio for the Taq buildings typically ranges between 1 and 2.5 (Fig. 2.76). Taq buildings are seen with their length varying between 10-20 m and the width varying between 10-12 m (Fig. 2.76).

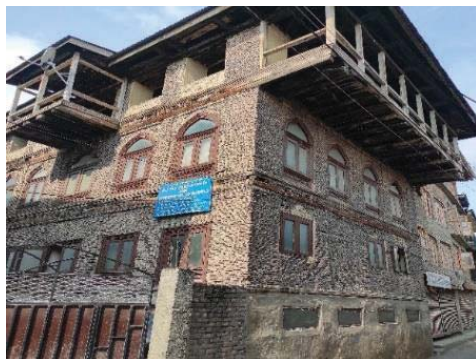
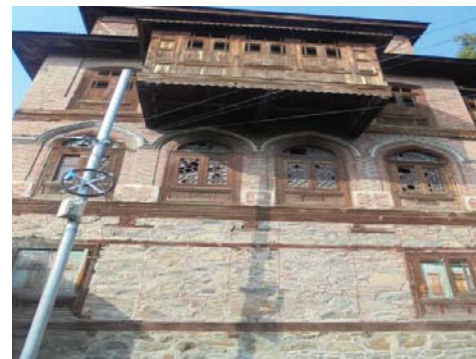
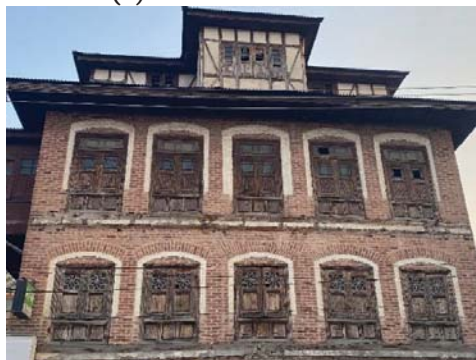
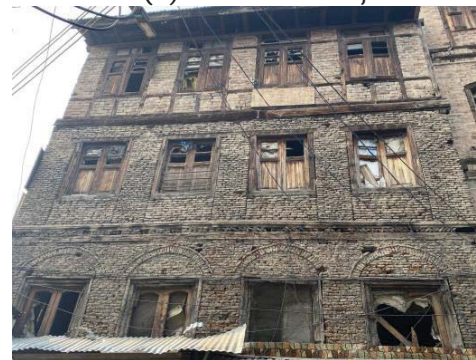
Figure 2.77: Openings in Taq buildings

(a) Windows on two sides

(b) Windows with jalli

(c) Openings between Taq piers

(d) Large openings

In general, in Taq buildings, windows are provided on all sides and closed with two sets of shutters: (i) the inside set being of solid wood, and (ii) the outside with jalli, an open filigree of carved wood (Fig. 2.77). To allow light into the house, oiled newspapers were stuck to jalli traditionally. Recently, traditional window provisions in Taq buildings are modified and glass windows are also seen. In Taq buildings, large openings (up to 1.5-2 m wide) are provided that cover up to 70-80% of the wall length (Fig. 2.77). Larger openings are kept in Taq construction to ensure adequate lighting in the

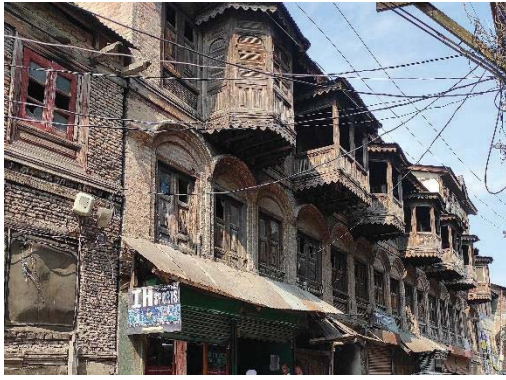
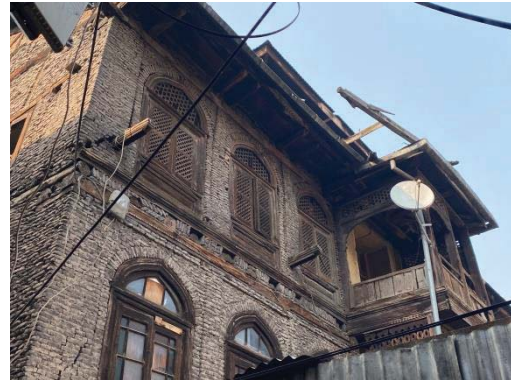
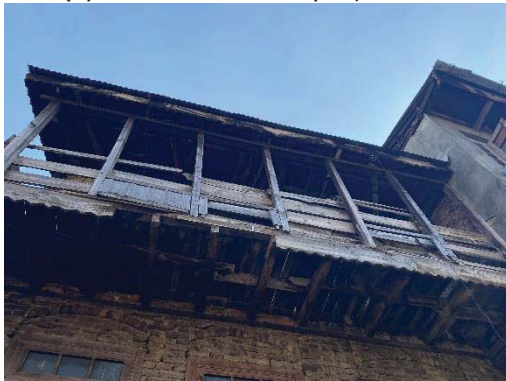
(a) Small Horizontal projections

(b) Small horizontal projections

(c) Small horizontal projections

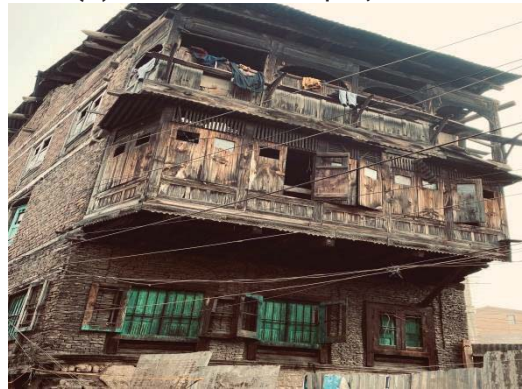
(d) Large horizontal projections

Figure 2.78: Horizontal projections in Taq buildings

The few specific features that could add to the seismic vulnerability of Taq buildings include too large horizontal projections. In addition, these buildings are closely spaced which could lead to pounding failure as observed during the 2005 Kashmir earthquake (Langenbach 2005). Further, the timber planks are nailed to floor joists, thus, they offer very limited in-plane stiffness, hence, the floor system in Taq buildings is expected to behave as a flexible diaphragm. The absence of bracings in the plane of the roof truss induces flexibility and the possibility of relative movements.

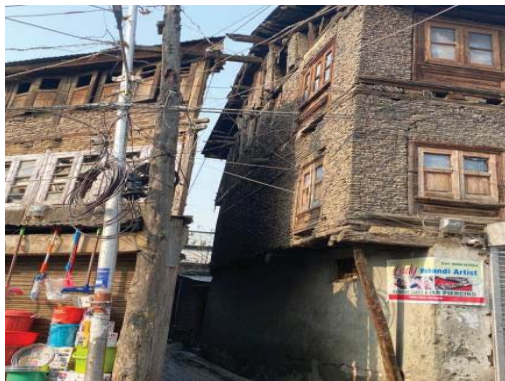
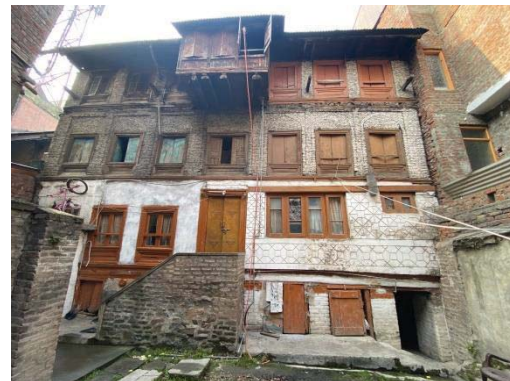
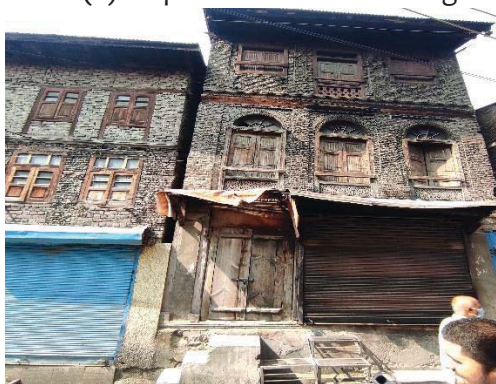
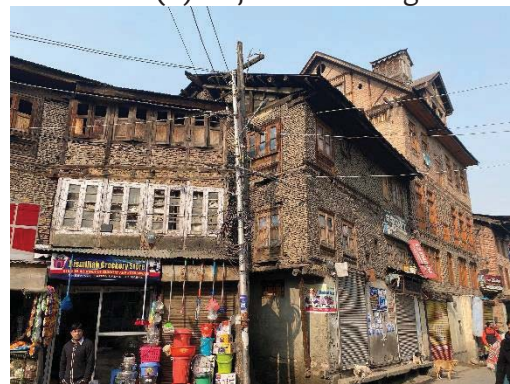
(a) Gap between two buildings

(b) Adjacent building

(c) Gap between two buildings

(d) Gap between two buildings

Figure 2.79: Gap between adjacent Taq buildings

During the winter season, the topmost floor is used for storage. In most of the Taq buildings, toilets are constructed away from the house (usually in the front court). The living room and kitchen are usually kept on the ground floor and bedrooms are generally situated on the upper floors. Taq buildings have horizontal projections that are called 'Taqshe' locally, whose lengths typically vary between 1-1.5 m (Fig. 2.77). Usually, Taq buildings do not share their walls with adjacent buildings. However, many closely spaced buildings were also seen in the study region (Fig. 2.79).

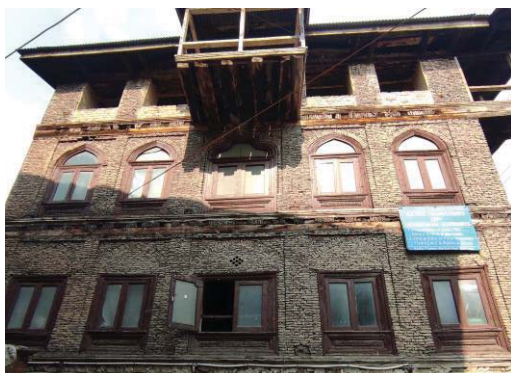
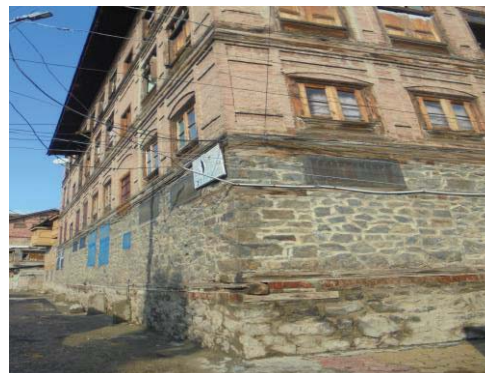
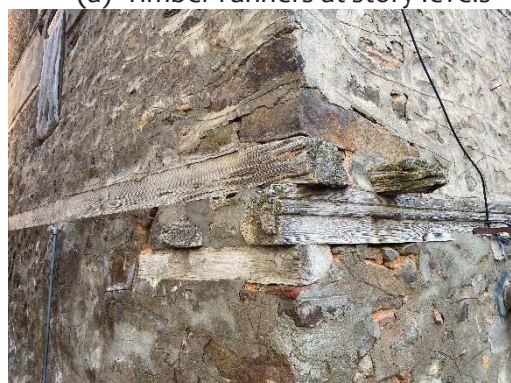
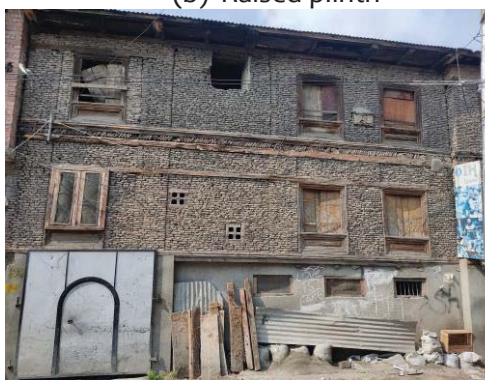
(a) Timber runners at story levels

(b) Raised plinth

(c) Timber runners with cross-piece

(d) Discontinuous window lintel

Figure 2.80: Structural features of Taq buildings

The load-bearing system of the Taq building is timber-laced masonry (Maharaji or sun-dried bricks at the upper floors and random rubble stones at the lowermost floor) with large timber runners embedded in heavy masonry walls (Fig. 2.80(a)-(d)). The face bricks used during the 19th and early 20th centuries are rough-surfaced, quite small in size, and hard-fired bricks which are called Maharaji bricks (Fig. 2.80(a)). Maharaji bricks are weather-resistant, locally burnt bricks that are half the size of modern bricks. The size of bricks that are currently being used in Taq construction is 0.065 X 0.115 X 0.23 m. Taq building walls are raised on a plinth made of rubble stone, up to a height of 1-1.5 m (Fig. 2.80(b)). The horizontal runners (bands) are placed on masonry walls without any connections. The walls are laid using a combination of rubble stones and bricks laid on thick mud mortar. There are two different levels of timber band used at each story level that are namely - ceiling band and floor band. The ceiling band represents the end of the lower story whereas the floor band represents the beginning level of the upper story.

The two parallel timber runners are connected with a cross-piece, usually at the bottom of the runners (Fig. 2.80(c)). The timbers runners are further lapped at the cross wall (Figs. 2.80 and 2.81). In a few buildings, the timber runners are also seen just above the window, however, they were not continuous (Fig. 2.80). One of the interesting features of the Taq construction is that the wall openings lie between two piers (Fig. 2.82(a) and (b)) and the piers and wall opening surroundings have unbonded butt joints without any mortar (Fig. 2.82(d)). The piers in Taq construction are usually of square to rectangular shapes with their cross-section typically between 0.75 x 0.75 m to 0.9 x 0.9 m (Fig. 2.82(c)). The distance between two Taq (piers) is typically between 1.4-1.8 m (Fig. 2.82(c)).

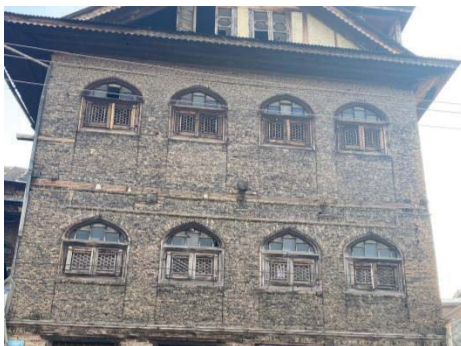
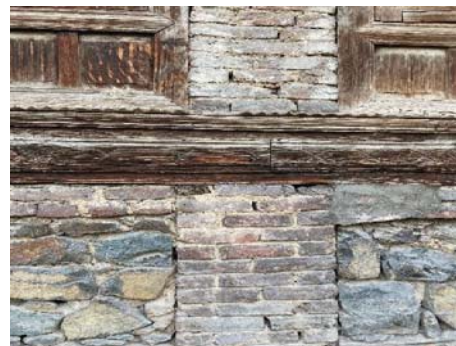
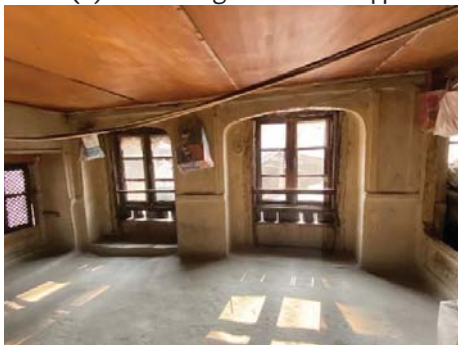
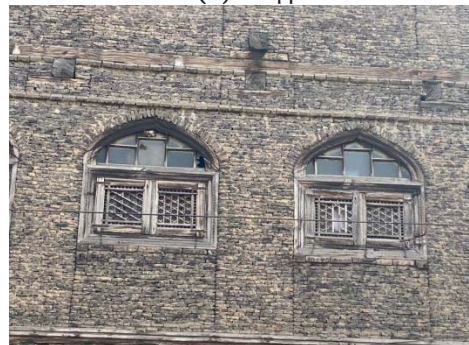
(a) A building with five Taq piers

(b) Taq pier

(c) Internal view of Taq piers

(d) Unbonded butt joint

Figure 2.82: Taq piers and their details

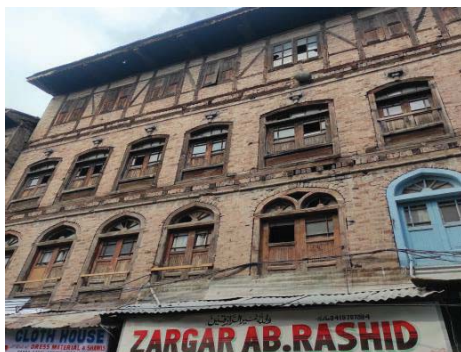
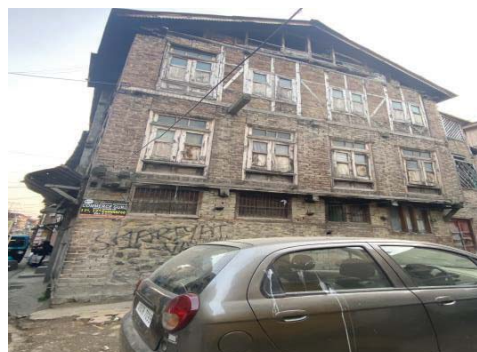
(a) Dhajji-dewari at upper stories

(b) Dhajji-dewari at upper stories

Figure 2.83: Intermixing of Taq and Dhajji-dewari structural systems

Traditionally, the internal walls are thinner walls made of wattle and daub (thin walls made of wooden strips and sticky paste) or thin timber walls with thicknesses ranging between 0.1-0.15 m. The walls of Taq buildings are generally not plastered externally. However, the internal walls are plastered using a mixture of clay and straw that offer adequate insulation. A mixture of clay and water is applied to the existing surface to renew the plastered walls. Apart from providing thermal insulation, mud mortar also assists in keeping the masonry walls together during an earthquake by imparting some amount of compressive strength. In many cases, Taq buildings are seen with a combination of timber frames (Dhajji-Dewari) in the uppermost stories to reduce the seismic weight of these buildings (Fig. 2.83).

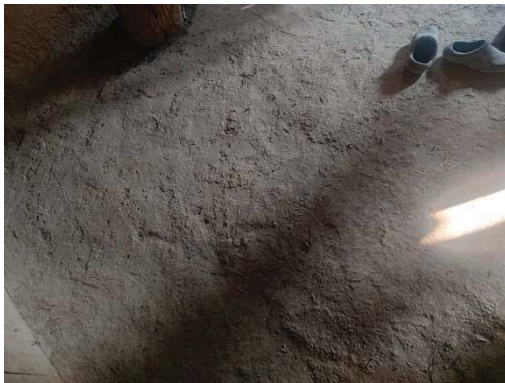
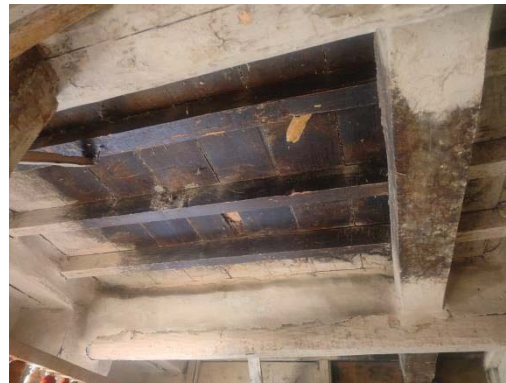
(a) Mud floor

(b) Floor system

The ground floor of the Taq building usually consists of stone filling overlaid with mud flooring. The upper floor system in Taq construction practice is generally made of wooden joists on which wooden planks rest that are covered with mud as shown in Fig. 2.84. At the floor level, the timber floor joists (of sizing 0.10 m x 0.15 m) comprise two sets of ladder-like timber bracings. Hence, the wooden beams tie the floors of the structure together with the walls. Timber beams locally called 'Ker' sandwich the floor joists between them (floor joists between double bands) and at the ends, the floor joists protrude out of the walls. There are 3 levels of timber band (Fig. 2.85) used in each story level that is namely - ceiling band, floor band, and floor joists (no particular connection observed), and the timber planks are nailed to floor joists that are spaced around 0.4 m. The floor joists rest on piers which enables complete load transfer from floor to piers. Cross-planks or any other arrangements are not seen in the floor system thus the floor system is expected to behave as a flexible diaphragm.

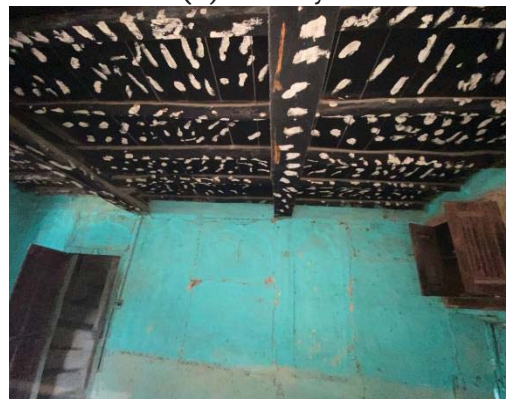
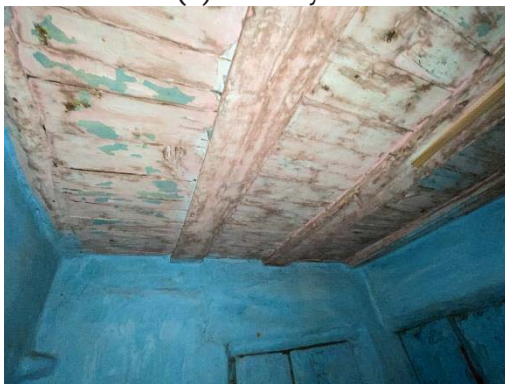
(b) Floor system

(c) Floor system

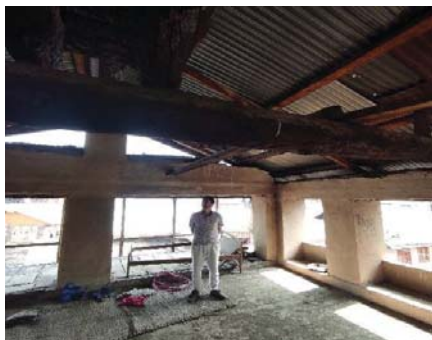
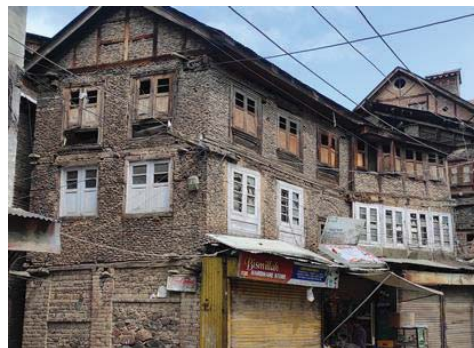
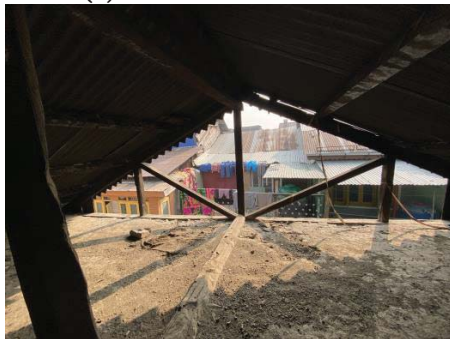
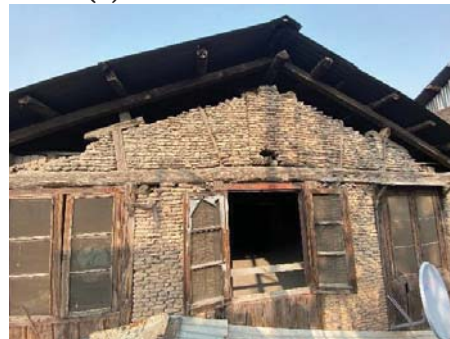
(a) Gable roof with CGI sheets

(b) Gable roof with CGI sheets

(c) Roof system

(d) Braces and queen posts

Figure 2.86: Roof systems in Taq buildings

The roof system of Taq buildings is mostly of gable roofs comprising ridge beams, tie beams, lateral boards, braces, king & queen posts, rafters & purlins. Heavy large sections of tie beams are placed on wall plates without any connection. Rafters are connected to ridge beams (also referred to as nar kooth that run throughout the length of the building) with grooves and nailing. King & queen posts are connected to the rafter and tie beam with the help of tenon and mortise joints. No cross-bracings were observed in the roof truss. A typical sketch of the roof system of Taq buildings is shown in Fig. 2.87.

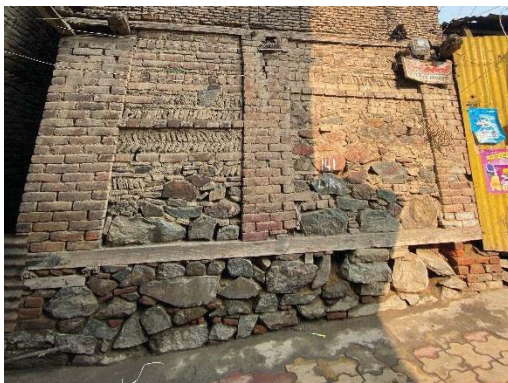
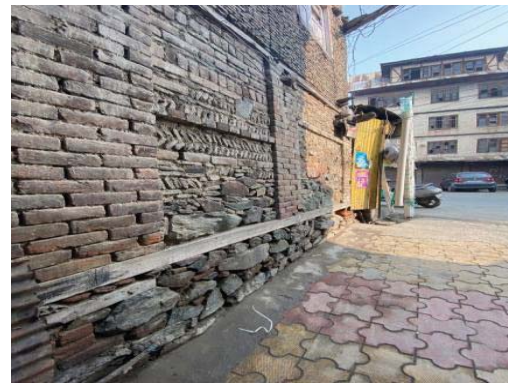
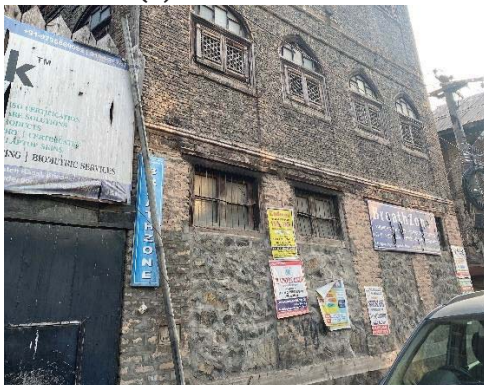
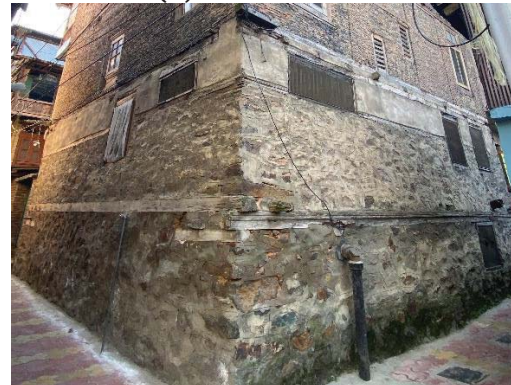
(a) Stone foundation

(b) Stone foundation

(c) Plinth band on the stone foundation

(d) Stone foundation

Taq buildings rest on shallow foundations made of rubble stone on which a plinth level of 0.3-1 m is raised using the rubble stones (Fig. 2.88). Above the foundation, there are timber bands called *dassa* that serve as plinth bands. The depth and width of the foundation vary according to the local soil characteristics (Fig. 2.89). The majority of the soil in the area where Taq construction is common is soft, and when compared to other traditional Himalayan methods, the width and depth of the foundation in Taq construction are considerably larger. The typical sketch of the foundation of Taq buildings is shown in Fig. 2.89.

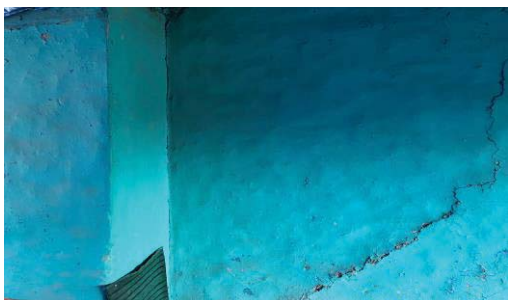
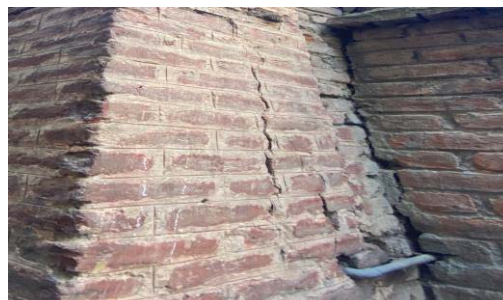
(a) Crack in walls

(b) Crack in walls

Figure 2.90: Visual conditions of Taq buildings

The visual conditions of the Taq buildings when surveyed were found to be average to good. As exterior walls are not plastered, the timber bands are subjected to degradation due to direct exposure to the external environment. Fig. 2.90 shows cracks in walls observed during survey.

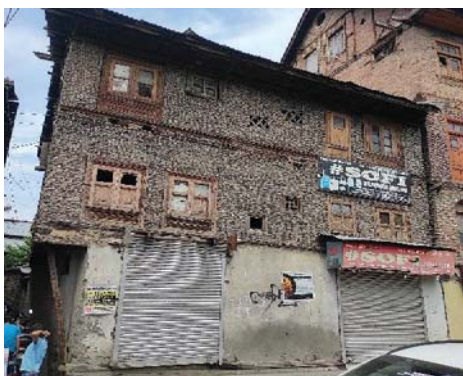
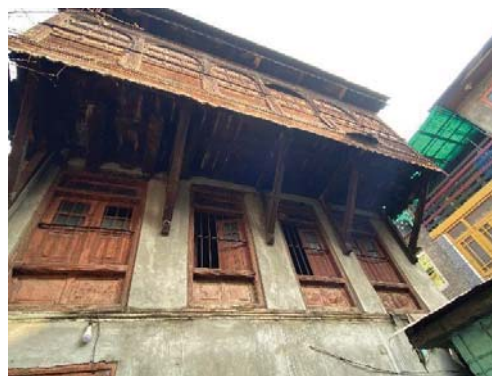
(a) Cement plaster

(b) Cement plaster

Figure 2.91: Influence of contemporary materials in Taq buildings

Contemporary modifications exist in Taq buildings however such modifications are mostly incompatible. The contemporary practices include the use of cement plaster on walls, and use of the modern bricks against traditional Maharaji bricks (Fig. 2.91). The manufacture of Maharaji bricks has also become nil leading to the use of modern bricks in Taq buildings. Due to the unavailability of wood and the decline in the quality of craftsmanship over time, CGI sheets are used as roofing material instead of traditional sod roofs (bark roof).

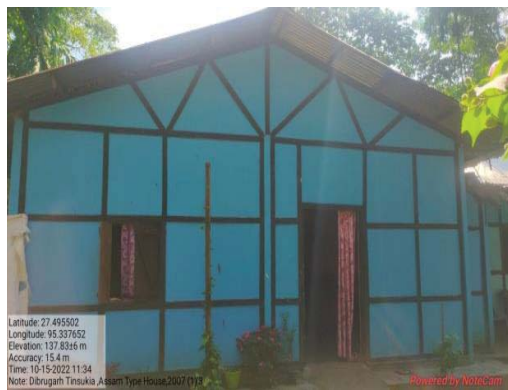
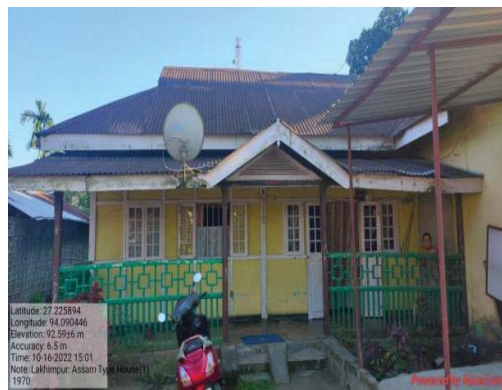
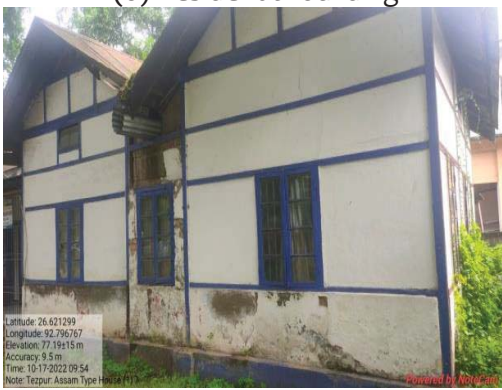
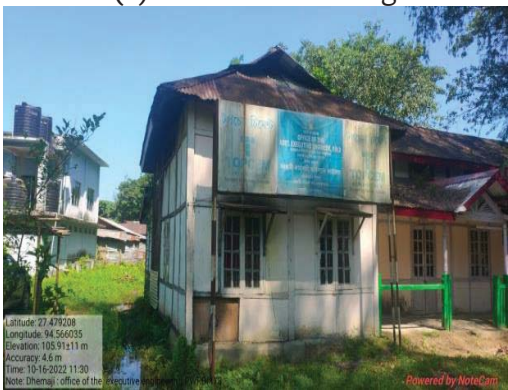
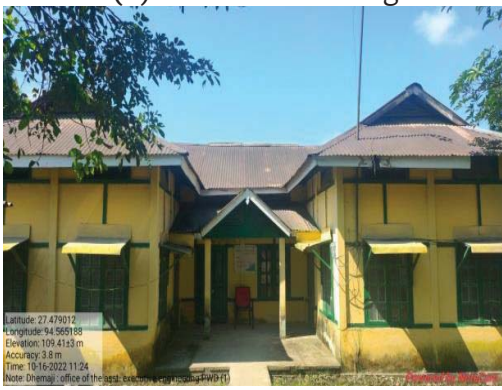
(a) Residential building

(e) Office building

Figure 2.96: Occupancies in Assam-type buildings

Assam-type houses are seen in a variety of occupancies. These houses are used for residential, commercial, and institutional (government) buildings as shown in Fig. 2.96. In general, Assam-type buildings are constructed following the principles of earthquake safety by maintaining symmetry and regularity in their plan and elevation. It has been observed that Assam-type buildings are constructed with a rectangular plan shape (Fig.2.97 (a) and (b)), with their plan aspect ratios typically varying between 1-2. However, a few exceptions have also been seen during the field surveys, where these buildings are complex plan shapes such as 'L' or 'T' shape plan (Fig.2.97 (c)-(d)).

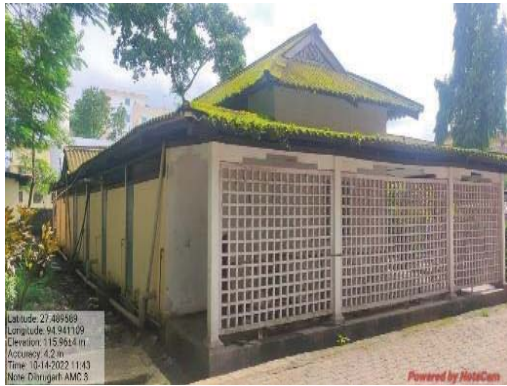
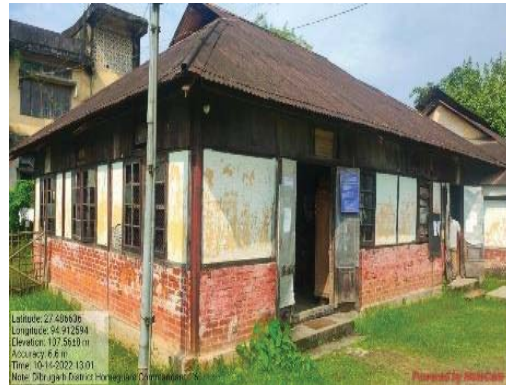
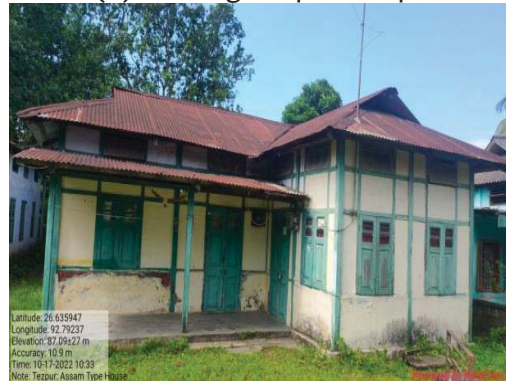
(a) Rectangular plan shape

(c) L-plan shape

(d) L-plan shape

Figure 2.97: Plan shapes in Assam-type buildings

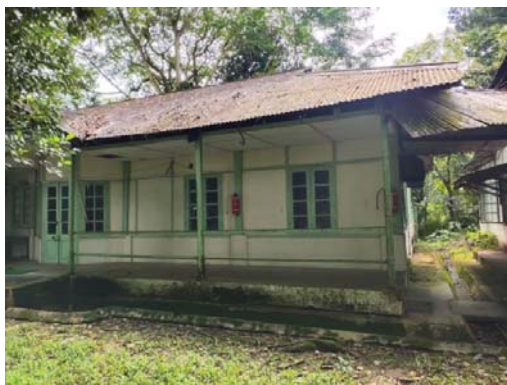
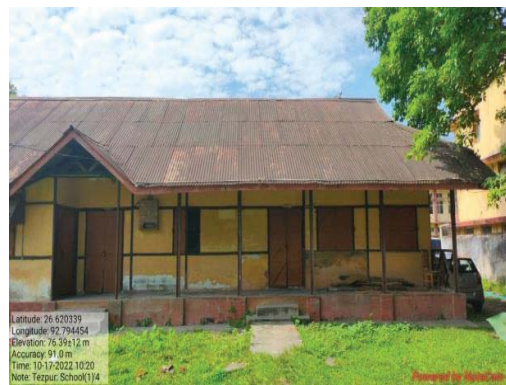
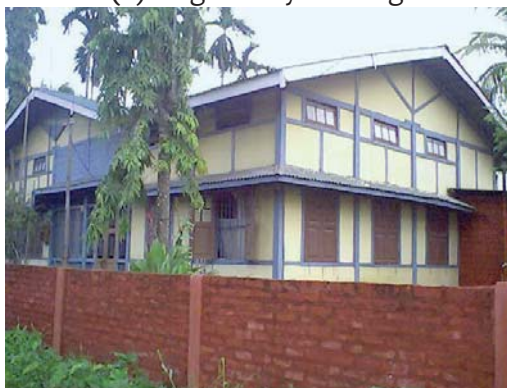
(a) Single-story building

(c) Single-story with attic space

Figure 2.98: Number of stories in Assam-type building

The Assam-type buildings are low-rise buildings mostly observed to be single-storied, though exceptions are also seen where these buildings are seen as a single story with an attic space or as two-storied buildings (Fig. 2.98). The story height in the Assam-type building typically varies between 2.8-3.5 m, with a raised stone/brick masonry platform of height varying between 0.6-1 m. The Assam-type buildings encompass moderate to large door and window openings between the timber framing. The typical length of openings can vary from 20-60% of the wall length in any given direction (Fig. 2.99). These openings are mostly placed away from the edges and toward the center of the frame. The length and width of Assam-type buildings range between 6-12 m and 6-12 m respectively.

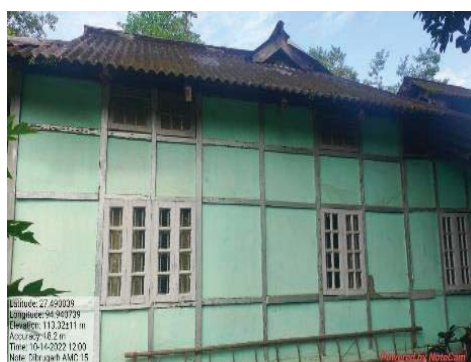
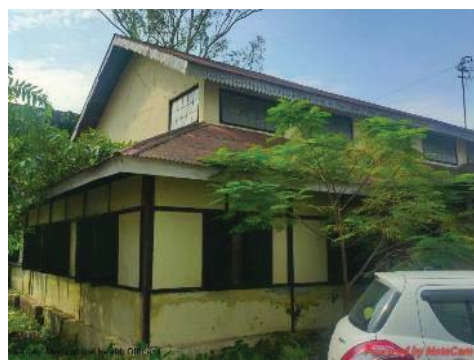
(a) Small openings

(b) Closely spaced openings

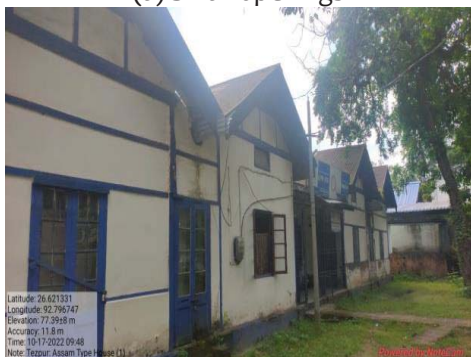
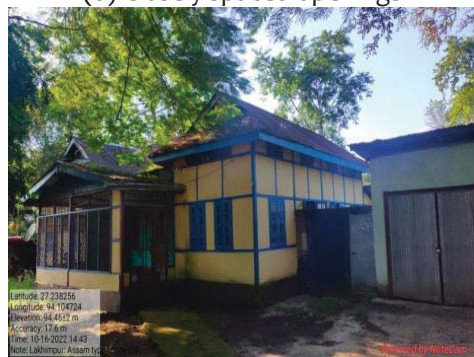
Figure 2.99: Openings in Assam-type buildings

(c) Uniformly distributed large openings

(d) Large openings

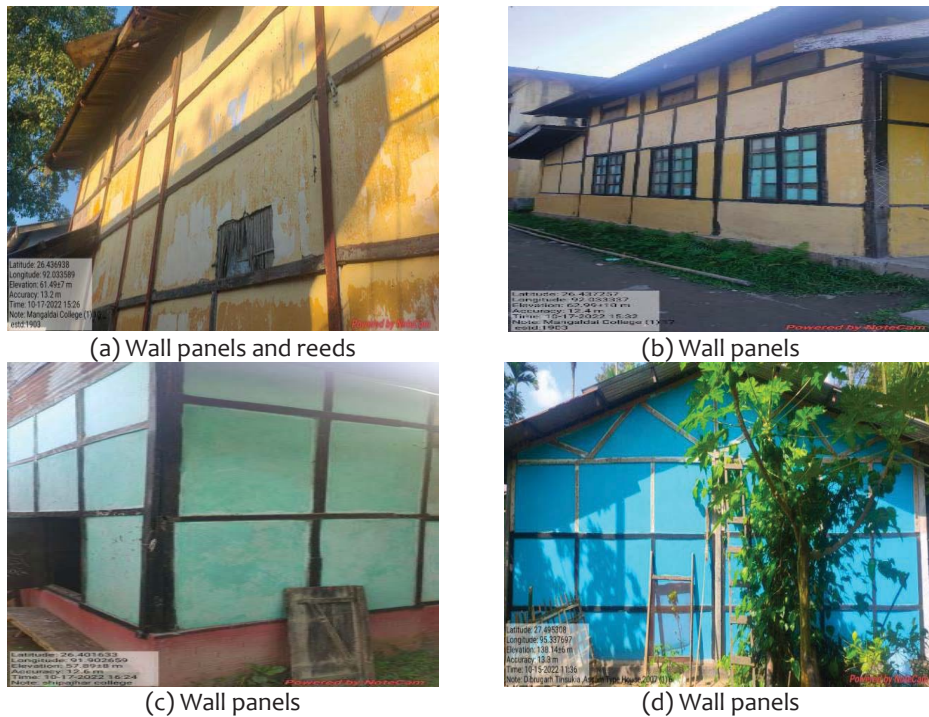
Figure 2.100: Wall system in Assam-type buildings

The traditional Assam-type houses are consisting of walls that are made up of stone/brick masonry up to a height of approximately 0.6-1 m. This brick or stone masonry supports the bamboo/Ikra wall panels that are woven together along with a timber frame. The walls in Assam-type houses are made of ikra (reed) and bamboo of diameters 0.0015 m and 0.025 m, respectively, that are plastered internally and externally using a mixture of mud and cow dung traditionally. The cow dung slurry is also used to fill up the gap between ikra reeds. The walls are further painted on both faces and plaster is re-applied to the walls in cycles. In a few buildings, plastered walls are constructed only up to the lintel level, and above the lintel level, un-plastered walls are constructed that continue up to the roof level. The typical wall density of an Assam-type building can vary between 10-15%. The walls of Assam-type buildings are divided into several smaller panels (Figs. 2.100-2.101). The timber frame of the Assam-type house consists of (i) vertical posts (ii) horizontal struts (iii) corner posts (iv) top plate and (v) bottom plate. The most important part of Assam-type buildings is the connections that exist between various elements. The elements are nailed and bolted formally, but at times are tied together using coir ropes. The vertical intermediate posts are connected to the horizontal struts

using steel clamps, bolts, and nails at the floor, sill, lintel, and roof level. The corner posts ( $0.15\text{ m} \times 0.15\text{ m}$ ) are connected through a combination of grooving and tenon and mortise joints that are nailed as shown in Fig. 2.102. The intermediate vertical elements ( $0.12\text{ m} \times 0.12\text{ m}$ ) spaced at 1-2 m are connected to horizontal struts through grooves and nails. The main vertical posts are spaced between 2-3 m. The horizontal struts of dimension  $0.075\text{ m} \times 0.075\text{ m}$  are spaced between 0.5-1.5 m and the dimension of the top plate is typically found to be  $0.1\text{ m} \times 0.1\text{ m}$ .

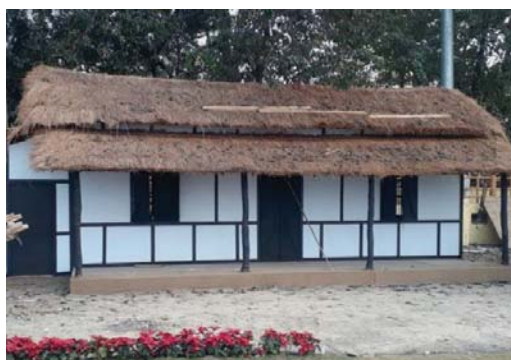
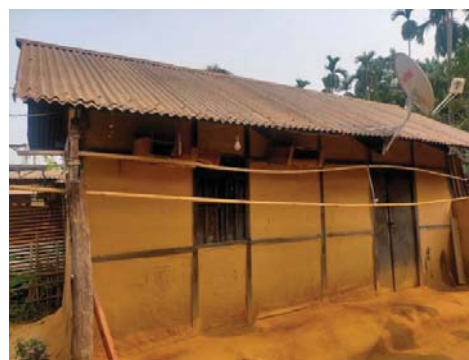
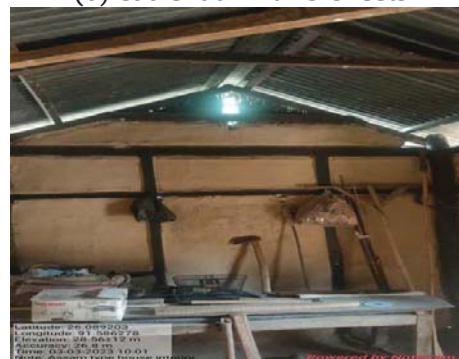
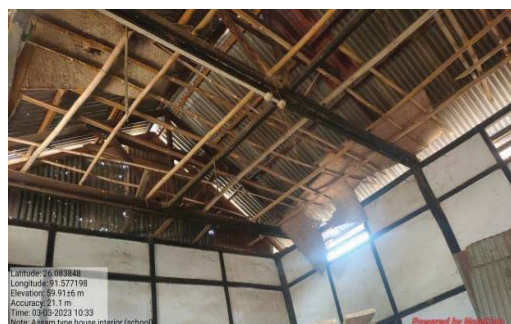
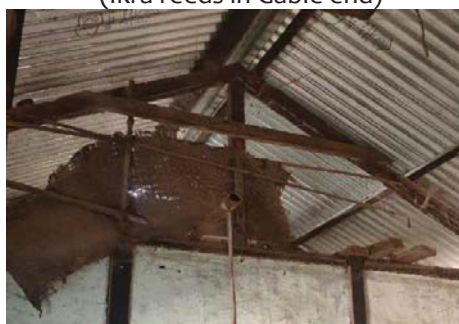
**Figure 2.104:** Roof geometry and systems in Assam-type buildings

The roofing system of the Assam Type buildings is either Gable or Hipped roofs due to high amounts of rainfall in the regions of their prevalence. The traditional roofing material used is “thatch” (rural areas) and nowadays it is replaced with lightweight CGI sheets. In general, two of the most common roof systems are A-frames and the king-post truss with braces, depending on the span of the roof.

(a) Gable roof with Thatch

(b) Gable roof with GI sheets

(d) A-frame with tie beam  
(Ikra reeds in Gable end)

(e) King post truss with braces

(e) King-post truss

The roof system consists of (i) rafters, (ii) purlins, (iii) king posts, (iv) tie beams, and (v) ridge beams. Collar ties and additional braces are at times provided in case of large rafter length (greater than 3 m). The rafters (0.15 m diameter) are made of wooden logs that are locally available and the spacing between rafters ranges between 0.6-0.7 m. The purlins made of bamboo are attached to rafters that are spaced at 0.3 m. The thatch roofing commonly observed in Assam-type buildings is made of ikra reeds. The pitch of the sloped roof is about 2 m. The slope of the roof varies from one-third to one-fifth of the span depending upon the permeability of the roofing material. Thatched roofs

have steeper slopes than tin sheet roofs. However, in recent times, timber rectangular elements are used to form the roof truss with purlins ( $0.1\text{ m} \times 0.075\text{ m}$ ) nailed to rafters ( $0.075\text{ m} \times 0.15\text{ m}$ ) and rafters nailed to ridge beam of ( $0.15\text{ m} \times 0.15\text{ m}$ ). The tie beams are connected to the top plate by C-type joints and the rafters are connected with the help of grooves and nails. No cross-bracings were observed in the roof truss. The photographed images of the roof system taken during the survey are shown below in Fig. 2.104. The typical sketch of the roof system is shown in Fig. 2.105.

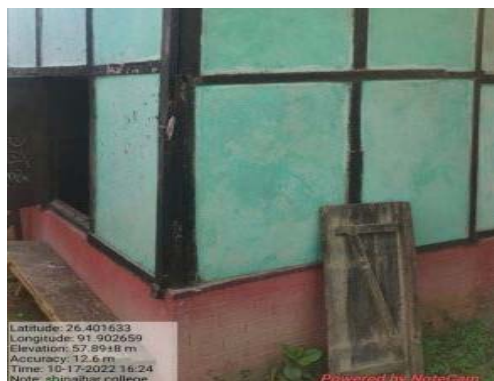
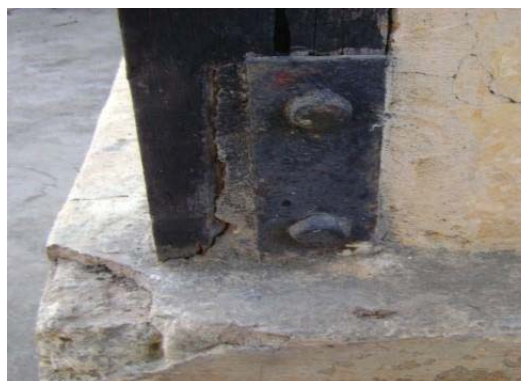
Figure 2.106: Foundations and their connections to post in Assam-type buildings

(a) Masonry foundation

(b) Post-bolted to foundation

The foundation system for Assam-type buildings is the shallow foundation. The vertical posts are inserted into the ground for a distance of 0.6-0.9 m. In recent times, vertical posts are attached to concrete pedestals using iron clamps. In a few buildings, the vertical posts are supported on brick masonry or plain concrete pillars that are raised to the plinth level. The vertical posts are connected to the pillars through steel bolts and U-clamps (Fig. 2.106). In new Assam-type buildings, R.C.C. foundations as per design, with a depth of the foundation of 1.0 m from the ground level and well-connected RC plinth beam as per design were also found during the field survey. The typical sketch of the foundation of Assam-type buildings is shown in Fig. 2.107.
