# Compendium of Traditional Earthquake Resilient Construction

# Compendium of Traditional Earthquake Resilient Construction for Knowledge Sharing and Disaster Risk Reduction

**Project Report**

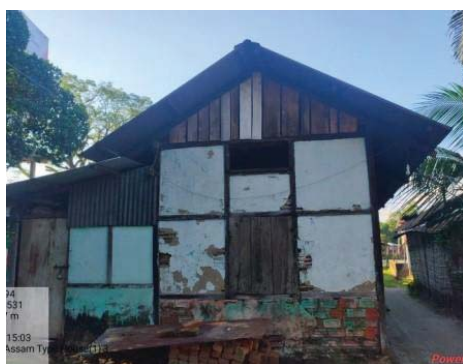
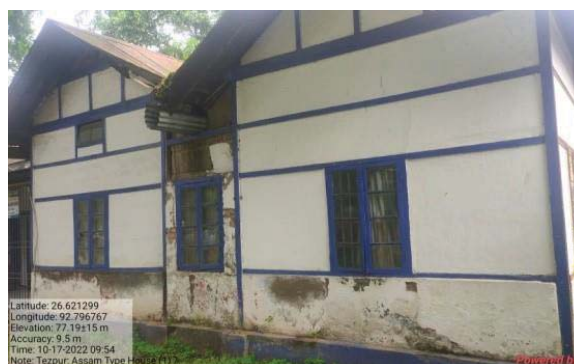
Figure 2.108: Visual conditions of Assam-type buildings

In Assam-type buildings, deterioration is often observed at various locations of the building, due to poor workmanship and quality of timber, joinery, and mortar, and due to the corrosion in nails and steel clamps at the foundation level. One of the reasons for such deterioration in Assam-type buildings is the cyclic wetting and drying of different materials over the season. The construction arrangement of vertical posts in Assam-type buildings over the stone/masonry brick infills protects them from ground moisture and increases their lifespan. Due to such simpler construction practices, Assam-type buildings require less maintenance and are easy to repair in case of damage or deterioration. The conditions of the Assam-type buildings when surveyed were found to be average to good. The mud plaster in the walls of Assam-type buildings cracks frequently and required regular maintenance (Fig. 2.108). In the case of regions subjected to floods, buildings are protected from water as buildings rest on stilts. In recent times, concrete columns are also used hence timber elements are well protected from water penetration. CGI sheets need maintenance and replacement as Assam and Meghalaya are prone to high rainfall.

(a) Plaster deterioration

(b) Plaster deterioration

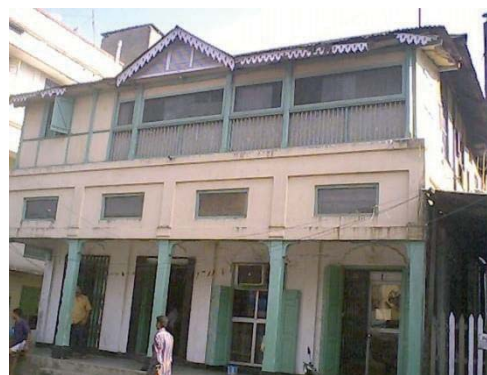
Figure 2.109: Influence of contemporary materials in Assam-type buildings

(b) Timber frame and bricks

a legal ban on the cutting of trees, which has reduced the supply of timber as a building material. This situation has forced or encouraged masonry constructions for smaller houses and RC frames for larger or multi-storied houses. Nowadays, traditional Assamese houses coexist along with RC or masonry constructions that have become more popular. RC slabs, GI sheets, heavy masonry infills, and RC columns in place of stilts are found widely nowadays in Assam (Fig. 2.109). However, such modifications in Assam-type should be implemented with caution.

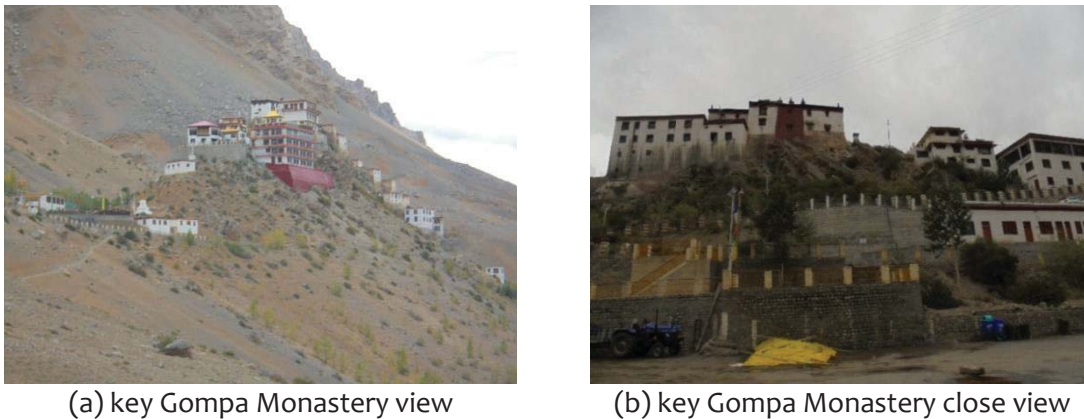
Figure 3.2: Rammed earth buildings on hill slopes in Spiti Valley – Key Gopa Monastery

The presence of mild-to-steep slopes characterizes the regions of the prevalence of rammed-earth buildings (Fig. 3.3). Thus, many rammed-earth buildings are constructed on slopes and sometimes even on the top of a hill (Fig. 3.2(a)). The typically observed siting in the rammed earth buildings include: (i) buildings resting on flat ground (Fig. 3.4(a)-(b)), (ii) buildings with a raised platform of stone masonry approximately upto a height of 0.6-1.0 m (Fig. 3.4(c)), (iii) buildings with two different founding levels (Fig. 3.4(d)-(e)), and (iv) buildings following the natural slope of the ground (Fig.

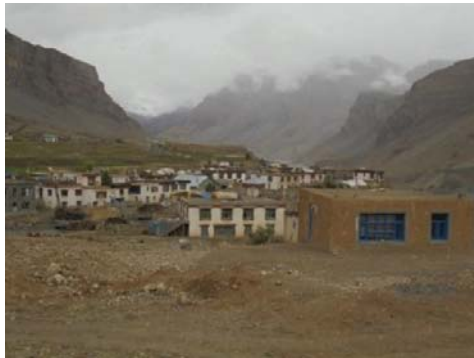
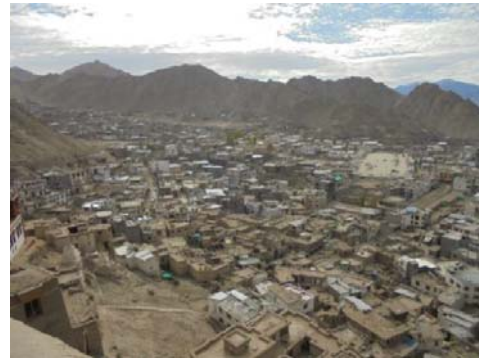
**Figure 3.3:** Prevalence of low-rise rammed earth construction in Spiti valley and Leh

(a) Spiti valley

(b) Leh

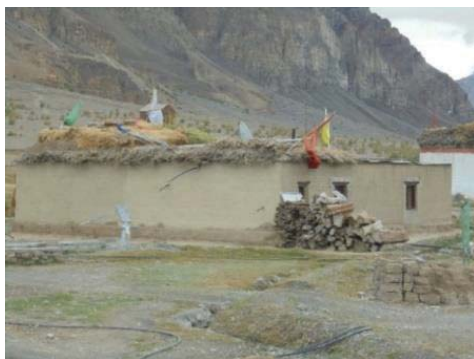
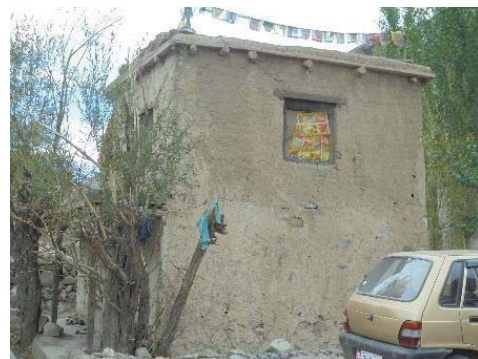
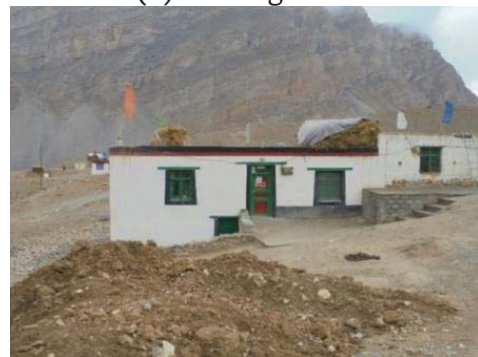
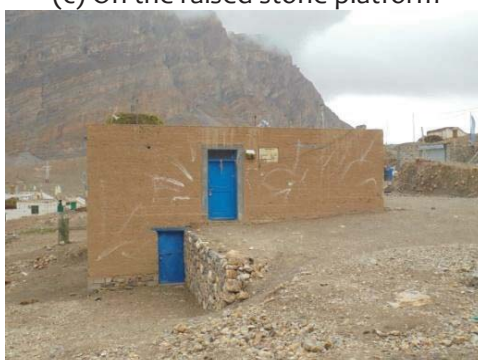
(a) On flat ground

(b) On flat ground

(d) Two foundation levels

(e) Two foundation levels

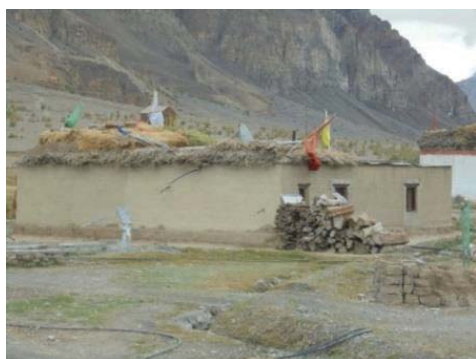
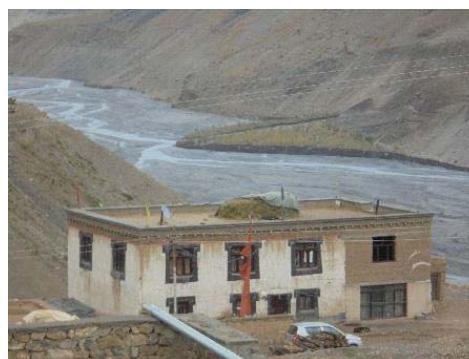
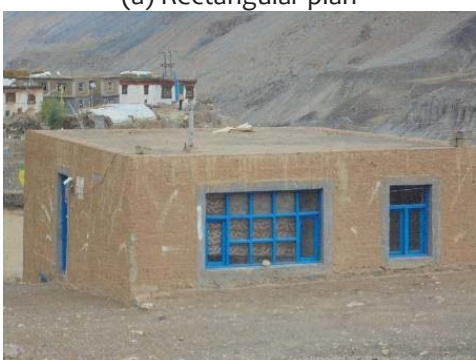
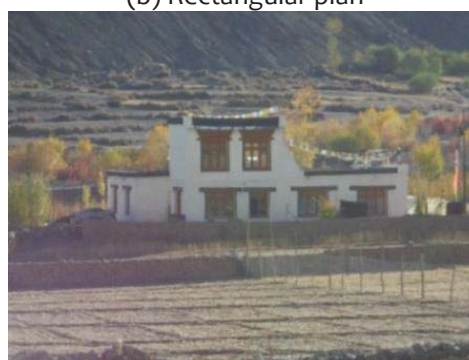
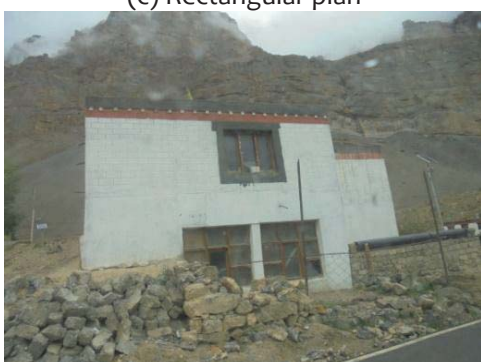
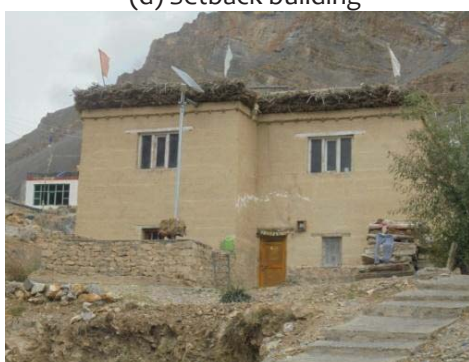
**Figure 3.5:** Plan and elevation shapes in rammed earth buildings

(a) Rectangular plan

(b) Rectangular plan

(c) Rectangular plan

(d) Setback building

(e) Re-entrant corner

(f) Re-entrant corner

Various building plans and elevation shapes can be seen in the Spiti valley and Ladakh for the rammed earth construction. Usually, most of the rammed earth buildings are constructed, ignoring the fundamental principle of earthquake safety, i.e., without maintaining regularity in plans and elevations (Fig. 3.5). As a result, except a very few buildings (Fig. 3.5 (a)-(c)), many rammed earth buildings are seen with the plan and elevation irregularities. The commonly seen elevation irregularity include setbacks in their elevation (Fig. 3.5 (d)), and widely seen plan irregularities include the presence of re-entrant corners in the building plan (Fig. 3.5 (e)).

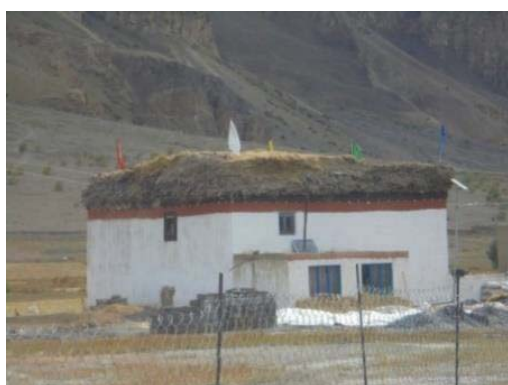
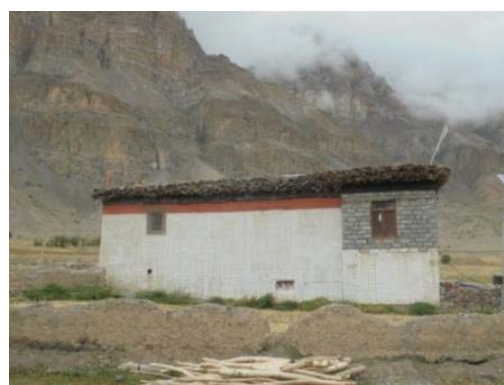
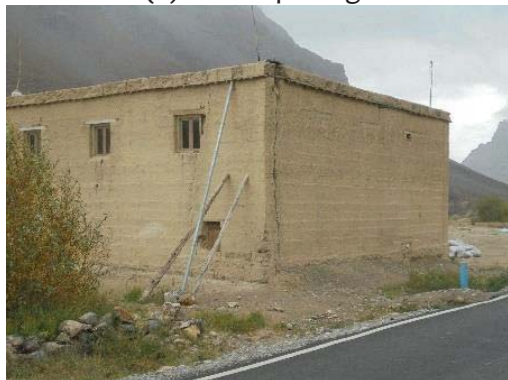
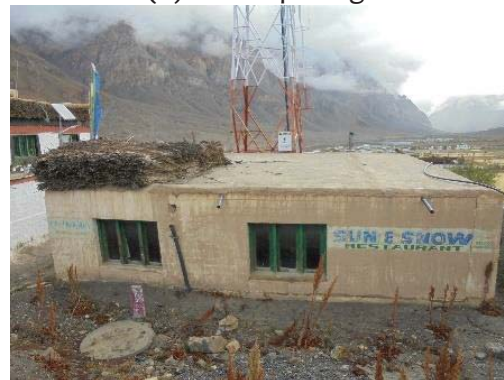
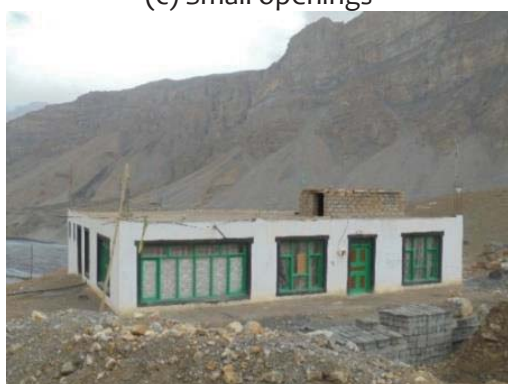
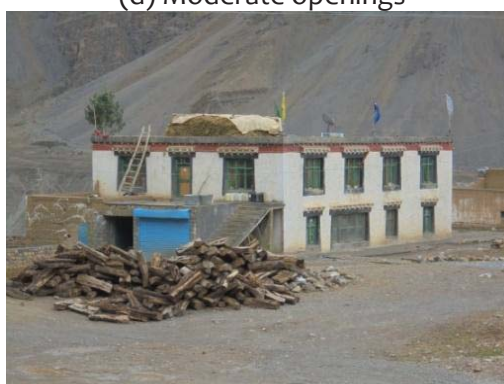
**Figure 3.6:** Openings in rammed earth buildings

(a) Small openings

(b) Small openings

(c) Small openings

(d) Moderate openings

(e) Large openings

(f) Large openings

structures. Most of the rammed earth buildings are one-storied with few exceptions, where two or sometimes even three stories are also seen (Fig. 3.5). The rammed earth buildings in the region are characterized by significant variations in terms of the extent of openings provided for doors and windows in different buildings (Fig. 3.6). The maximum openings in walls of this construction have been observed to vary between 15%-75% of the length of the wall, with a usual concentration of openings in one of the building directions and also in one of the walls (i.e., more openings provided at the front face of the building). There were no projections observed in both vertical or horizontal directions. Further, rammed earth buildings are constructed with a sufficient distance between adjacent buildings and do not share walls with the neighboring buildings in rural areas (Fig. 3.7(a)). However, in densely populated areas (e.g., Leh), some buildings in close proximity were also seen (Fig. 3.7(b)).

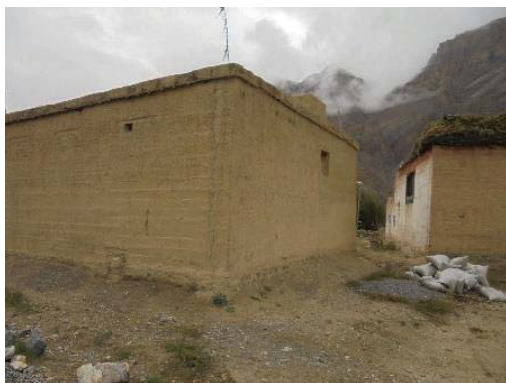
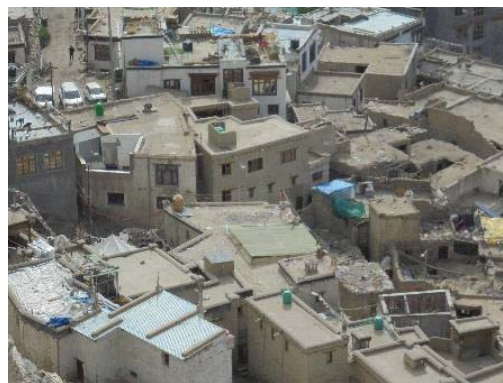
Figure 3.7: Distance between two adjacent rammed earth buildings

(a) Gap between buildings

(b) Closely spaced buildings

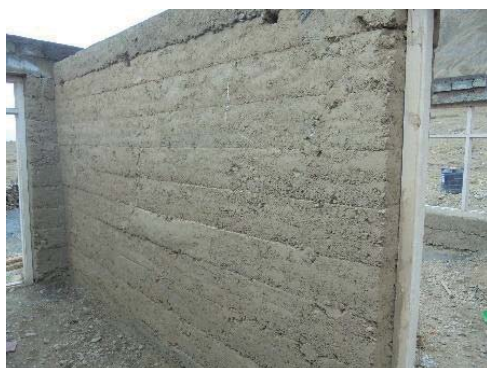
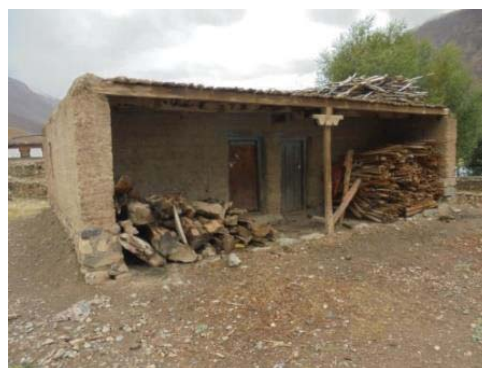
Figure 3.8: Load-bearing walls in rammed earth buildings

(a) Wall thickness @ 0.35 m

(b) Wall thickness @ 0.40 m

Rammed earth buildings have load-bearing walls made of rammed earth locally available in the Lahaul and Spiti, and Leh regions. The bottommost portion (approximately 0.60-1.0 m high) of walls in rammed earth buildings is a raised platform made up of field stones (Fig. 3.8) to prevent direct contact of walls with heavy snow cover in the region during the winter season. The gravity and lateral loads are expected to be resisted by the load-bearing rammed earth walls. These rammed earth walls possess very little tensile (bending) and shear strength. Two different wall thicknesses were observed for the rammed earth construction in the study region. The centuries-older rammed earth building walls have a thickness of 0.40 m (Fig. 3.8), whereas; the relatively newer rammed earth building walls are 0.35 m thick (Fig. 3.8), thus, resulting in a height-to-thickness ratio of walls between 6.5-9. Rammed earth buildings have at least three walls in each horizontal direction, and the computed plan density of structural walls varies between 15-25%. The external and internal faces of walls are usually plastered using the Spiti river mud that exhibits good insulating properties. These rammed earth walls are constructed in lifts along the height, with each lift being approximately 0.30 m high. Therefore, the horizontal layering between two individual courses of walls is visible (Fig. 3.8(a)). It is seen that the wall-to-wall joints in rammed earth buildings are not staggered (Fig. 3.9) in the successive lifts along the height in the orthogonal walls, and in a few buildings, separation in the form of vertical cracks (Figs. 3.9(a)) can be seen at the wall-to-wall junctions.

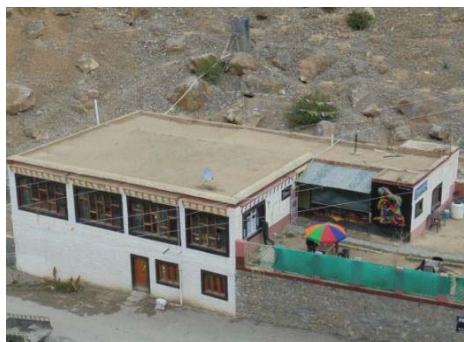
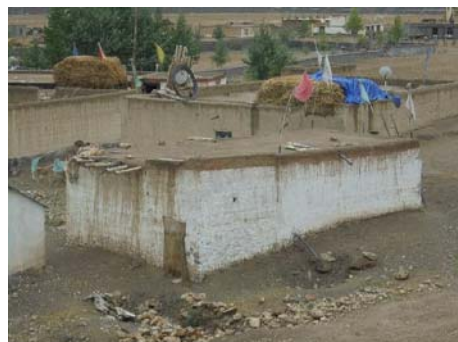
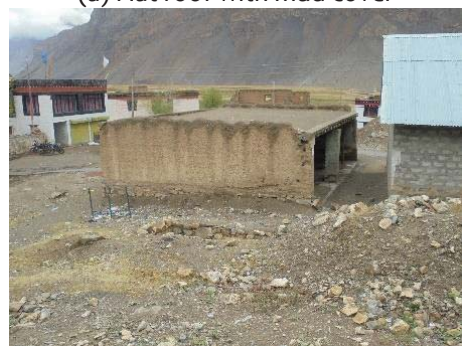
**Figure 3.13: Roofing materials in rammed earth buildings**

(a) Flat roof with mud cover

(b) Flat roof with mud cover

(c) Flat roof with mud cover

The region where rammed earth construction is practiced is characterized by desert area; thus, flat roofs (Fig. 3.13(a)-(c)) are often seen with a few exceptions of sloped roofs (Fig. 3.13(d)). The two of the most commonly used roofing materials in rammed earth construction include flat earthen roofs (Fig. 3.13(a)-(c)) and CGI sheets (Fig. 3.13(d)). In the case of flat roofs, closely spaced split timber elements, and wooden/bamboo beams (at equal intervals) are embedded in the rammed earth walls in two orthogonal directions (Fig. 3.14(a)-(c)), without any positive connection or arrangement to

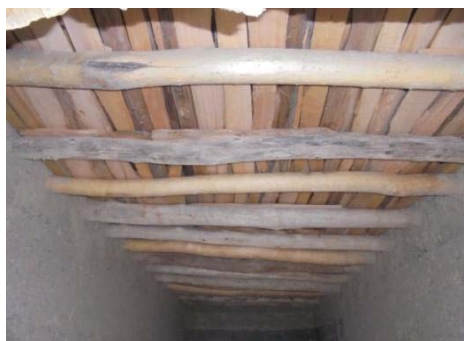
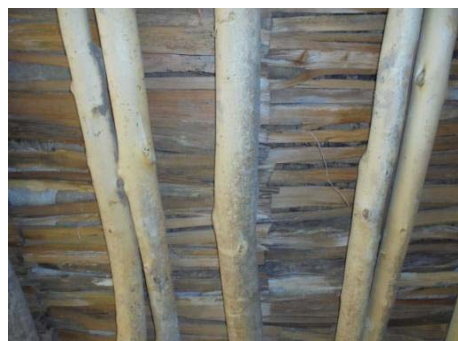
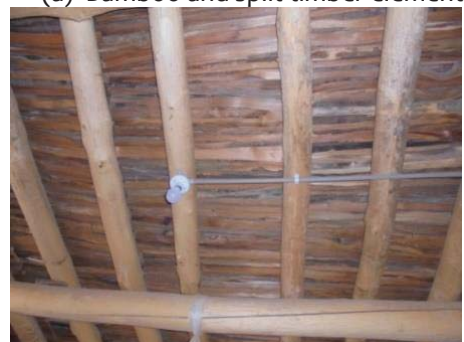
(a) Bamboo and split timber elements

(b) Bamboo and split timber elements

(c) Bamboo and split timber elements

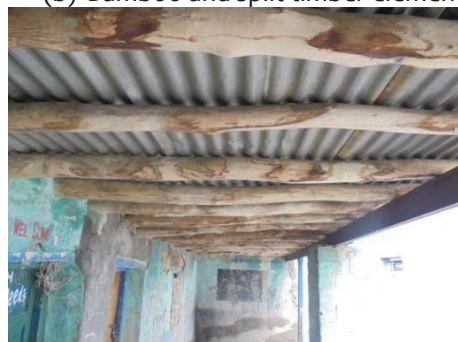
(d) Bamboo girders

**Figure 3.14: Floor/Roof systems in rammed earth buildings**

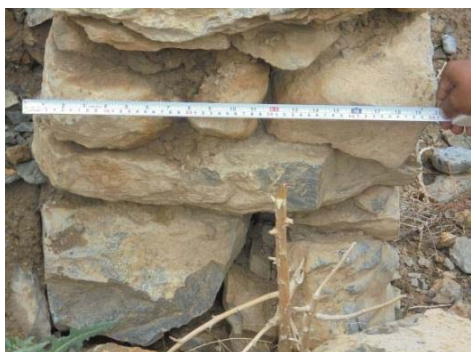
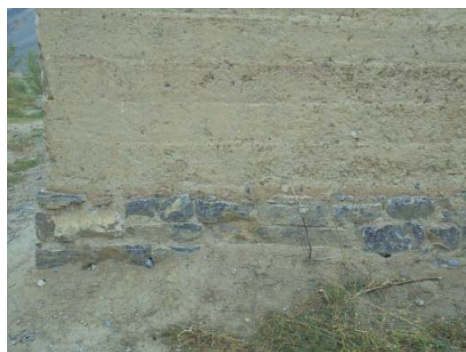
Figure 3.15: Foundations in rammed earth buildings

(a) 0.45m thick stone foundation

(b) Stone foundation

In rammed-earth construction, there are strip footings of locally available river/field stones (Fig. 3.15). The stone foundations are raised to 0.6-1.0 m above the ground level to prevent wall contact with water splashes and snow cover. The width of the foundation is equal to the thickness of the wall (0.40 m) and 1.5 times the thickness of the wall (0.60 m) for buildings resting on rock and soft soil, respectively. The depth of the footing depends upon the property of the soil strata. In the case of rocky strata, the depth of the foundation ranges between 0.3-0.6 m, and in the case of soft soil stratum, the depth of the foundation varies between 1.0-1.5 m (Fig. 3.16). The discussions with locals further revealed that no specific measures are taken in the rammed earth building to connect the building with its foundation.

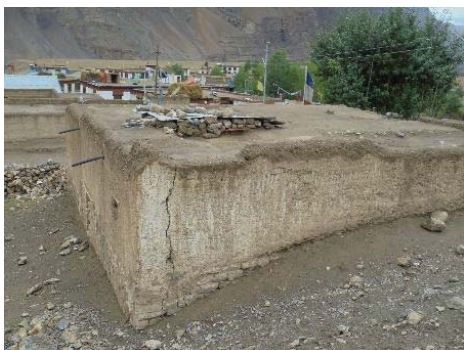
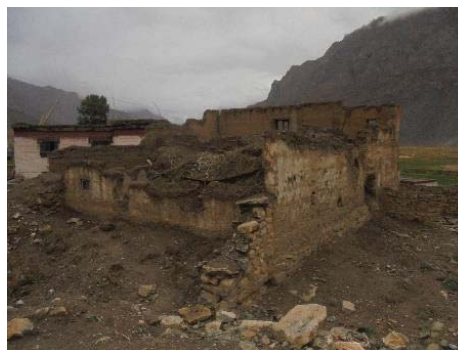
Figure 3.17: Deteriorated rammed earth buildings in the study region

(a) Deteriorated building

(b) Demolished building

these buildings. The exteriors and interiors of these buildings are periodically coated with mud slurry, with the frequency of interior coatings being almost three-to-four times per year. A few buildings with severe cracks at the junction of walls with overall deteriorated/damaged conditions were also seen (Fig. 3.17).

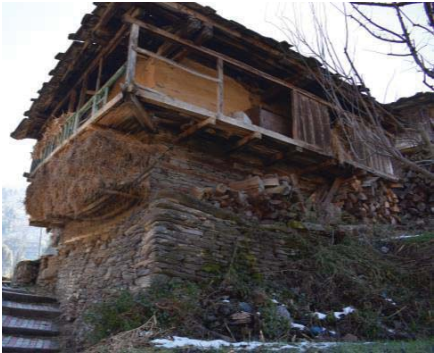
<ul style="list-style-type: none"> <li>• On the stone platform</li> <li>• Three-storied</li> <li>• Timber-laced stone masonry</li> <li>• Timber planks supported on timber floor joists</li> <li>• Sloping roof heavy-weight sheeting without cross-bracings</li> <li>• Stone foundation</li> </ul>	BB-LR-TL-FL3-RF2-FD2

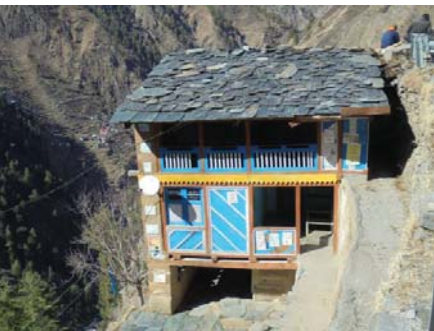
<ul style="list-style-type: none"> <li>• On two foundation level</li> <li>• Single-storied</li> <li>• Timber frame with timber-laced stone masonry</li> <li>• Timber planks supported on timber floor joists</li> <li>• Sloping roof heavy-weight sheeting without cross-bracings</li> <li>• Stone foundation</li> </ul>	FF-LR-TH-FL3-RF1-FD2

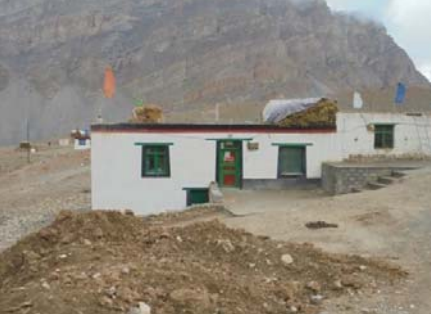
<ul style="list-style-type: none"> <li>• Two foundation levels</li> <li>• Single-storied</li> <li>• Rammed earthen wall</li> <li>• Stone covered with mud or earthen overlay</li> <li>• Flat flexible roof on bamboo floor joists</li> <li>• Stone foundation</li> </ul>	FF-LR-RE-FL4-RF1-FD2
