*A Primer on*  
**Rapid Visual Screening (RVS)**  
*Consolidating Earthquake Safety Assessment Efforts  
in India*

October 2020

National Disaster Management Authority

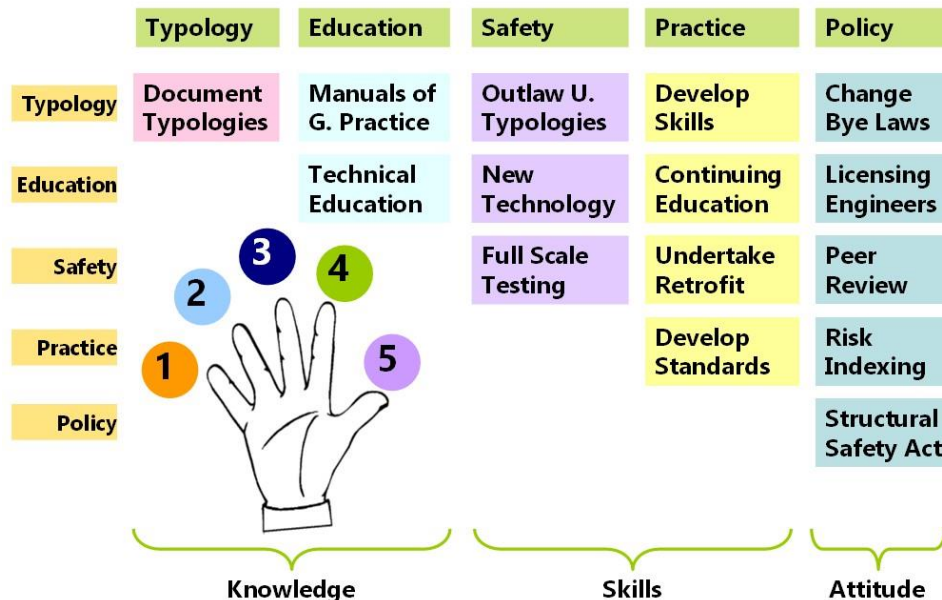
**Figure 1:** Principal activities involved in *Earthquake Disaster Mitigation* and *Risk Reduction*
