# **District Disaster**

# **Management Plan (DDMP)**

**FOR CHIKKAMAGALURU DISTRICT  
2019-20**

## GEOTECHNICAL APPRAISAL, OBSERVATIONS AND RECOMMENDATIONS

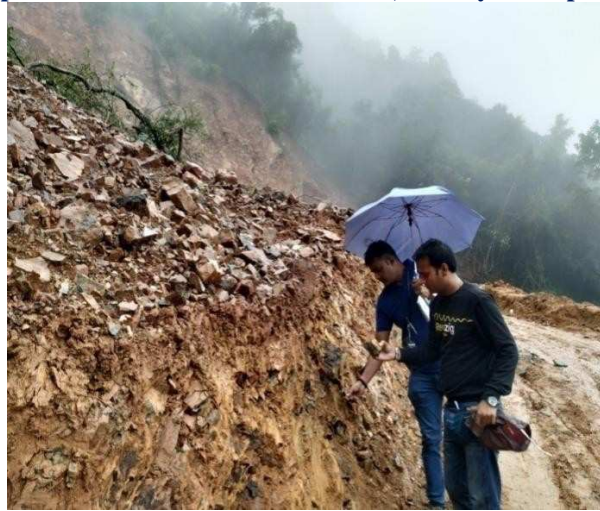
**Highly weathered and thickly saturated mass contributing the weight on slope**

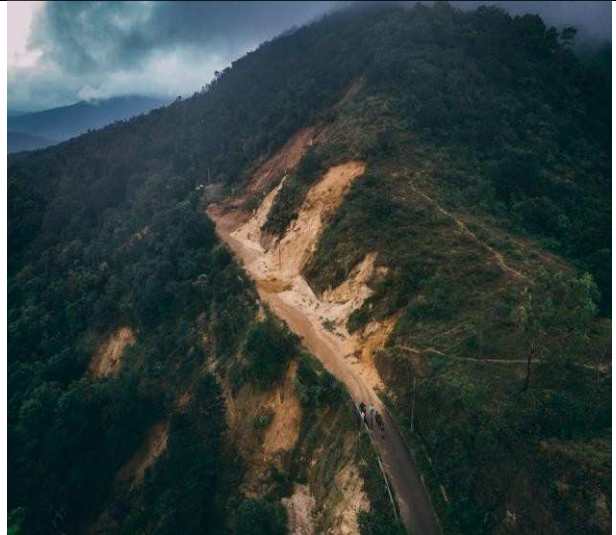
**Bird view of Multiple Debris slides occurred along Hirebail-Hemmakki road at Malleshwaragudda**

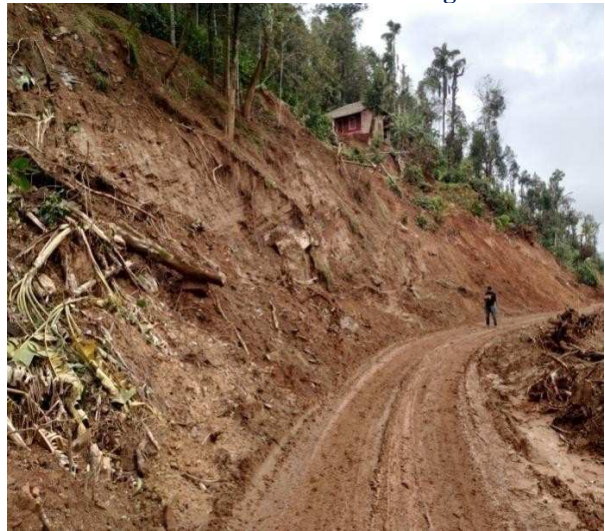
**Close view of a Debris slide occurred along Hirebail-Hemmakki road at Malleshwaragudda.**

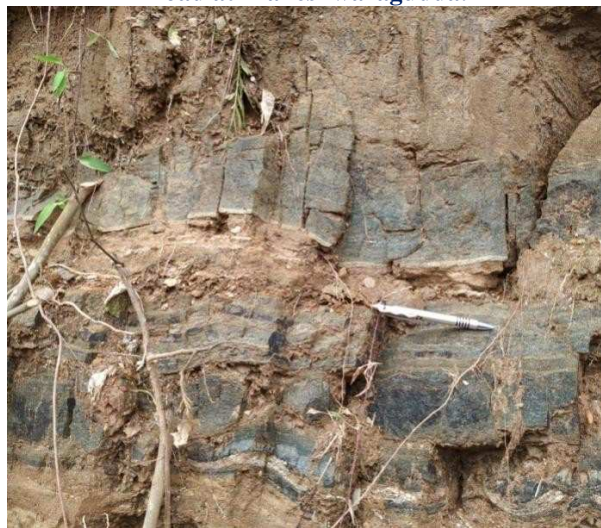
**Incompetent beds lying in between hard and thick jointed beds (BMQ)**

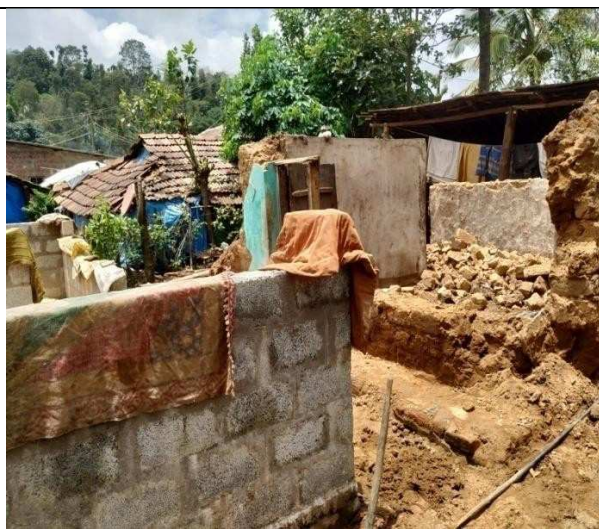
**Construction of house at the flood plain area with weak basement**

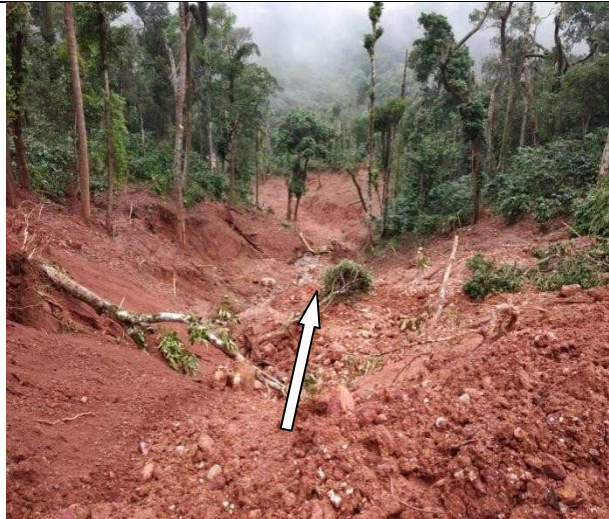
**Debris slides consuming part of coffee plantation at downslope**
